SERVICE LETTER NUMBER 119			
TITLE: Reposition elevator down spring attachment tab			
BY: KMT	AIRCRAFT MAKE/MODEL(S):	FLOAT MODEL(S):	NOTE(S):
APP: KMT	Quest Aircraft Co.	7000S or 7000A	<b><u>MANDATORY</u></b>
DATE: 30-Mar-11	Model 100 Kodiak		<b><u>COMPLIANCE</u></b>
REV: A

SERVICE LETTER P/N: 1005265 for ECO 22339

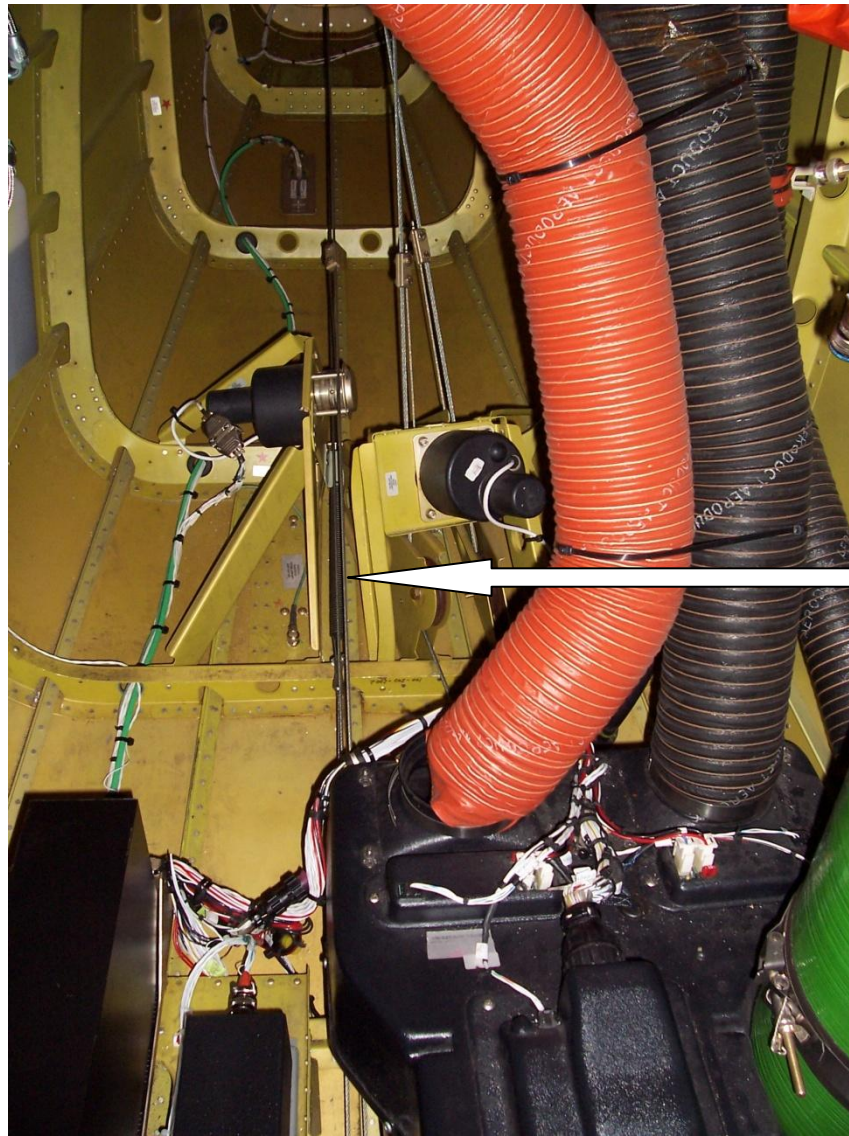
Fig. 1 – General location of elevator down spring (refer to drawing 1004690)  
Looking aft from rear passenger cabin with aft cabin bulkhead removed

- a. Inspect the elevator down spring installation (see fig.1).
  - b. Inspect the lower portion of the elevator cable adjacent to the spring for any damage. The forward most portion of the spring will have the least clearance.

- e. If the spring exhibits any grooves as a result of the rubbing cable, the spring must be replaced. This can be determined by running a finger nail along the spring coil to feel for a groove.

- f. If the cable exhibits *any* fraying, it must be replaced. This can be determined by slowly running a hand along the cable, feeling for frayed strands.

Elevator down  
spring in this  
area

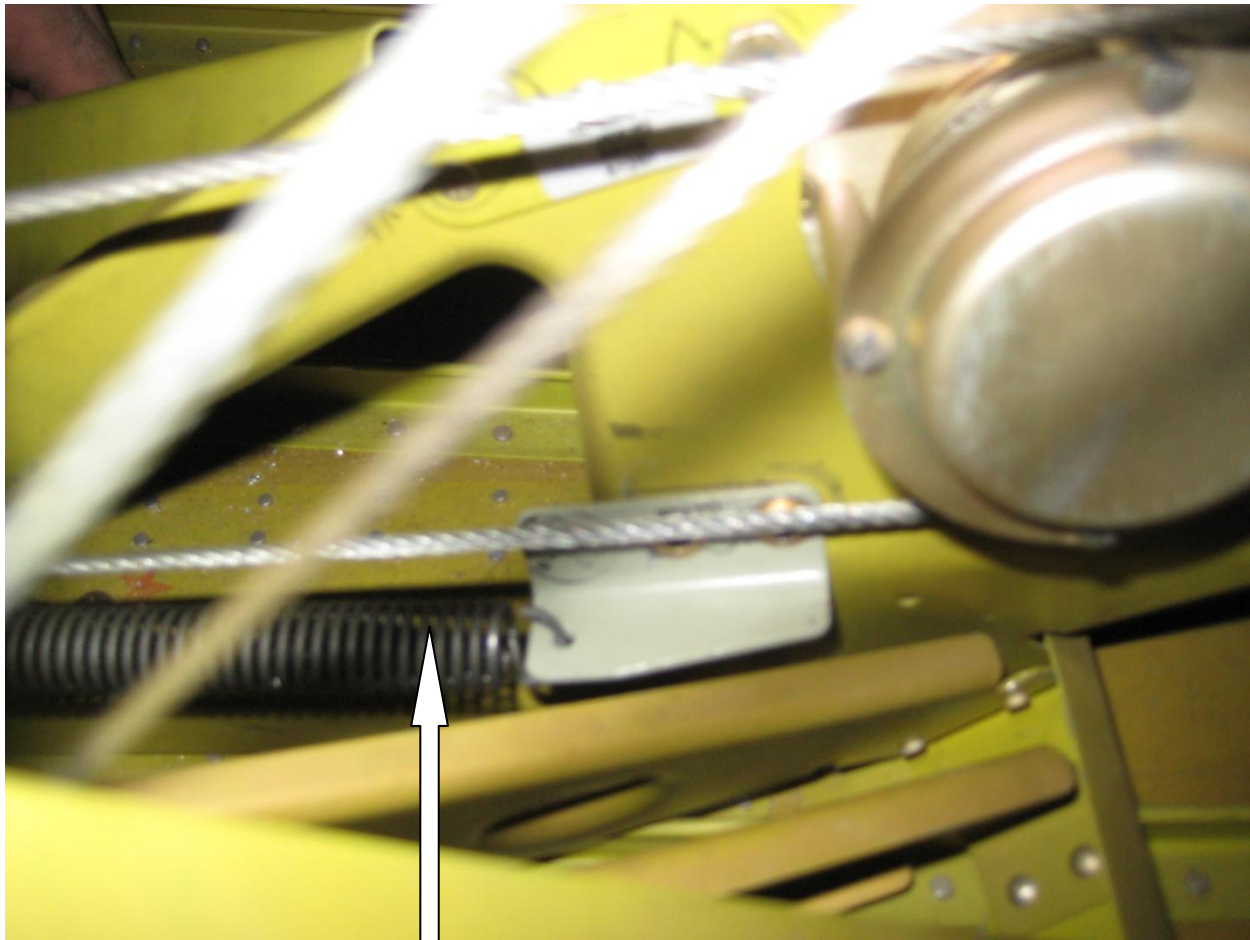
Fig. 3 – Clearance between elevator spring and cable after modification  
Looking starboard from center

Proper gap between spring and cable shown, as determined by hole locations in figures 4 and 5. Clearance between spring and cable must be 1/8 inch minimum at forward end of spring.
