SERVICE LETTER NUMBER 144			
TITLE: DRAG STRUT ATTACHMENT, WASHER REPLACEMENT			
BY: R. GLASS	AIRCRAFT MAKE/MODEL(S):	FLOAT MODEL(S):	NOTE(S):
APP: J. SORTOR	FIREBOSS	10000	MANDATORY COMPLIANCE
DATE: 18-JAN-16	AIR TRACTOR 802 & 802A		S/L P/N 1005968
REV: B			ECO-24216

EFFECTIVITY:

This service letter applies to all S/N 10126A and prior Wipline model 10000 amphibian floats, as installed on "Fireboss" Air Tractor 802 and 802A aircraft. This service letter applies to Air Tractor 802/802A aircraft equipped with STC SA01795CH.

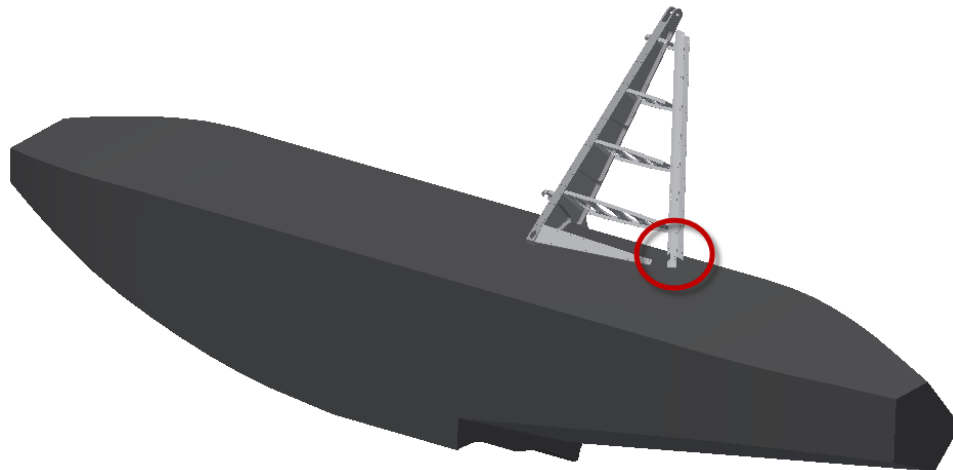
Figure 1: Attachment Location (Strut Fairings Removed)

The bolted attachment of the drag strut to the float has been found to cause coning of the flat washers both under the bolt head and the nut. Deformation of the washers in turn results in a loose bolted attachment.

NOTES: Figure 1 shows the attachment location in question and Figure 2 details the hardware replacement that must be made.
