SERVICE LETTER NUMBER 146			
TITLE: 13000 BULKHEAD #6 CRACK REPAIR			
BY: C. SCHLEMMER	AIRCRAFT MAKE/MODEL(S):	FLOAT MODEL(S):	NOTE(S):
APP: J. SORTOR	DEHAVILLAND TWIN OTTER	13000	COMPLIANCE OPTIONAL S/L P/N 1006027 ECO 24031
DATE: 04/03/15			
REV: B

FAA APPROVAL HAS BEEN OBTAINED FOR TECHNICAL DATA IN THIS PUBLICATION THAT AFFECTS STC OR TSO DESIGN COMPLIANCE

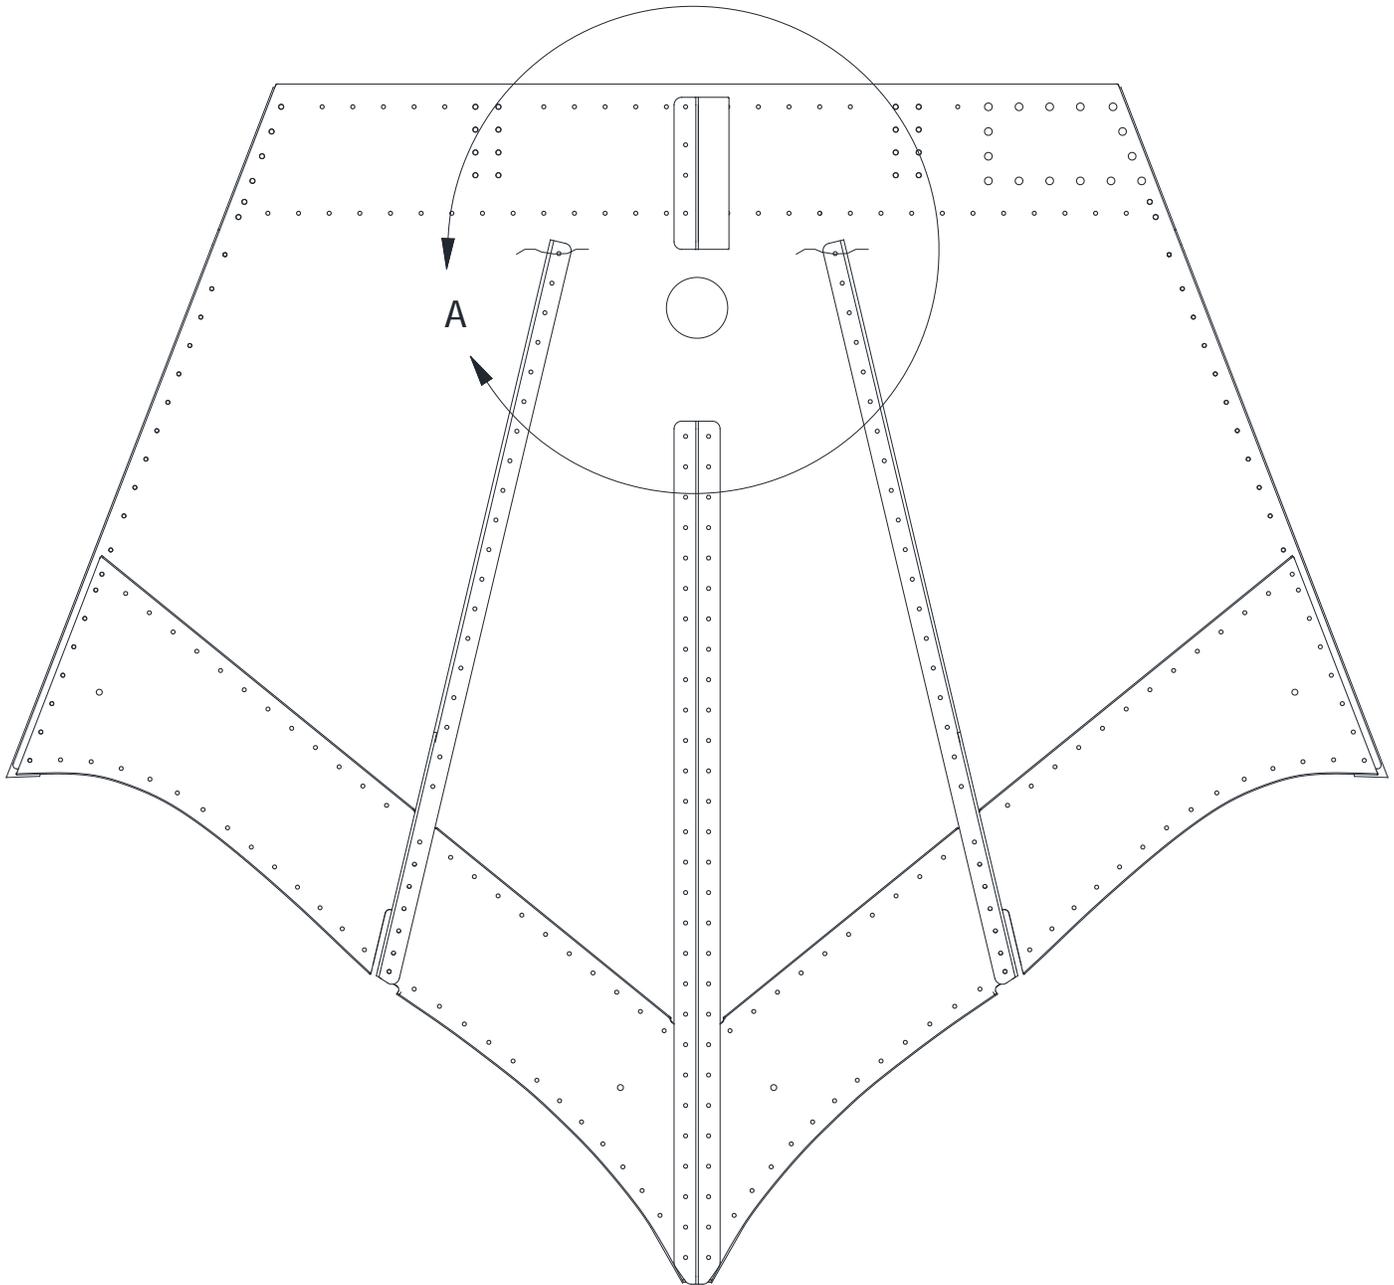
13A01000-190
BULKHEAD #6 ASSY, RH
(AS SHOWN BEFORE REPAIR)

Crack appears on 13A01150-052 Bulkhead Body originating from the top rivet hole in the 13A01359-164 LH and 13A01359-165 RH Sister Keel Angle Attach just below the 13A01160-003 LH and 13A01160-004 RH Upper Strut Fitting Panel requiring repair. This kit includes necessary parts to repair and restore integrity of bulkhead.

REMOVE MATERIAL ENCOMPASSING CRACKS.
MAINTAIN MINIMUM 3X DIA SIZE FROM RIVET LINE.
CORNERS MUST BE 0.50 R MINIMUM.

3. Remove second and third top covers from the front to access 13A01000-190 or -243 bulkhead #6 assembly.
4. Drill out top 7 rivets of 13A01359-165 and -164 sister keel angles and cut off angles as shown in drawing.

5. Drill out remaining rivets in boxed area as shown in Detail A drawing.
6. Trim bulkhead material to completely remove crack. Radius corners of trimmed area to 0.5" minimum. Maintain minimum distance of 3 times the diameter size from rivet line.

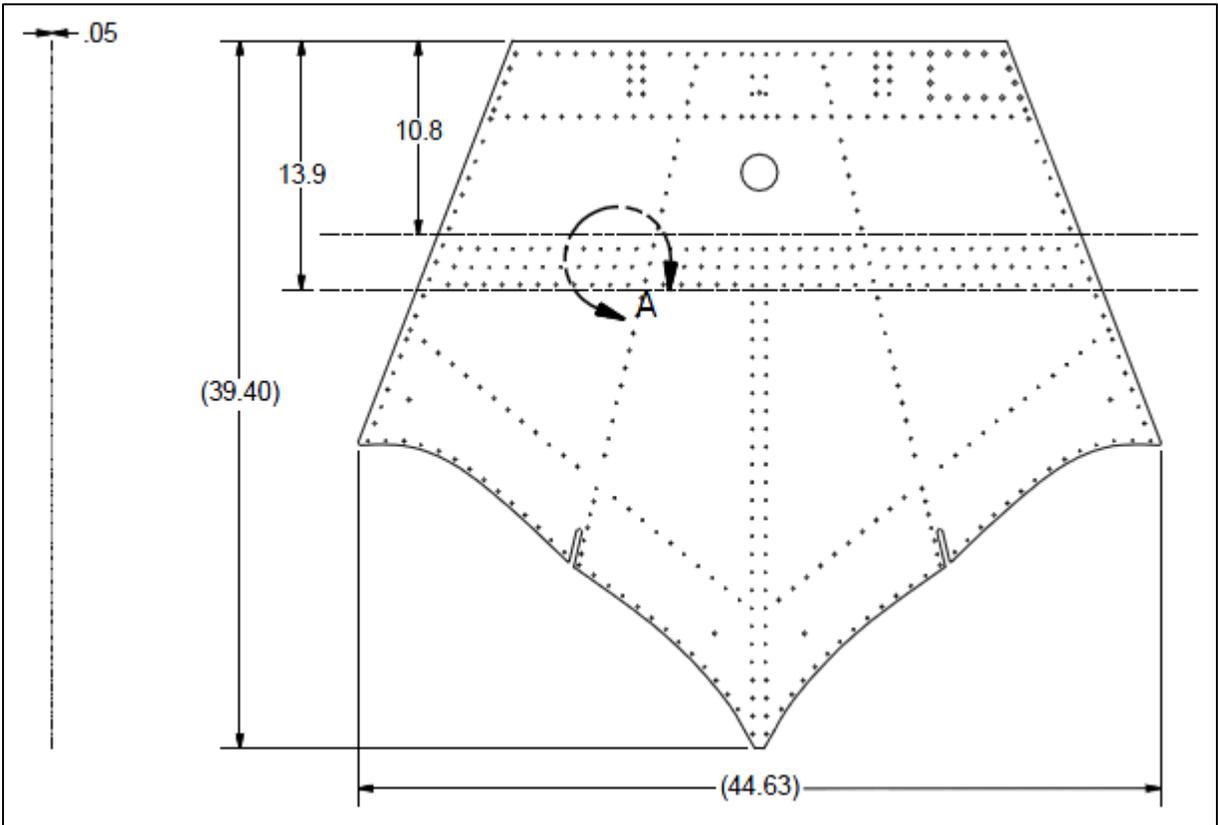
Figure 1 – Bulkhead Splice Repair

The second option is intended to repair the body of bulkhead #6 consisted of removing the damaged upper portion and replacing it with a new upper portion, connecting the original lower portion to the new upper portion with a riveted single overlap splice.

3. Remove required internal stiffeners, side skin attach arms, and top rail attach angle attached to bulkhead #6 as required to complete step 2.
4. Remove the damaged upper portion of the bulkhead body in location indicated by Figure 1.

5. Replace upper section of bulkhead with an upper portion from a new bulkhead body (Wipaire part number 13A01150-052), creating an overlap splice with the original lower section of the bulkhead body as indicated in Figure 1.

6. Reinstall all stiffeners and attach angles using “as designed” rivets, locations and sizes, except in the location of the overlap splice in the bulkhead body. At the splice location, install MS20470AD5 rivets, in original position, length as required. This requires upsizing the holes in the attach angles and stiffeners in the location of the splice; specifically 3 holes in each, except the center “T” section, which will have 6 holes up-sized.

7. Install an additional 96 MS20470AD5 rivets (length as required) in the splice of the bulkhead body as indicated in Figure 1: 11 columns of 3 between the side skin attach arm and the sister keel attach angle on both sides of the bulkhead body; and 5 columns of 3 between the sister keel attach angle and the center “T” section, on both sides of the bulkhead. For the additional 96 rivets, the spacing is defined in Figure 2.
