| SERVICE LETTER NUMBER 157 | | | |
| TITLE: 10000 BULKHEADS 9-12, LOWER FLANGE REINFORCEMENT | | | |
| BY: M.DILLON | AIRCRAFT MAKE/MODEL(S): AIR TRACTOR AT-802, AT-802A | FLOAT MODEL(S): 10000 | NOTE(S): OPTIONAL COMPLIANCE S/L P/N 1008067 ECO - 23622 |

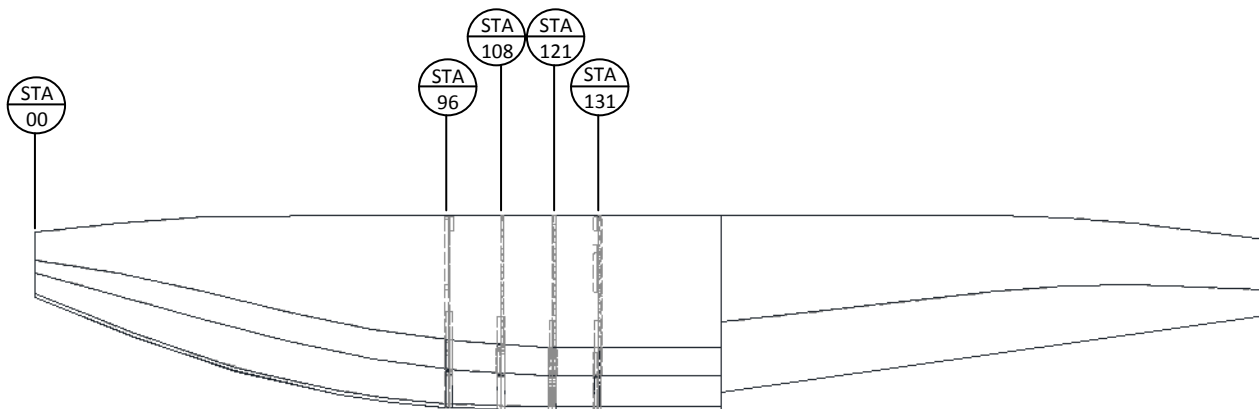
FIGURE 1: AFFECTED BULKHEAD FLOAT STATION LOCATIONS

Aircraft equipped with Wipline model 10000 amphibian floats and regularly operated in rough water may experience cracking of the forward and aft lower bulkhead flanges located in the baggage area of the float as indicated in Figure 1. This service letter and associated kit reinforce the lower bulkhead flanges to reduce probability of cracking as a result of operations in rough water.

- 1) Remove the top deck covers and open baggage hatches to gain access to the affected bulkheads shown in Figure 1. Remove baggage hatch floors to gain access to lower bulkhead flanges.
- 2) If cracks are found in flanges, stop drill as needed.
- 3) After drilling interfering rivets out of existing bulkhead, position the doublers best fit to contour and match drill at each forward and aft lower bulkhead flange.
 - 1 Match drill these rows to existing rivet locations in lower flange and bulkhead face.
 - 2 Add this upper row at 0.5 inch edge distance using the forward doubler, and then match drill into the aft doubler. Match lower row spacing.
