## SERVICE LETTER 182

### FIREBOSS STRUT ATTACH HARDWARE REPLACEMENT

<b>Aircraft Makes/Model(s):</b>	<b>Float Model(s):</b>	<b>Compliance:</b> Mandatory	<b>By:</b> RCG
Air Tractor AT-802, AT-802A	10000A	<b>Part Number:</b> 1009711	<b>Approved:</b> JRS
		<b>Date:</b> 5/2/2018	<b>Revision:</b> A

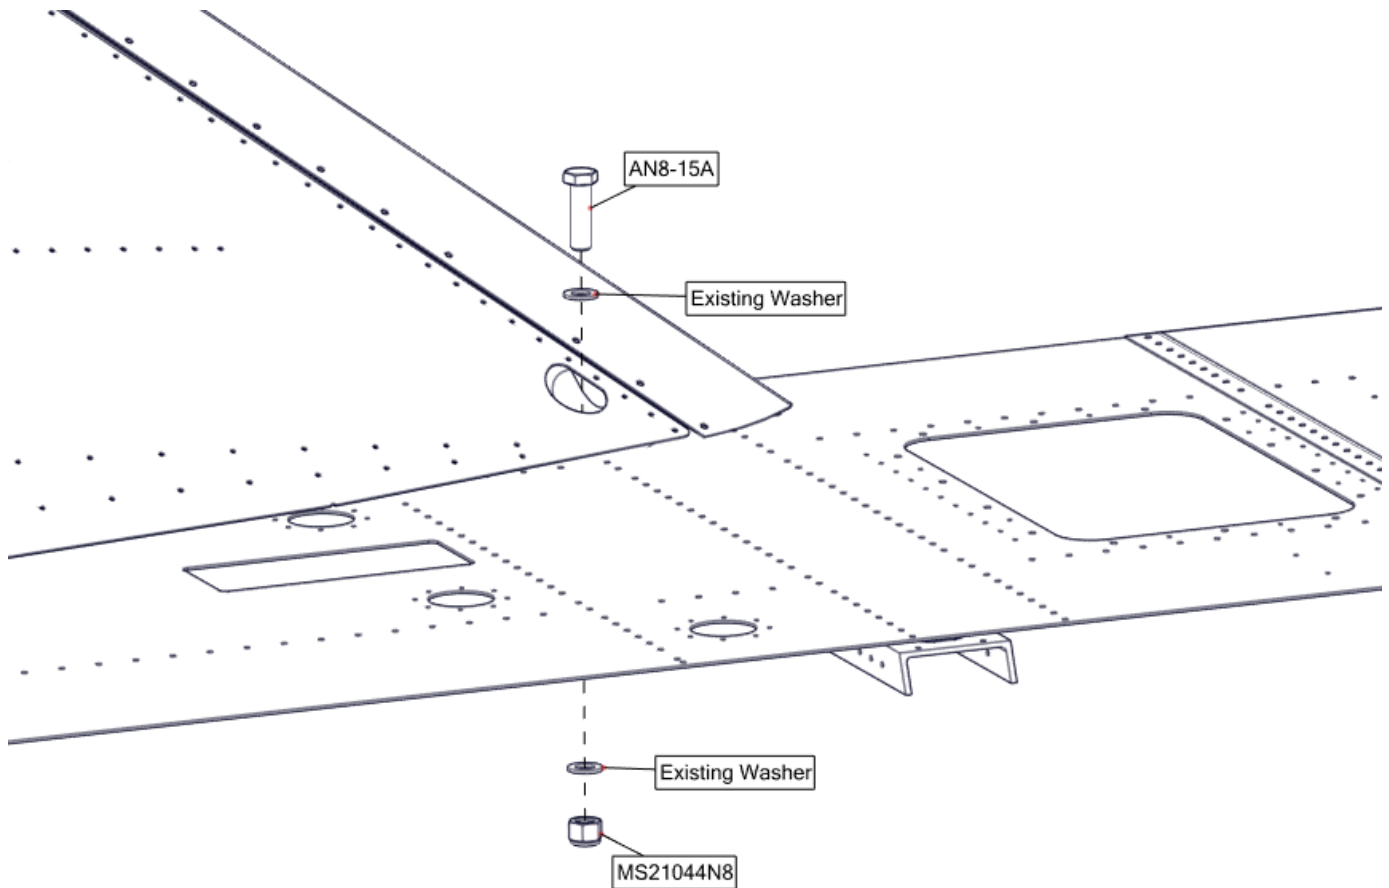
Existing hardware loosens and is wearing on the mounting hole. The hardware is being replaced with different style hardware.

6. Inspect hole in drag strut and top deck for wear. If hole is worn, comply with Wipaire Service Letter 145

1. Defuel aircraft
2. Position and secure aircraft for maintenance
3. Remove weight off pylon and provide for support of float once drag strut attachment hardware is removed
4. Remove access cover between bulkheads 18 and 19
5. Remove hardware shown
