SERVICE LETTER: #20

SUBJECT: Inspection of Fuselage Lateral Support Beam

EFFECTIVITY: Cessna 208 Caravan with Wipline 8000 floats,
built before January 1, 1990

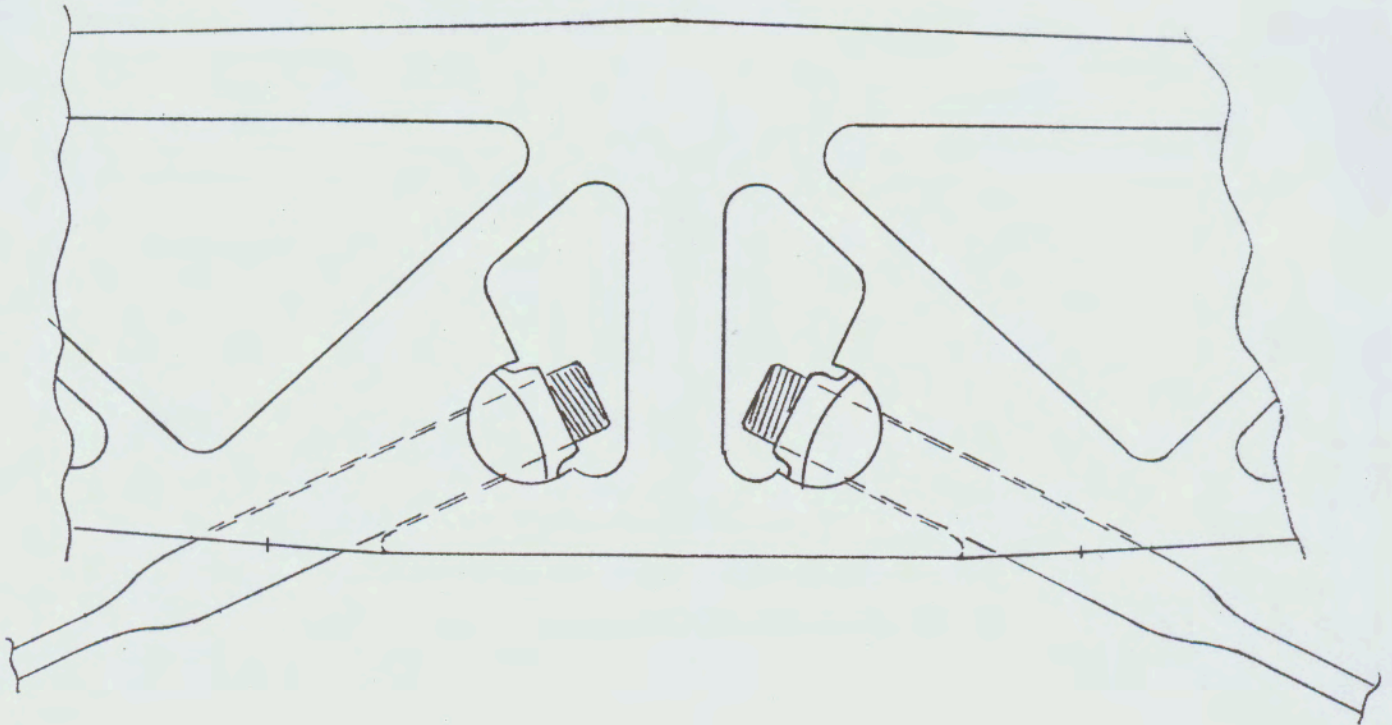
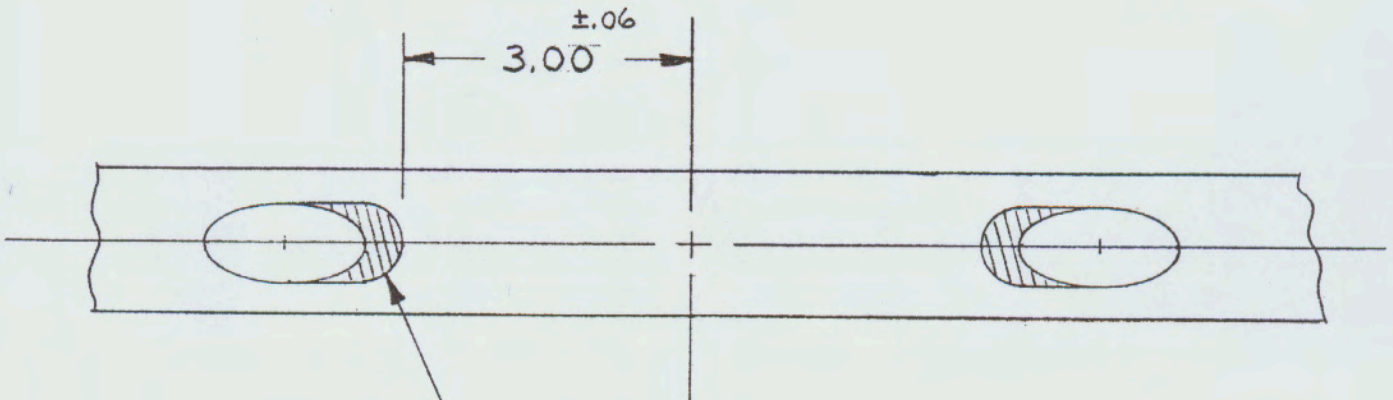
SKETCH S/L 20

COMPLIANCE: To inspect for cracks around .81 dia. drag wire holes in lateral support beam. Remove the main gear access cover located on the belly of the aircraft, that covers the lateral support beam. Locate hole where the drag wire goes thru, and visually inspect for cracks around hole, apply dye penetrant to determine if cracks are present, and to what extent they have developed. See sketch for area to be modified, also remove drag wires and inspect for corrosion, clean any corrosion and apply a flim of grease in the hole and on the wire prior to reinstallation.

RELIEF AREA—REMOVE
ALUMINUM AS SHOWN
.406 $\pm .015$ RADII
BREAK EDGE AROUND HOLE
.06-.12 RADII
