<p style="text-align: center;"> <small>           • MANUFACTURERS OF WIPLINE FLOATS &amp; SKIS            • SPECIALISTS IN AIRCRAFT MODIFICATION            1700 Henry Avenue - Fleming Field            South St. Paul, MN 55075            651-451-1205         </small> </p>			Rev / Latest Rev. Date B/ 11-26-08
			Original Release 11-20-08
Prepared by Ellen Parker	Aircraft Make / Model	Float / Ski Model Wipline 10000 Amphibious Floats	Page 1  2
	Title 10000 float baggage floor repair		
<b>ALL INFORMATION IN THIS SERVICE DOCUMENT BASED ON FAA APPROVED DATA</b>

## **SERVICE LETTER: 101**

**EFFECTIVITY:** All 10000 floats up to and including 10084A

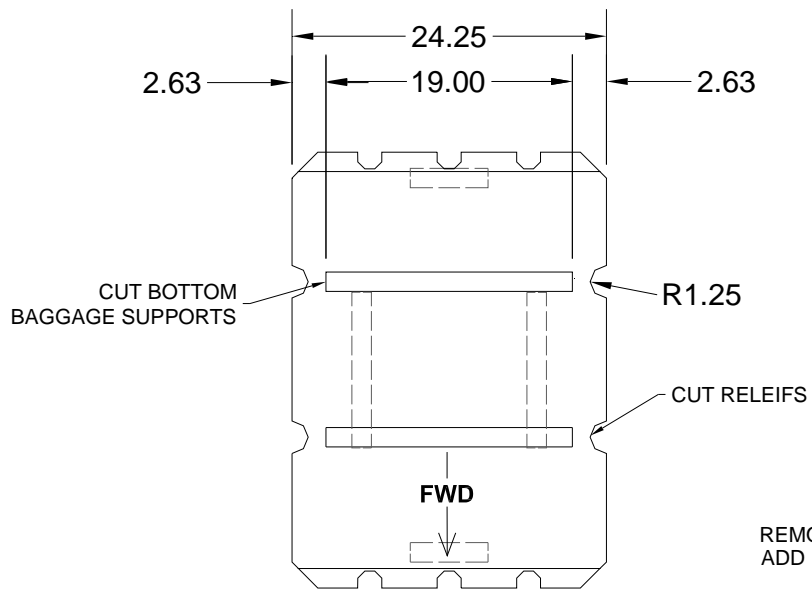
FIGURE C

**BACKGROUND INFORMATION:** A few operators have experienced the baggage bulkheads cracking. After investigation it was determined this can happen because the baggage floor flexes under loads and puts pressure on the nearby bulkheads.

**If no damage** is found Wipaire recommends owner-operators cutting reliefs in the baggage floor as shown in **figure C, page 2 and installing Wipaire Service Kit 74.**
