Prepared by Ellen Parker	Aircraft Make / Model Single Otter	Float / Ski Model 8000 Amphibious or Seaplane floats	Page 1 3
FAA Reviewed <input checked="" type="checkbox"/>	Title 8000 Water Rudder Pivot Shaft and Springs Inspection

SERVICE LETTER: 106

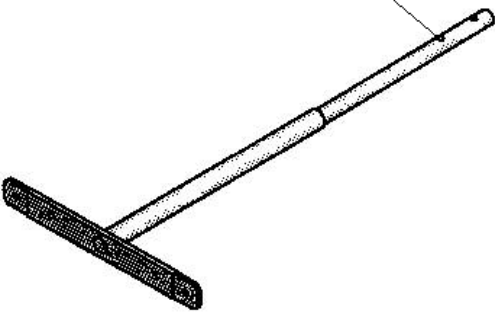
EFFECTIVITY	8000 Amphibious or Seaplane floats
COMPLIANCE	Inspection of the springs and shaft is mandatory. Replacement of the water rudder pivot shaft assemblies are at Owner/Operator discretion or if part of the assembly has failed or is damaged.
BACKGROUND	<p>Wipaire received reports of several failures of the water rudder pivot shaft assembly. The failures have occurred at the lower of the two retainer holes on the upper end of the shaft (see figure 1).</p> <p>Point where known failures have occurred.</p>

Some shafts may be experiencing hydrogen embrittlement causing the failure.

1. All aircraft should be inspected to insure the springs are installed and operating properly. If the springs are missing, corroded or in any way not functioning, they must be replaced.
2. At the Owner/Operator's discretion or if a shaft failure occurs the shafts should be replaced with the improved shafts.
3. Make a logbook entry regarding the compliance of this Service Letter.

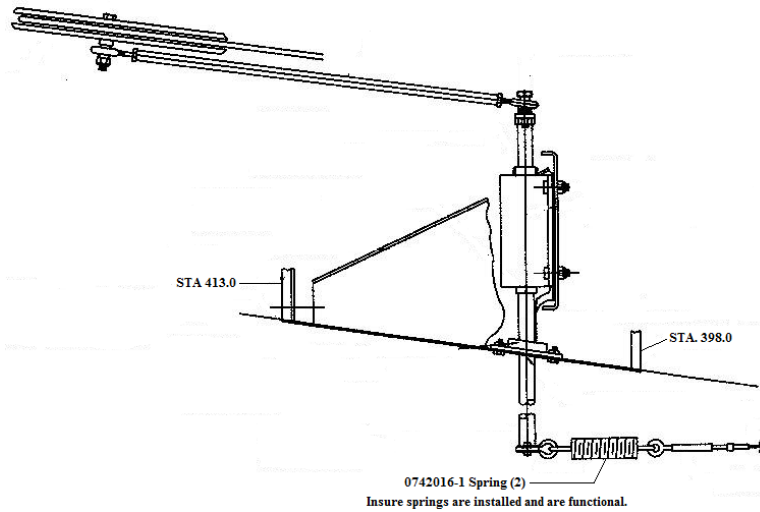
FIGURE 2

<p style="text-align: center;">FIGURE 1</p> <p>There are two possible causes for these failures:</p> <p>The springs attaching the cables to the tiller bar at the end of the shaft may be missing or damaged. These springs provide shock load relief for the shaft assembly. If they are compromised they could place high loads on the shaft assembly (see figure 2).</p>
