SERVICE LETTER 126 PAGE 1 of 2 REV: B

SERVICE LETTER NUMBER 126			
TITLE: STERN BULKHEADS, LOWER FLANGE REINFORCEMENT			
BY: K. TAYLOR	AIRCRAFT MAKE/MODEL(S):	FLOAT MODEL(S):	NOTE(S):
APP: R. ADLER	1		OPTIONAL COMPLAINCE
DATE: 7-DEC-11	FIREBOSS	10000	S/L P/N 1005511
REV: B	AIR TRACTOR 802 & 802A		ECO 22619

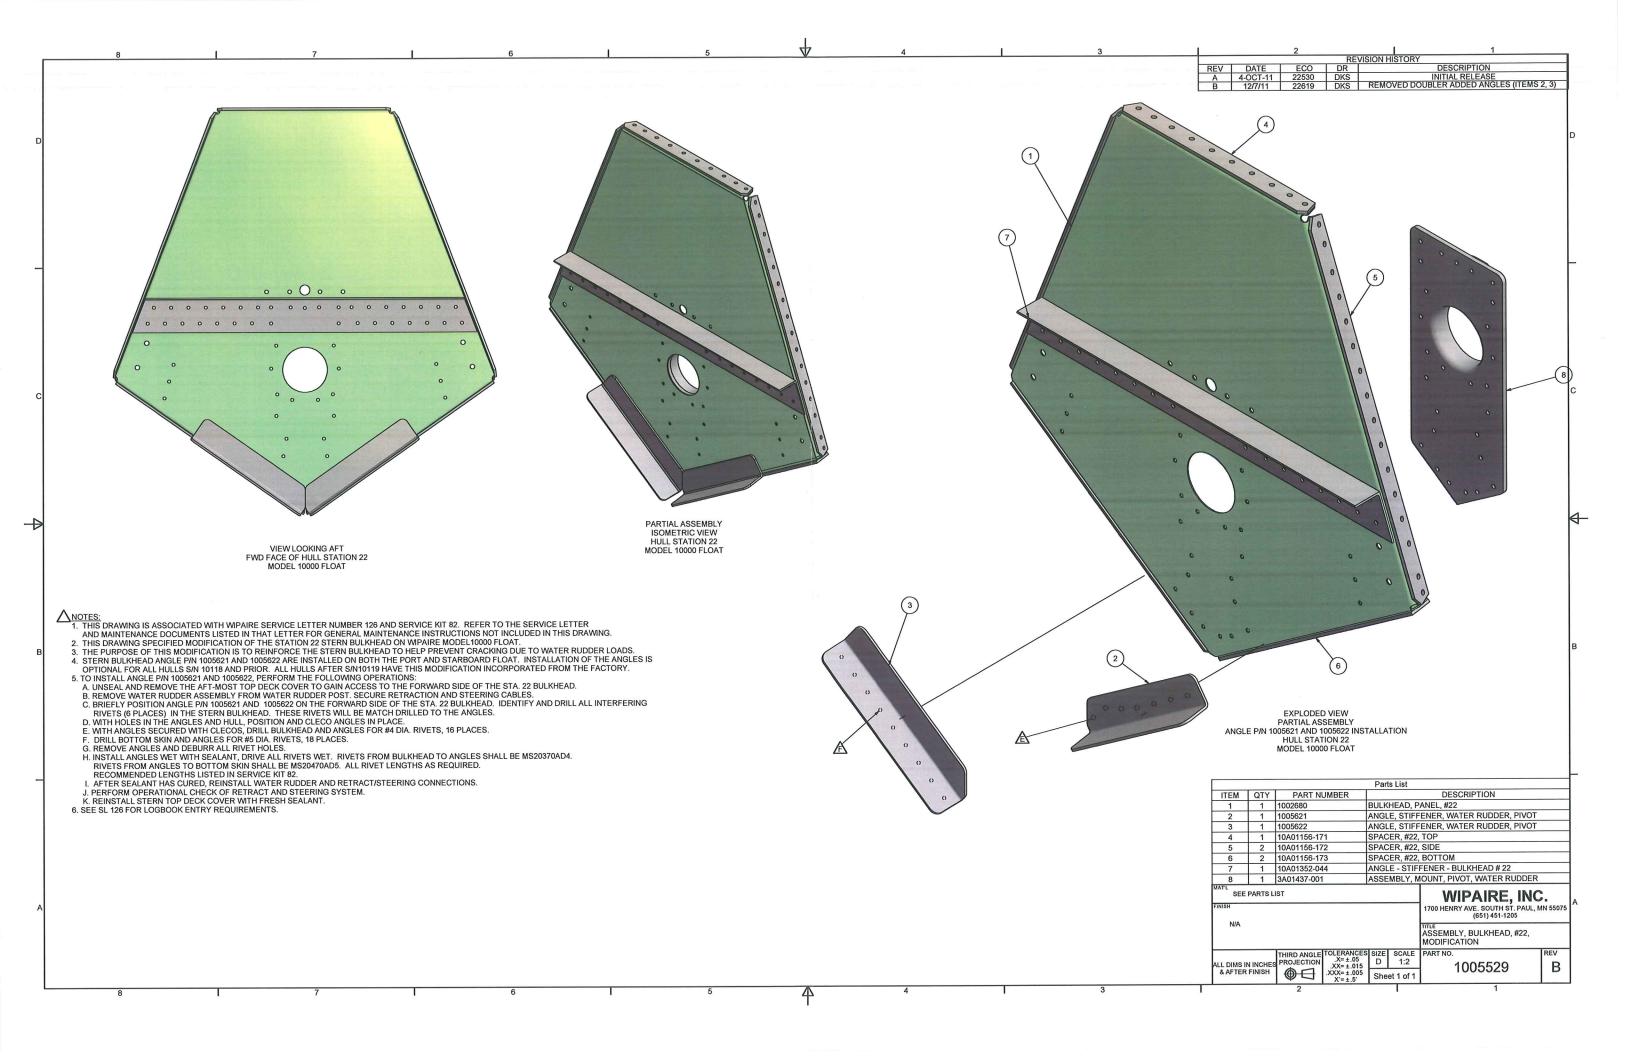
Certain aircraft operated in rough water or operated in a high-cycle water scooping environment may experience cracking of the lower stern bulkhead flanges below the lower water rudder post attachment. This service letter and associated kit reinforce the lower bulkhead flanges of the stern bulkheads to assist in load transfer and reduce probability of cracking.

To accomplish this modification: Install lower angle doublers P/N 1005621 and 1005622 on the forward side of hull bulkhead station 22 in accordance with modification drawing P/N 1005529, latest approved revision. Follow the detailed instructions on the modification drawing to install the angles. The doubler should be installed on both the port and starboard hulls. For reference, the stern bulkhead assembly is P/N 1002681. The angles tie the bottom skin to the bulkhead and reinforce the structure.
