SERVICE LETTER NUMBER 137			
TITLE: INSTALLATION OF ANGLE REINFORCEMENT ON MODEL 7000 AFT BULKHEAD			
BY: D. Smith	AIRCRAFT MAKE/MODEL(S):	FLOAT MODEL(S):	NOTE(S):
APP: D. Garrett	Quest Kodiak 100	7000 Amphibian	OPTIONAL COMPLIANCE
DATE: 11/19/13			S/L P/N 1005839
REV: A			ECO--22949

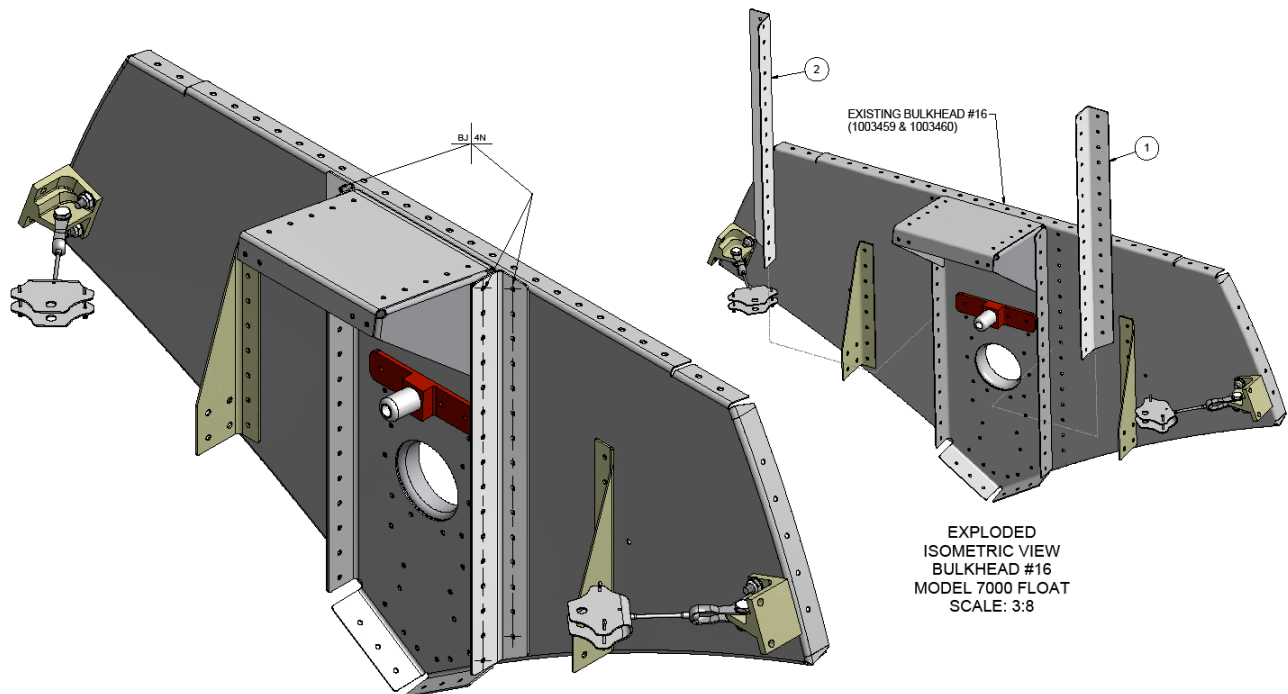
P/N 1003229 is a doubler for the water rudder pivot block, and also helps reinforce the stern bulkhead. Certain hulls have exhibited buckling of the forward flange on P/N 1003229 during normal operations. The buckling behavior of this particular structure is not critical and does not affect airworthiness of the seaplane. This service letter and associated kit reinforce the flanges of P/N 1003229; two angles are added to the flanges of the doubler, to increase the buckling strength of the subject flange.

1. See image below.
2. Open aft most top deck cover to gain access to the forward face of the stern bulkhead.
3. If the flanges of P/N 1003229 are buckled or deformed, hand form them back into position using duckbill pliers or other sheet metal forming tools. Be sure not to penetrate the surface finish with pliers as to help prevent future corrosion.

4. Position the angles, one at a time, against the flange of the doubler.
5. Match drill the doubler flanges and stern bulkhead from the angle using a #30 drill bit. (see drawing).

6. Remove angles, deburr all drill holes, and touch up any exposed surfaces with primer.
7. Rivet angles to the doubler flange and the stern bulkhead. Parts should be riveted wet with adhesive/sealant (see Maintenance Manual 1004646 for adhesive/sealant type).

8. After riveting, touch up rivet heads with primer to help prevent corrosion.
9. Replace and seal stern top deck cover.
