SERVICE LETTER NUMBER 153			
TITLE: FLOAT PUMP OUT TUBE INSPECTION			
BY: M.DILLON	AIRCRAFT MAKE/MODEL(S):	FLOAT MODEL(S):	NOTE(S):
APP: D.GARRETT	ALL MAKE/MODELS EQUIPPED WITH WIPLINE FLOATS	ALL WIPLINE FLOATS	MANDATORY INSPECTION S/L P/N 1006820 ECO--23440
DATE: 10/24/13			
REV: A

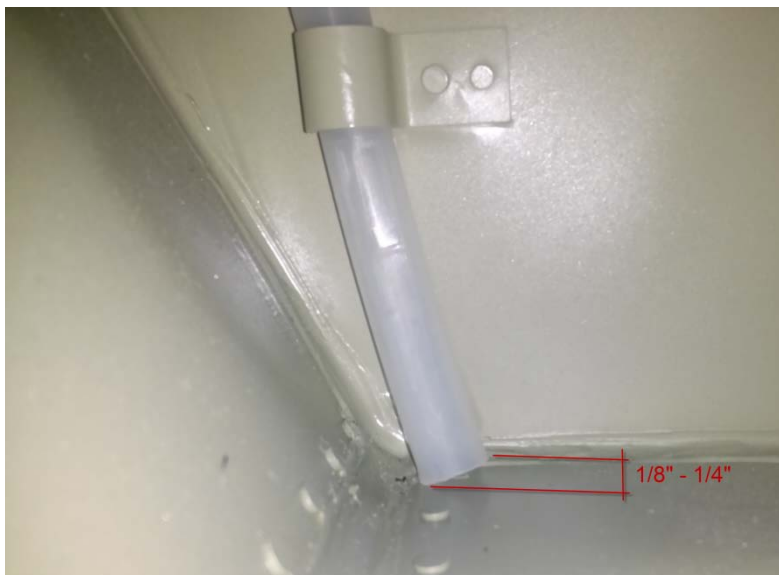
Figure 1

Pump Out Tube has difficulty functioning and may become blocked if the tube opening is in contact with the bottom float skin. This blockage creates suction between the tube and bottom skin when attempting to purge water from compartments, and results in an accumulation of water in the float bays. Prolonged contact between the Pump Out Tube and bottom skin can cause visible wear and potential wear through of the bottom skin.

1. Open inspection covers and visually inspect all Pump Out Tubes. In locations where the tube opening is parallel to the bottom float skin, measure the distance between tube opening and skin (figure 1).
 - a. If distance is 1/8" to 1/4", proceed to Step 3.
 - b. If distance less than 1/8", proceed with corrective action in Step 2.
