SERVICE LETTER 170 REVISION A PAGE 1

SERVICE LETTER NUMBER 170 AIR TRACTOR EMPENNAGE CRACKS

This service letter applies to: Air Tractor models AT802 and AT802A with Wipline 10000A Fireboss Amphibious Floats installed per STC SA01795CH

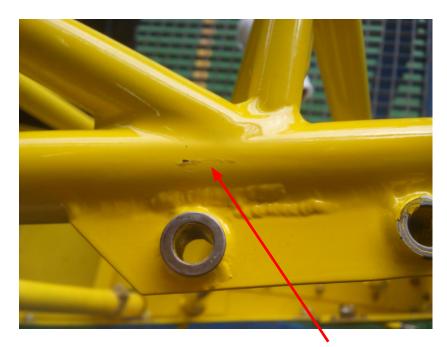
Fuselage cracking has been found in areas such as the horizontal tail section, tail pedestal, and upper longeron section

1. Inspect empennage for cracking per 1 of the 2 following methods. Inspection area and examples of cracking are shown below:

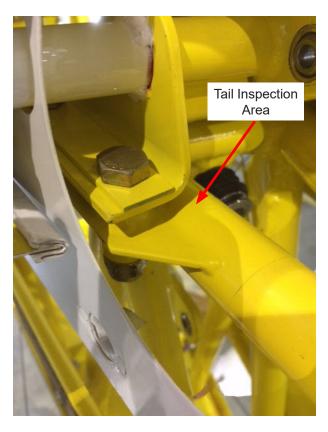
Example of a crack

Inspect critical areas every 50 hours. Use an inspection mirror and flashlight to look for cracks on the pedestal mounts. Use the access location shown in Figures 1 through 4. At certain angles, deformations in the paint may be seen. These deformations could signify a fracture has been created under the paint and should be addressed immediately. Cracks that have broken through the paint should be addressed and repaired with the use of Air Tractor Service Letter or Service Kit, or any additional guidance given by either Air Tractor or Fireboss on a case by case basis.

Inspect critical areas every 50 hours. Use a 6 or 8 mm borescope to inspect the locations shown in Figures 1 through 4 and the pedestal mount for any deformation in paint or signs of cracking.
