Prepared by MAS	Aircraft Make / Model Single Otter	Float / Ski Model 8000 Amphibious or Seaplane floats	Page 1 3
FAA Reviewed <input checked="" type="checkbox"/>	Title 8000 Water Rudder Pivot Shaft and Springs Inspection

SERVICE LETTER: 106

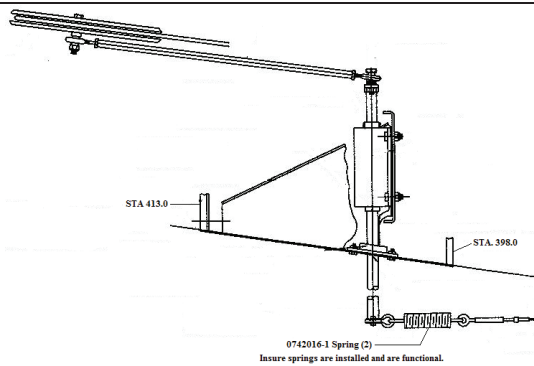
FIGURE 2

<p style="text-align: right;">FIGURE 1</p> <p>There are two possible causes for these failures:</p> <p>The springs attaching the cables to the tiller bar at the end of the shaft may be missing or damaged. These springs provide shock load relief for the shaft assembly. If they are compromised they could place high loads on the shaft assembly (see figure 2).</p>

Some shafts may be experiencing hydrogen embrittlement causing the failure.

1. All aircraft should be inspected to insure the springs are installed and operating properly. If the springs are missing, corroded or in any way not functioning, they must be replaced.
2. At the Owner/Operator's discretion or if a shaft failure occurs the shafts should be replaced with the improved shafts.
3. Make a logbook entry regarding the compliance of this Service Letter.
