SERVICE LETTER NUMBER 157			
10000 BULKHEADS 8-12, LOWER FLANGE REINFORCEMENT			
BY: MAS	AIRCRAFT	FLOAT MODEL(S):	NOTES: OPTIONAL
APP: DRH	MAKE/MODEL(S):	10000	COMPLIANCE
DATE: 3/11/2026	AIR TRACTOR		S/L P/N 1008067
REV: C	AT-802, AT-802A

This service letter applies to Air Tractor AT-802 and AT-802A when equipped with Wipline model 10000 floats (STC SA01795CH), float serial numbers 10268A and prior.

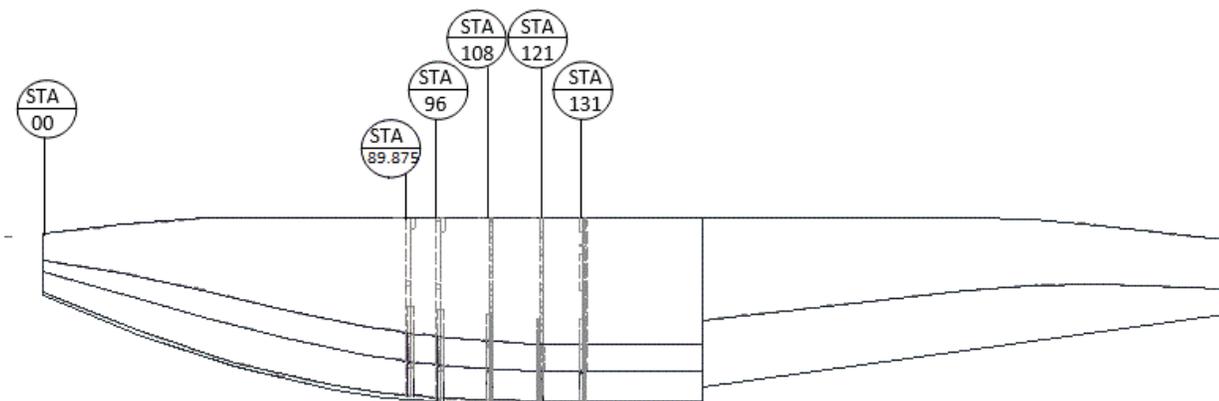
FIGURE 1: AFFECTED BULKHEAD FLOAT STATION LOCATIONS

Aircraft equipped with Wipline model 10000 amphibian floats that regularly operate in rough water, may experience cracking of the forward and aft lower bulkhead flanges located in the baggage area of the float as indicated in Figure 1. This service letter and associated kit reinforce the lower bulkhead flanges to reduce probability of cracking as a result of operations in rough water. Reinforced flanges for these bulkheads became standard production for float serial numbers 10269A and later.

- 1) Remove the top deck covers and open baggage hatches to gain access to the affected bulkheads shown in Figure 1. Remove baggage hatch floors to gain access to lower bulkhead flanges.
- 2) If cracks are found in flanges, stop drill as needed.
- 3) After drilling interfering rivets out of existing bulkhead, position the doublers best fit to contour and match drill at each forward and aft lower bulkhead flange.
