SERVICE LETTER: 76

DATE: July 18, 2024

TITLE: AT-802 Fire Boss Finlet Inspection & Repair

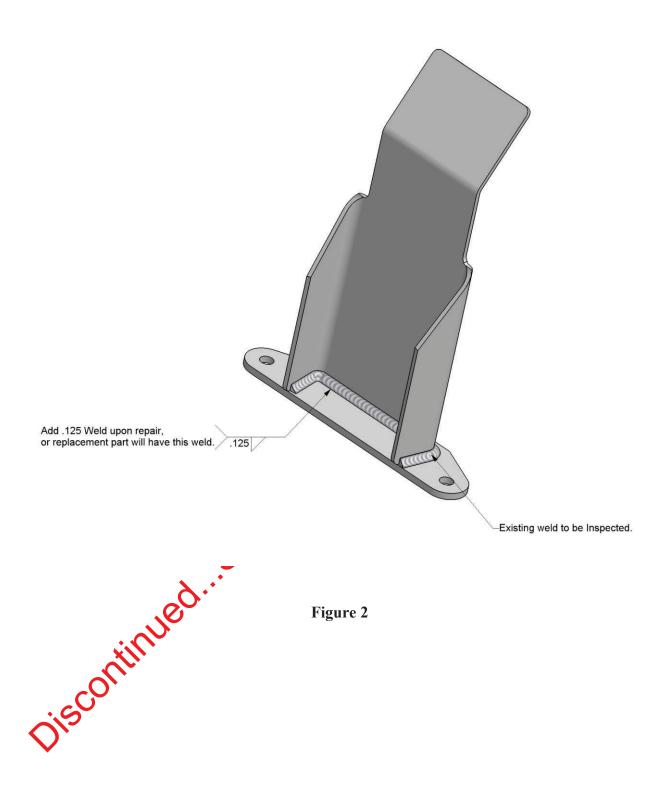
BACKGROUND INFORMATION: AT-802 with Fire Boss modifications have been experiencing cracking along the weld on the front bracket that holds the finlet onto the horizontal stabilizer. Thus far the cracks have been limited to the early model conversions. Corrosion in this area may have been a factor.

Visually inspect the welded seam of the finlet's forward attach bracket (p/n 10A12000-070) for cracks along the weld. Fax or email results of inspection as noted below. Pictures may be helpful to Wipaire Engineering.

Option 2: Remove the bracket from the finlet using the directions included for field replacement in Service Kit 55. Remove all finish from the bracket. Clean and re-weld crack area and continue the weld all the way around the bracket, as shown in Figure 2, as per FAR 43.13. Stress relieve the bracket and re-price and paint for corrosion protection.
