SERVICE LETTER 172 8750A BULKHEAD 9 CRACKING

By: MAS	Aircraft Makes/Model(s): Cessna 208 Cessna 208B Quest Kodiak 100	Float Model(s): 8750A 7000A	Note(s): Mandatory Compliance Service Letter P/N 1008990
Approved: DRH			
Date: 8/14/2023			
Revision: D

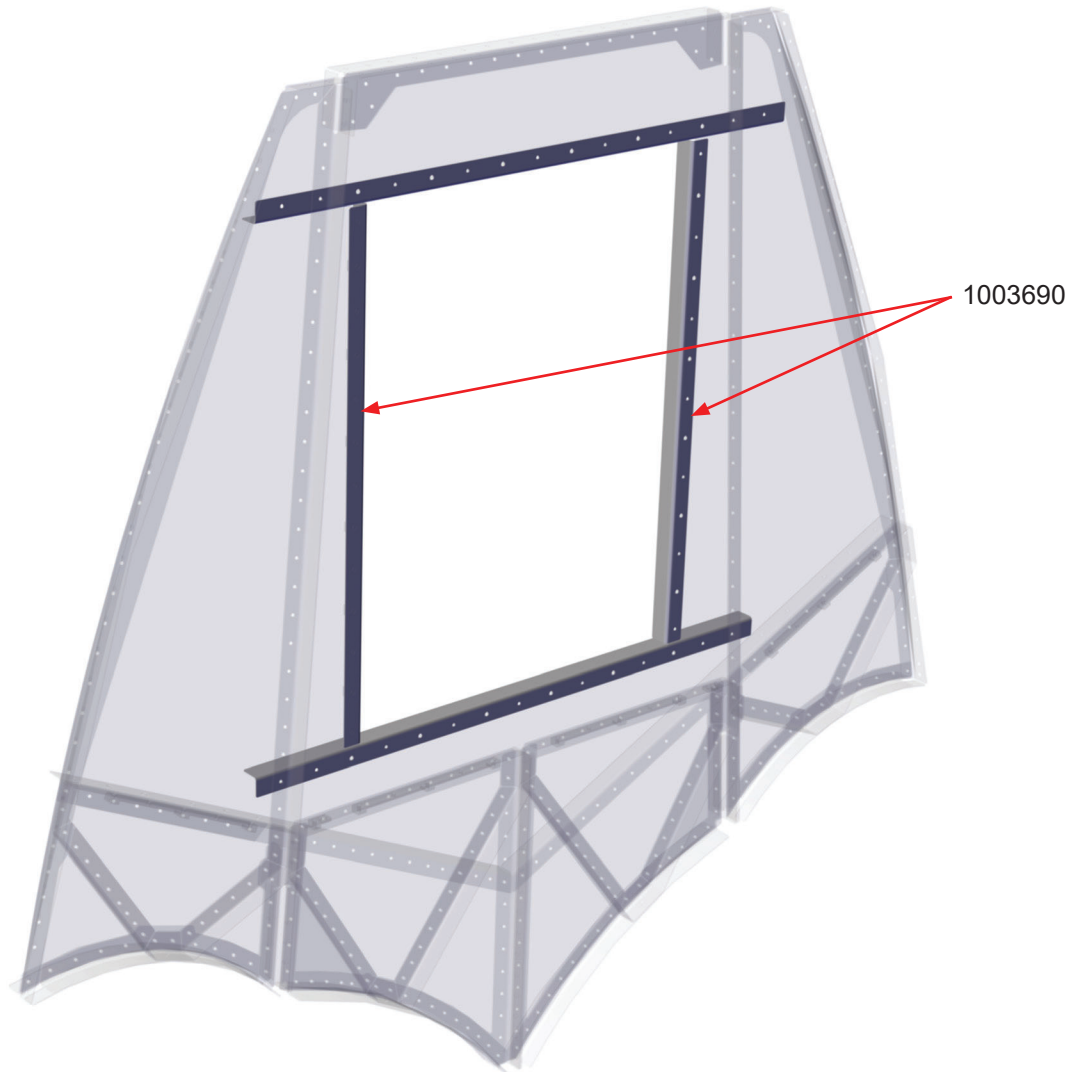
Cracking has been found on the 1006080 Bulkhead 9 Main Panel. The 1003690 Vertical Stiffeners have been revised to include a flange that will be riveted to the Horizontal Stiffeners for additional support

1. Gain access to the bulkhead 9 assembly through the aft baggage compartment and remove 1003688 Bulkhead 9 Access Panel. Discard (24) AN526-832R6 screws
2. Drill out (2) 1003690 Vertical Stiffeners
