## SERVICE LETTER NUMBER 174

### 3000A/3450A MAIN LANDING GEAR SHAFT REPLACEMENT

| <b>By:</b> MAB | <b>Aircraft Makes/Model(s):</b><br><br>Cessna 180 (through K model), 185 through E model), A185E, A185F, 182 (P through T model), 206H, T206H, T/U206 (through G model)<br><br>Maule M6-235, M7-235, M7-260, M7-420, MT7-235, MT7-260, MT7-420, MX7-235 | <b>Float Model(s):</b><br><br>3000A<br>3450A | <b>Note(s):</b><br><br>Mandatory Compliance<br><br>Service Letter P/N 1009195 |

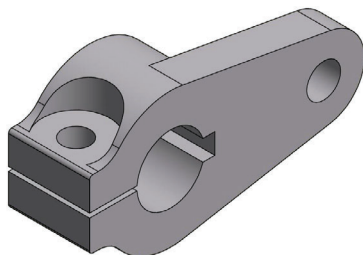
Revision A

<sup>1</sup> 1005280 gear actuator arm could be revision A or B depending on when the floats were manufactured. This work instruction shows revision B. If revision A is installed, use following images for reference only as NAS6206-21 bolt could be an AN bolt and installed from the opposing direction
