SERVICE LETTER

SKI SERVICE LETTER NO. 1

Subject: **INSPECTION OF SKI YOKE ARM**

Models Affected: **MODEL 3000 SKIS**

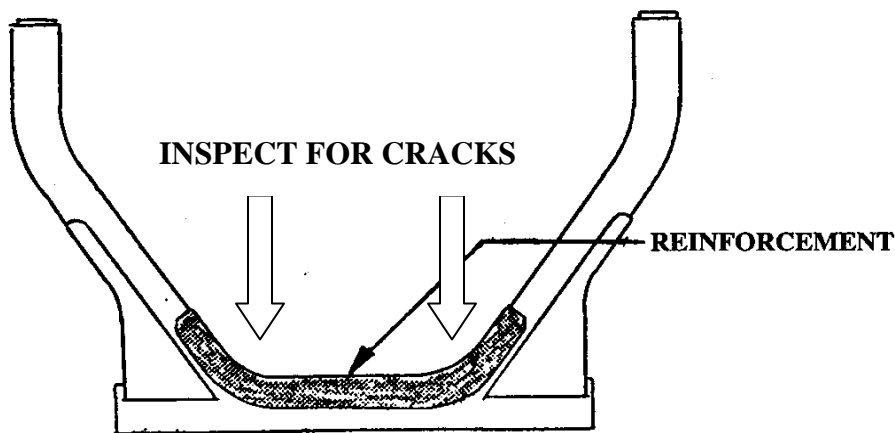
F3099-2 REINFORCED YOKE ARM

The purpose of this letter is to inform owners of Fli-Lite Skis to inspect the yoke arm in the areas noted on the sketch below. The yoke arm Fli-Lite p/n D-3099-1 (one rod-end bearing) and D-3099-2 (2 rod-end bearings) is the part affected.

Visually inspect the yoke arm every 25 of flight time for possible cracks in the areas noted.

If cracks are found, replace the yoke arm with re-enforced yoke arm p/n F3099-2.

If yoke arm re-enforcement (F3099-2) is installed with the gusset as shown in the sketch below, the inspection is not required.

Since this yoke arm is heat-treated, no field repair should be attempted.
