SERVICE LETTER 190

8750 SERIES BONDED STIFFENER CORROSION

Aircraft Makes/Model(s):	Float Model(s):	Compliance: Mandatory	By: MAS
Textron Aviation 208 and 208B	8750 Series	Part Number: 1009944	Approved: DRH
		Date: 6/28/2024	Revision: E

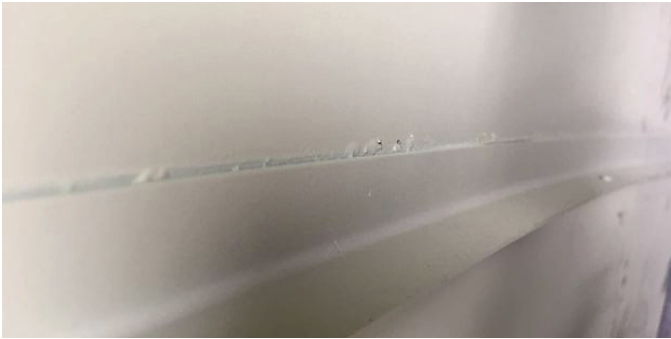
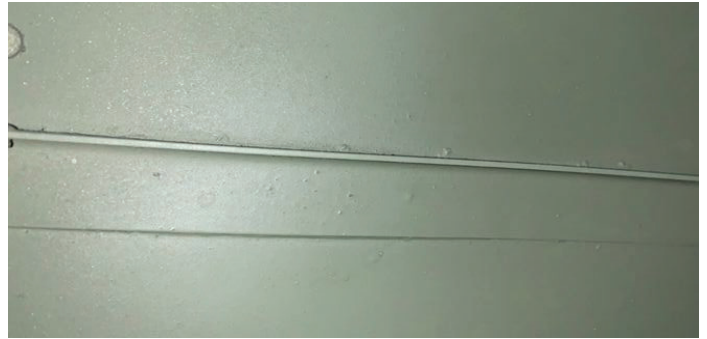
Condition 1 - No corrosion or minimal superficial corrosion is present

- Perform [Work Instruction - Method A](#) below.

1. Do not remove stiffener. Clean, alodine and prime any visible corrosion found on the interior of the side skin or the stiffener.
2. Seal the sides of stiffener with PR 1422-B2 or equivalent.

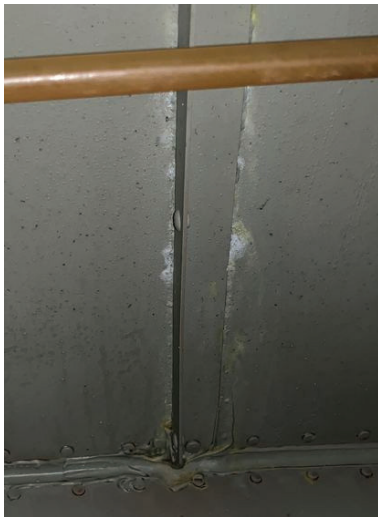
Condition 2 - Corrosion is visible around the stiffener, and the stiffener will need to be removed for replacement and for closer inspection of the skin.

- Perform [Work Instruction - Method B](#) below.
