SERVICE LETTER NUMBER 157			
10000 BULKHEADS 8-12, LOWER FLANGE REINFORCEMENT			
BY: MAB	AIRCRAFT	FLOAT MODEL(S):	NOTES: OPTIONAL
APP: SDW	MAKE/MODEL(S):	10000	COMPLIANCE
DATE: 5/21/2019	AIR TRACTOR		S/L P/N 1008067
REV: B	AT-802, AT-802A

This service letter applies to Air Tractor AT-802 and AT-802A when equipped with Wipline model 10000 floats (STC SA01795CH).

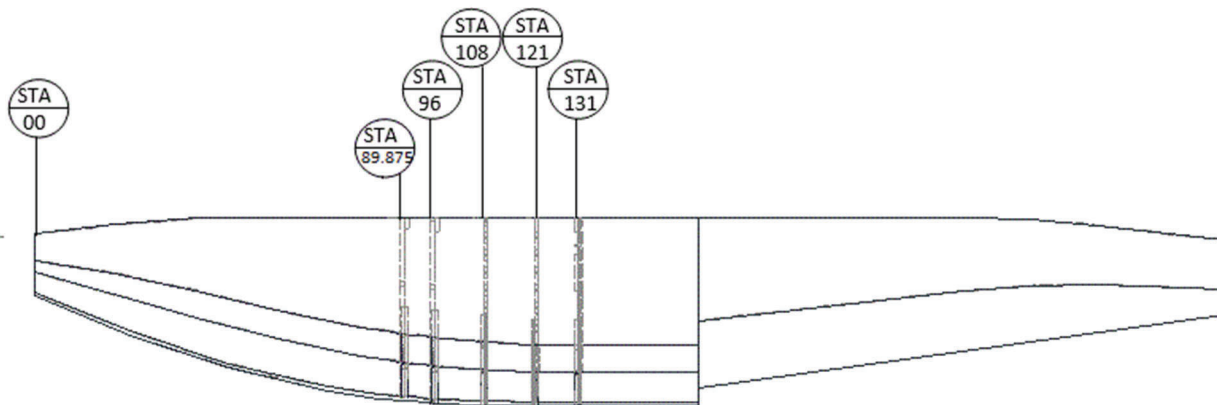
FIGURE 1: AFFECTED BULKHEAD FLOAT STATION LOCATIONS

Aircraft equipped with Wipline model 10000 amphibian floats that regularly operate in rough water, may experience cracking of the forward and aft lower bulkhead flanges located in the baggage area of the float as indicated in Figure 1. This service letter and associated kit reinforce the lower bulkhead flanges to reduce probability of cracking as a result of operations in rough water.

- 1) Remove the top deck covers and open baggage hatches to gain access to the affected bulkheads shown in Figure 1. Remove baggage hatch floors to gain access to lower bulkhead flanges.
- 2) If cracks are found in flanges, stop drill as needed.
- 3) After drilling interfering rivets out of existing bulkhead, position the doublers best fit to contour and match drill at each forward and aft lower bulkhead flange.
