SERVICE LETTER 234

Trimming of Fire Boss Interconnect Assembly

Aircraft Makes/Model(s):	Float Model(s):	Compliance: Optional	By: MAB
Air Tractor AT-802 & AT-802A	10000A	Part Number: 1011928	Approved: SDW
		Date: 5/2/2022	Revision: B

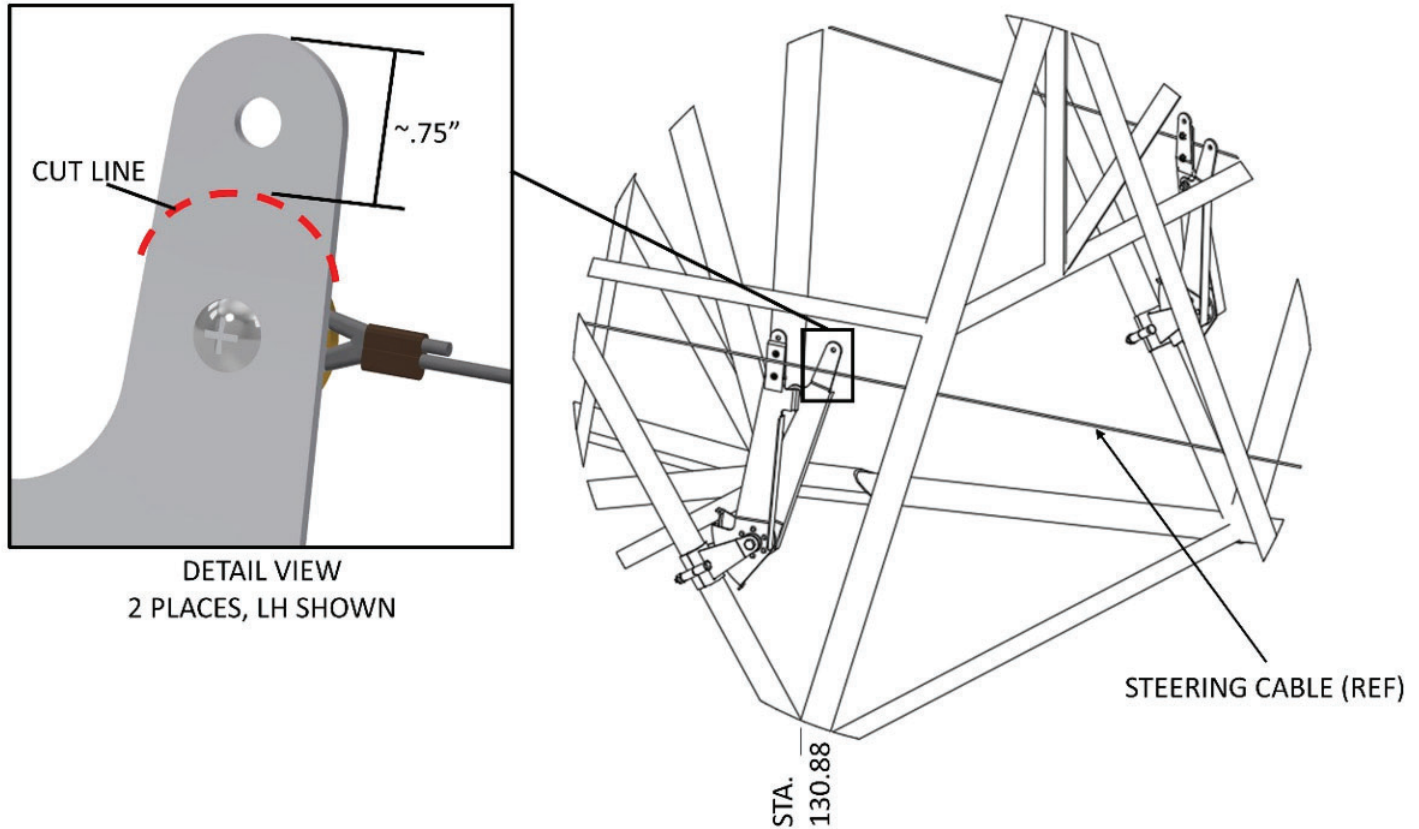
Figure 1

During installation of steering/retract/balance cables, the rudder-aileron interconnect assemblies are slightly “clocked” about their connections to the tubular frame in order to provide clearance. This introduces a possibility of interfering with other aircraft rigging, especially while adjusting the rudder pedals.

1. Gain access to the interconnect assemblies and trim approximately 0.75" from the top of each aft arm. Do not interfere with the cable and hardware below (remove these items as needed while cutting). See Figure 1.

2. Curve and smooth any sharp corners or edges.
3. Prime and paint the cut edges.
4. Reinstall aircraft panels.
