SERVICE LETTER NUMBER 98			
MAIN GEAR RAM INSPECTION AND IMPROVEMENT			
BY: MAS	AIRCRAFT MAKE/MODEL(S): DeHavilland DHC-2, DHC-6 Cessna 208, Air Tractor AT-802, AT-802A	FLOAT MODEL(S): ALL AMPHIBIOUS 6100, 8000, 10000, 13000	NOTE(S): MANDATORY P/N 1002759
APP: DRH			
DATE: 8/9/2022			
REV: C

EFFECTIVITY: This service letter is to inform customers of a main gear required inspection and subsequent product improvement. All amphibious 6100, 8000, 10000 and 13000 are affected by this change.

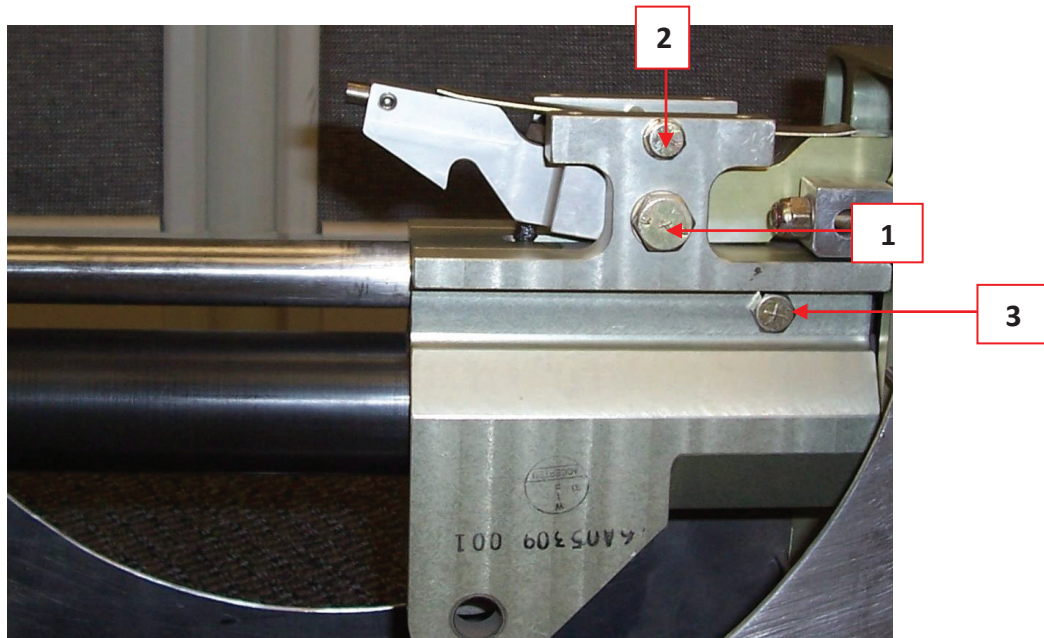
FIGURE 1

1. Jack the aircraft as per the respective Service Manual. Remove the appropriate inspection plate for access to the main gear ram trolley. To get the trolley in the right place, pull the circuit breaker for gear retraction and put the gear switch in the up position. Then just bump the circuit breaker until the trolley is in the window but not in the fully locked position.
2. Remove the main ram catch bolt (Item 3, Figure 1). Lift the down lock and the ram will slide out.

MAKE SURE NOT TO OVER-TIGHTEN THE TROLLEY BOLT (Item 1&2, Figure 1). THE LOCKING LATCHES SHOULD MOVE FREELEY AFTER THE BOLTS ARE SNUG.

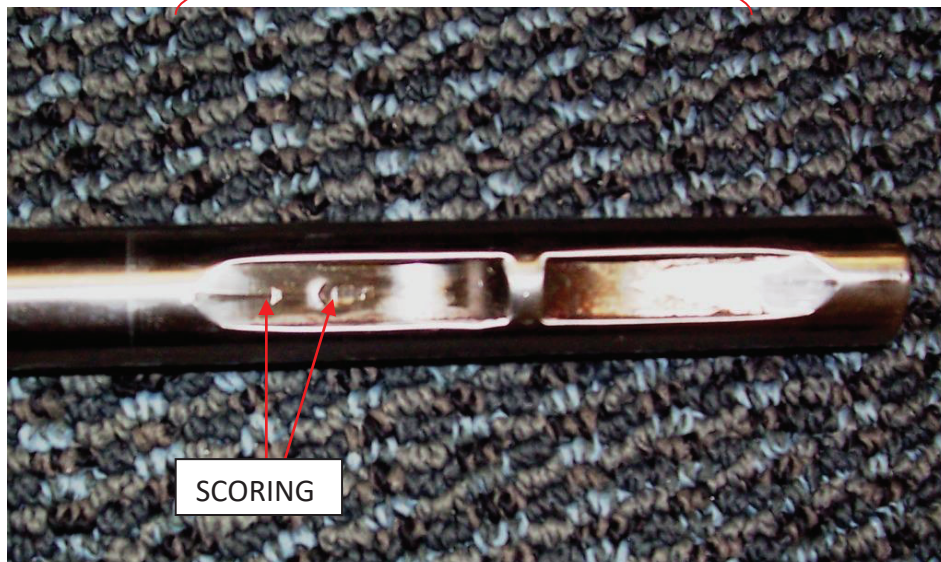
FIGURE 2

BACKGROUND: Some of our customers have had main gear trolley failure. This has been linked to uneven scoring and gouging on the main gear ram. It is normal for the set screw to wear into the ram over time, but when that wear becomes jagged or uneven, the set screw breaks, and the main gear retraction fails.

DEPRESSION IN GEAR RAM

3. Inspect ram depressions for wear. It will likely appear as scoring; this is from the set screws applying pressure as they slide past the depressions onto the body of the ram. The wear must be smooth without gouging or scoring.
4. If there is no wear, or the wear is smooth and even, fill the depressions with grease, install new set screws that have the smooth ends and put everything back together.

COMPLIANCE METHOD: The main gear actuating ram needs to be inspected under the trolley gear lock. If there is uneven wear or pocketing from the set screw on the ram, as in Figure 2, the rod must be polished smooth or replaced. We authorize and encourage customers to polish the ram when possible. The set screws must be replaced if they have a dimple in the end as they have been improved by removing the machined dimple and polishing

5. If there is uneven wear on the ram, it will have to be polished smooth or replaced.
6. When parts are received, put back together and fill ram depressions with grease before final assembly.
7. When this Service Letter has been complied with, make an entry in the logbook as to its completion and whether or not the ram and set screws were replaced

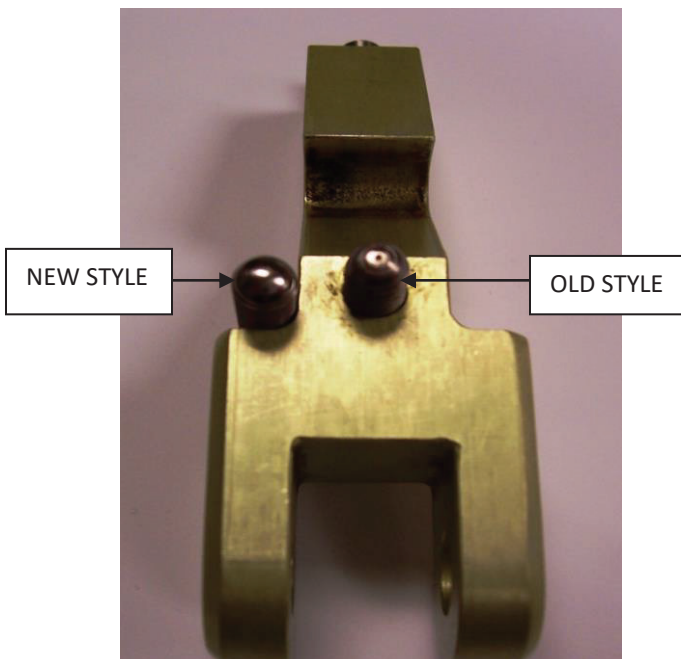
FIGURE 3

8. The product improvement part of this Service Letter is that the set screw is now manufactured so that there is no indent at the tip. Figure 3 illustrates the difference
