SERVICE LETTER 209

Fire Boss AT-802 (Two Seater) Removal of Fixed Ballast

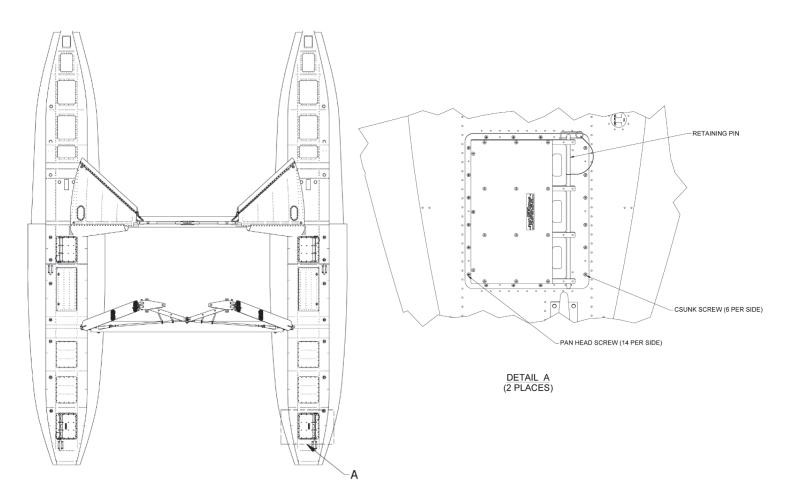
Figure 1

Recent revisions of the fire gates are lighter, shifting aircraft balance forward. This service letter provides the option to remove one or both of the plates bolted to the underside of the forward ballast assemblies.

- 1. Temporarily remove forward ballast assemblies from floats by removing (14) pan head screws and (6) countersunk screws per float. Remove retaining pin as needed to access screw heads. Reference Figure 1.
- 2. Remove the fixed ballast plates from bottom of assembly by removing (16) AN3 bolts. Reference Figure 2.
- 3. Either:
 - a. Re-fasten the thicker ballast plates using red Loctite (or equivalent) and hardware shown in Table 1. The longer bolts are used closest to the center, screwing into the two ribs which form the bay for the center removable ballast plate.
 - b. Remove both the thick and thin ballast plates from aircraft. New hardware not required.
- 4. Reinstall both forward ballast assemblies using (14) pan head screws and (6) countersunk screws per float. Reinstall retaining pin, if removed.
