SERVICE LETTER 253

Horizontal Stabilizer Spar Cracking At Finlets

Aircraft Makes/Model(s):	Float Model(s):	Compliance: Mandatory	By: MAS
Air Tractor AT-802 & AT-802A	10000A	Part Number: 1012347	Approved: DRH
		Date: 7/3/2024	Revision: D

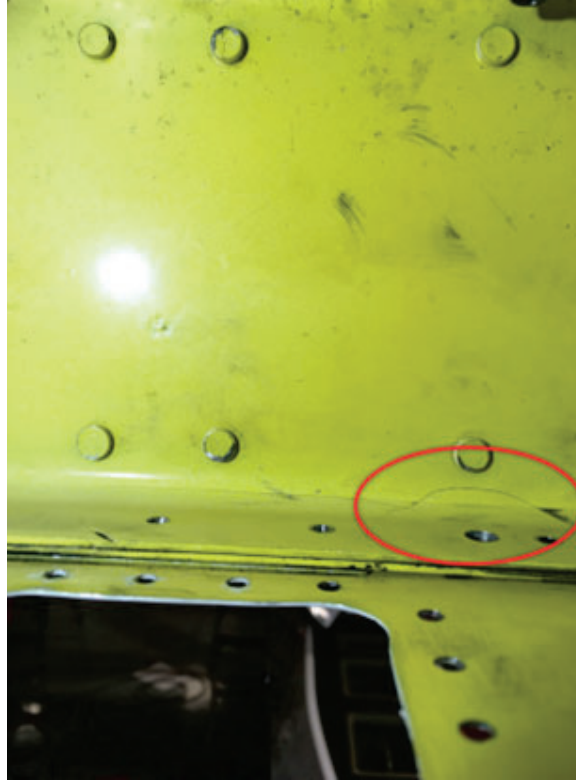
Figure 4

5. Clean the area that is to be inspected.
6. Visually inspect for cracks on the forward and aft horizontal stabilizer spars, including both upper and lower flanges and the web area between. Two primary varieties of cracks have been observed. These are described below to aid inspection, but the entire area is to be thoroughly examined:
 - a. A crack originating in the spar web above the forward, outboard mount bolt of the lower finlet. See Figures 4 and 5.
 - b. A crack near the forward, inboard mount bolt, typically within the radius of the spar, and perhaps centered at the corner of the strut brace shim plates. See Figure 6.

Crack above lower finlet forward, outboard mount bolt location (spar strap removed)

Any cracks discovered in this area of the horizontal stabilizer spar necessitate replacement of spar; the procedure for replacing the spar is beyond the scope of this service letter. Forward spar assemblies may be ordered directly through Wipaire. See the parts list in the WORK INSTRUCTIONS – INSTALL BATHTUB FITTINGS section.

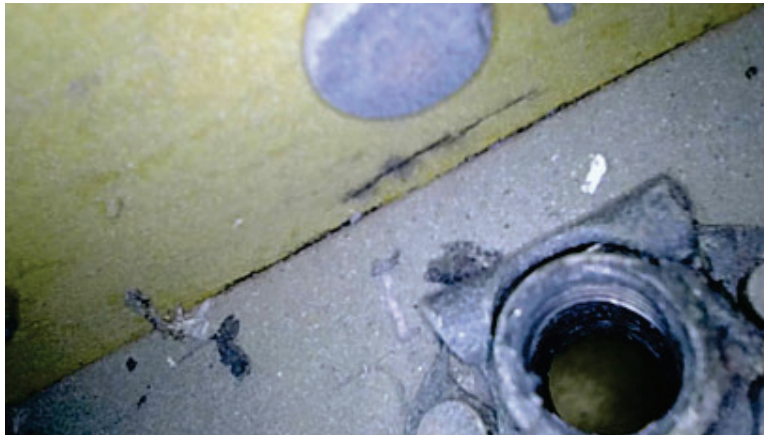
Figure 5

Early-stage crack above lower finlet forward, outboard mount bolt location (shown with spar strap in place)

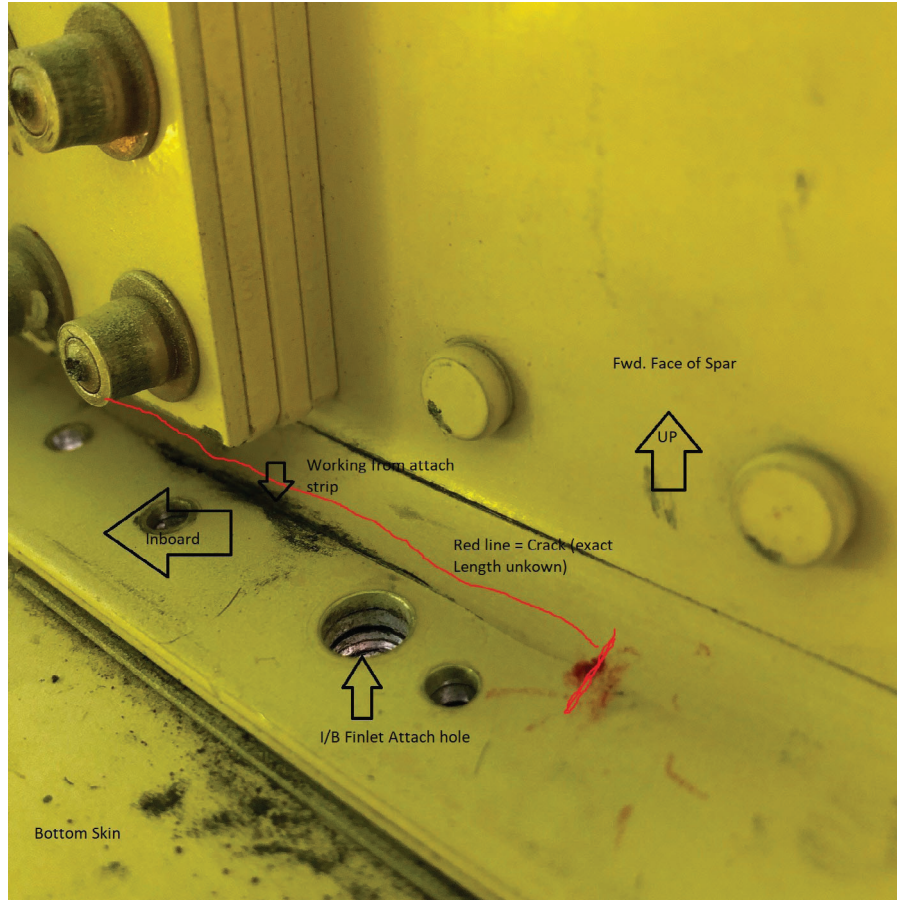
Figure 6

Crack at lower finlet forward, inboard mount bolt location (spar strap removed)
