# SERVICE LETTER 253

## Horizontal Stabilizer Spar Cracking At Finlets

<b>Aircraft Makes/Model(s):</b>	<b>Float Model(s):</b>	<b>Compliance:</b> Mandatory	<b>By:</b> MAS
Air Tractor AT-802 & AT-802A	10000A	<b>Part Number:</b> 1012347	<b>Approved:</b> DRH
		<b>Date:</b> 6/18/2026	<b>Revision:</b> G

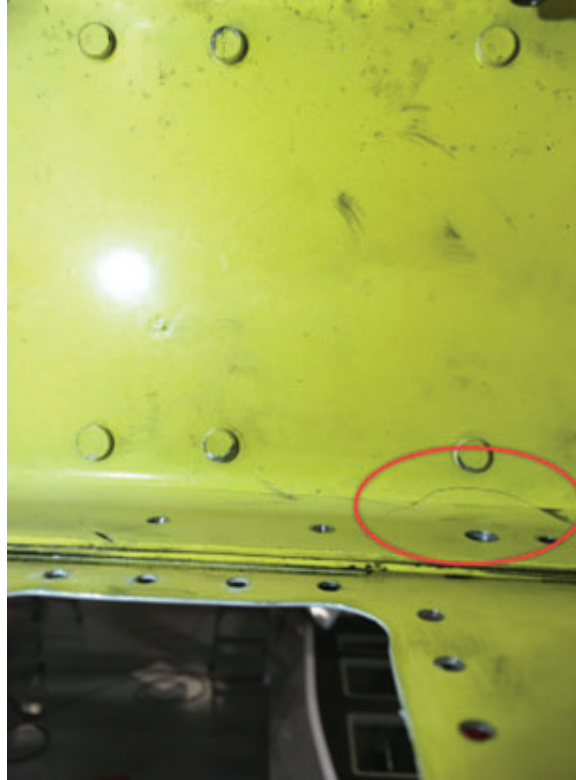
**Figure 4**

Instances of cracked horizontal stabilizer spars have been observed, primarily on the forward spars near the finlet mounting locations, at/near the spar bend radii. The installation method has since been changed. This service letter supports a phase-out of the prior method while also describing the retrofit process and its altered, ongoing maintenance requirements.

**Crack above lower finlet forward, outboard mount bolt location (spar strap removed)**

Any cracks discovered in this area of the horizontal stabilizer spar necessitate replacement of spar; the procedure for replacing the spar is beyond the scope of this service letter. Forward spar assemblies may be ordered directly through Wipaire. See the parts list in the WORK INSTRUCTIONS – INSTALL BATHTUB FITTINGS section.

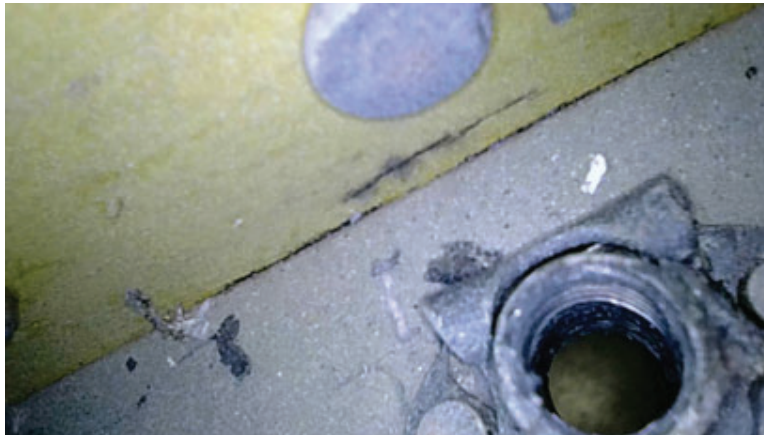
**Figure 5**

**Early-stage crack above lower finlet forward, outboard mount bolt location (shown with spar strap in place)**

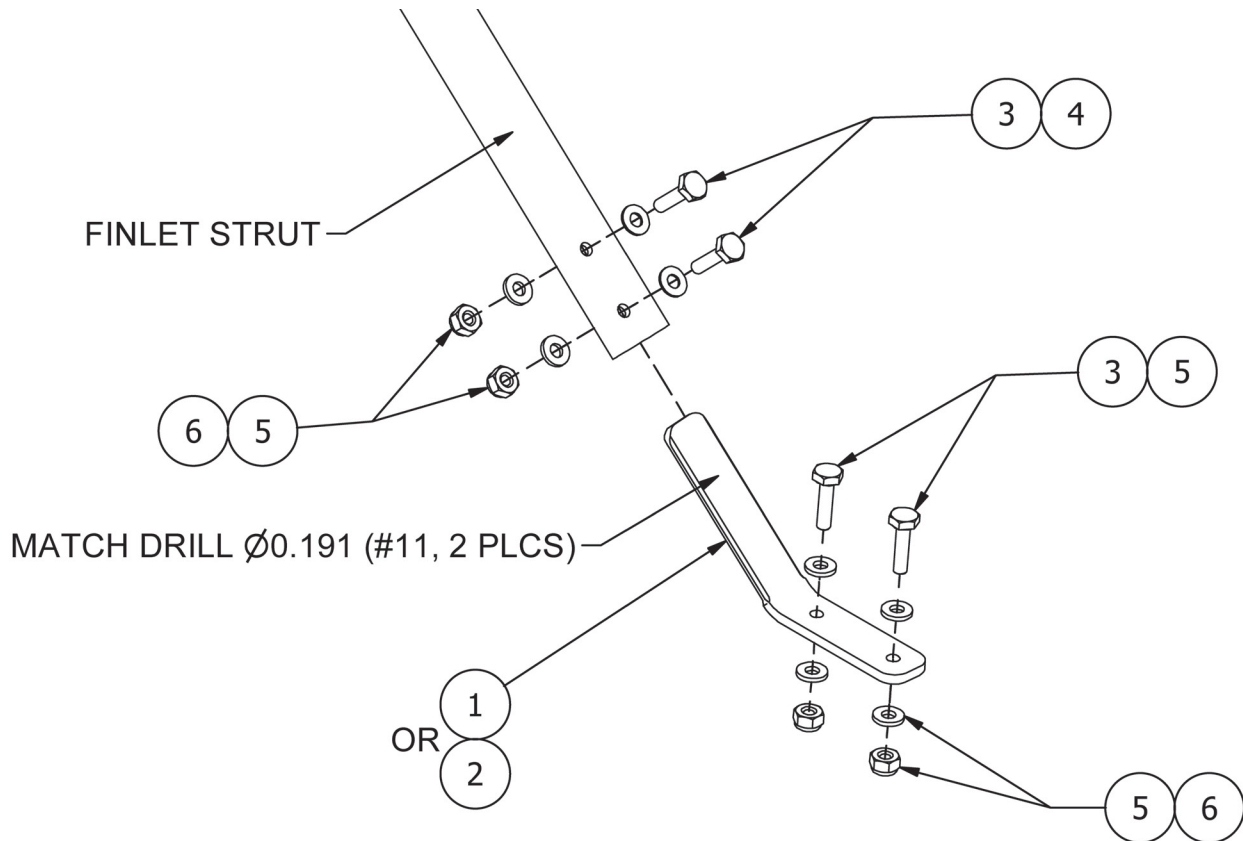
**Figure 10 – Finlet Strut to Spar Attachment**

Observe position of inboard fitting and check for fit with the spar; fitting is to fully rest flat against spar. Check the alignment of the fitting bolt holes; up to .030 inches of misalignment is acceptable. To correct misalignment replace the strut fitting on each affected strut. Replacement of the fitting requires match-drilling from the strut through strut fitting. Replace damaged or deformed struts. Refer to Table 1 and Figure 10 below. Apply corrosion protection to match-drilled holes. Torque fasteners to 20-25 in-lbs. Refer also to Parts Manual 1002179.
