## SERVICE LETTER 253

### Horizontal Stabilizer Spar Cracking At Finlets

| Aircraft Makes/Model(s): | Float Model(s): | Compliance: Mandatory | By: MAS |
| Air Tractor<br>AT-802 & AT-802A | 10000A | Part Number: 1012347 | Approved: DRH |

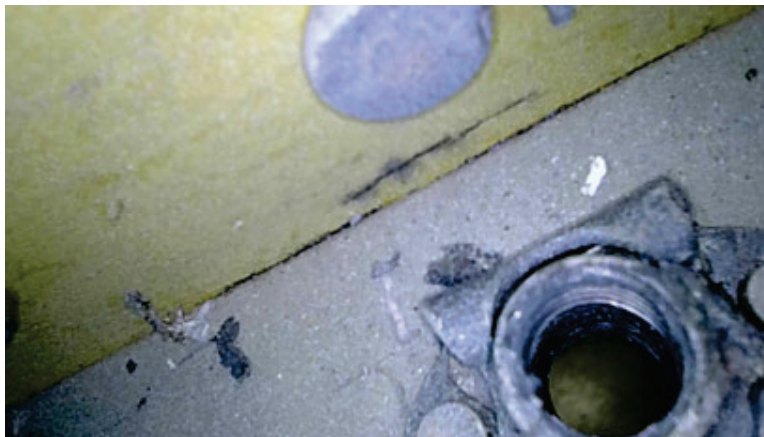
**Figure 5**

**Early-stage crack above lower finlet forward, outboard mount bolt location (shown with spar strap in place)**

Any cracks discovered in this area of the horizontal stabilizer spar necessitate replacement of spar; the procedure for replacing the spar is beyond the scope of this service letter. Forward spar assemblies may be ordered directly through Wipaire. See the parts list in the WORK INSTRUCTIONS – INSTALL BATHTUB FITTINGS section.

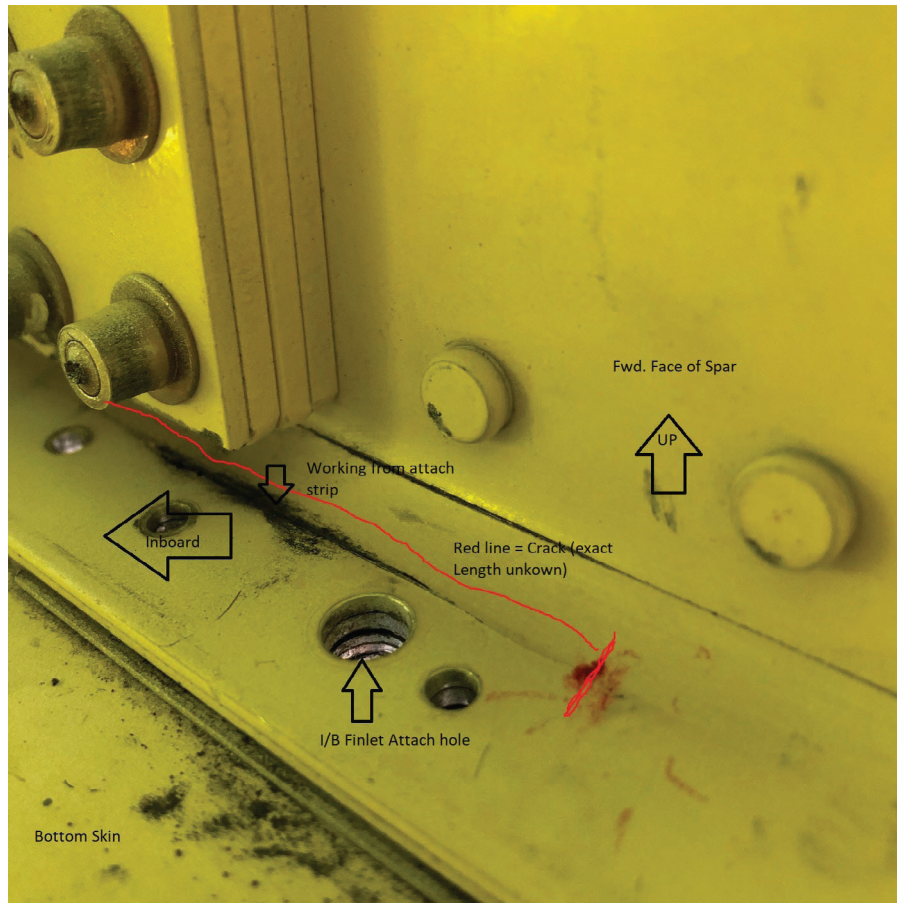
**Figure 6**

**Crack at lower finlet forward, inboard mount bolt location (spar strap removed)**
