## SERVICE LETTER 261

### WIRE TERMINAL BLOCK REPLACEMENT

<b>Aircraft Makes/Model(s):</b>	<b>Float Model(s):</b>	<b>Compliance:</b> Optional	<b>By:</b> MAS
Textron Aviation 208, 208B, Air Tractor AT-802 & AT-802A, DeHavilland DHC-6	8750A, 10000A, & 13000A	<b>Part Number:</b> 1012490	<b>Approved:</b> DRH
		<b>Date:</b> 4/3/2025	<b>Revision:</b> C

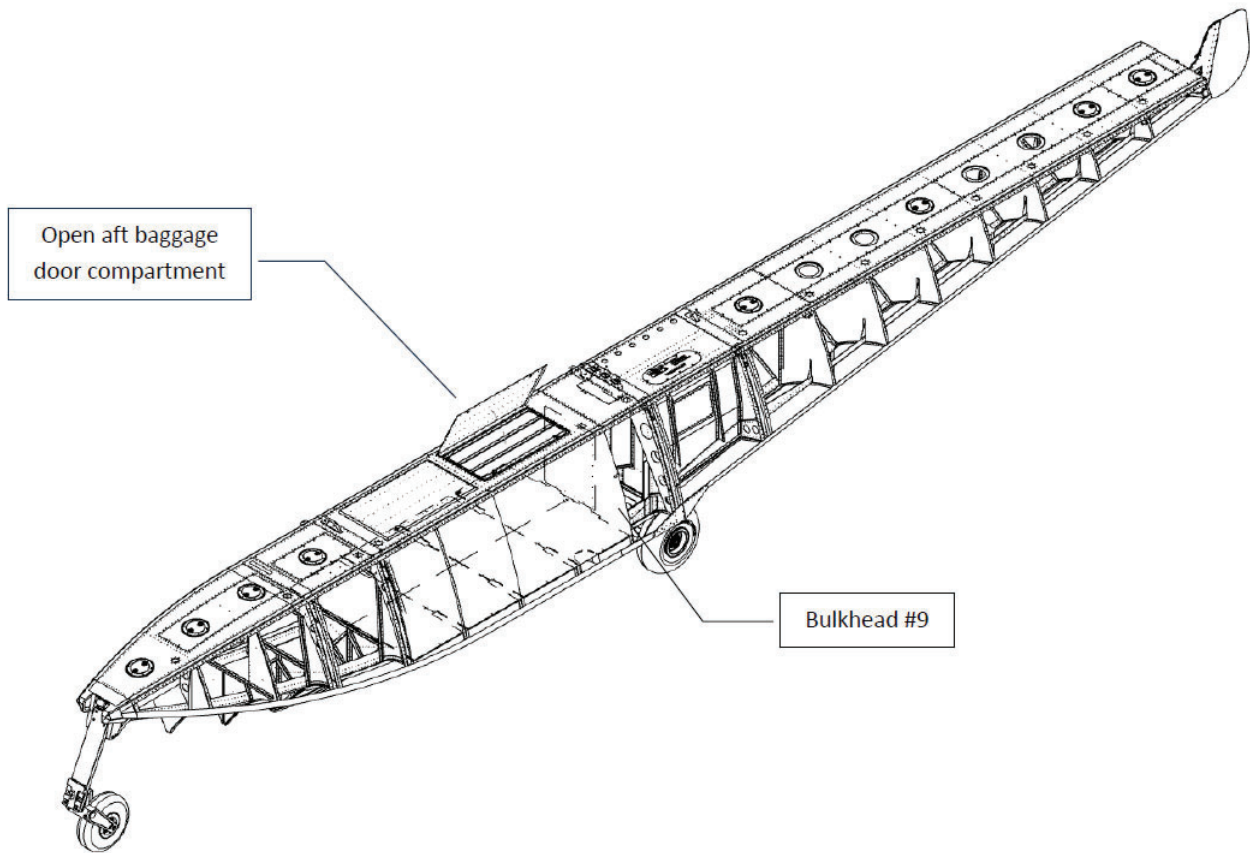
**8750A Float Model**

1. Position and prepare aircraft for safe maintenance.
2. Disconnect aircraft battery.
3. Locate the existing wiring terminal. For 8750, the terminal is in the aft baggage compartment on bulkhead #9. For 10,000 series, the terminal is on the forward bulkhead in the baggage compartment, bulkhead #9. The terminal block on the 13000 series float is in the front baggage compartment on bulkhead #6.
