SERVICE LETTER 274

3000/3450 Rotary Actuator Shaft Key Retainer

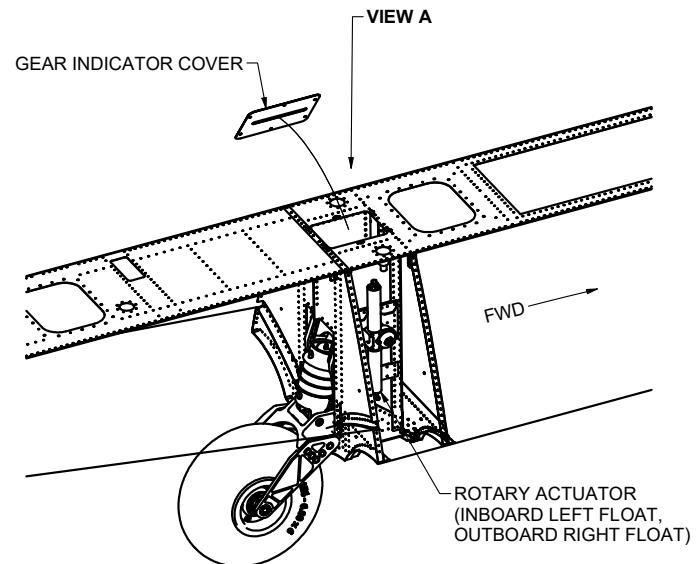
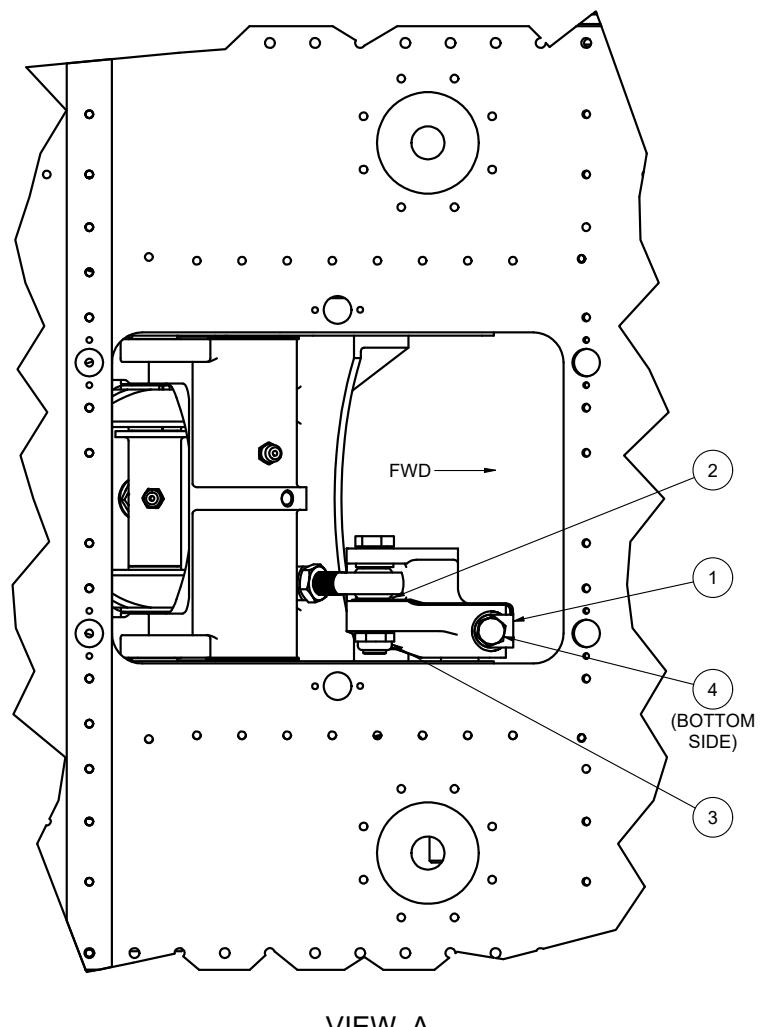
Figure 1

The central rotating shaft within these rotary actuators is splined into landing gear linkage with a square key. The tolerances of these parts are such that it is possible for the key to slip from the keyway, perhaps disengaging the actuator from the linkage and/or damaging nearby components. To remedy this, a retainer entered production in 2025 with float serial numbers:

- Note:** Refer to Figures 1 and 2 for steps 3-9.
3. Remove gear indicator cover (yellow) from float top deck.
4. Unfasten two bolts through actuator arm. Arm may remain in place on actuator shaft, unless removal would help facilitate steps 5-7.

5. Check condition of key within keyway: Inspect for damage including, but not limited to missing material such as worn edges or ends, corrosion, and deformation (bending, twisting) that could affect its ability to properly engage. Reference part number: MS20066-183.

6. Check condition of rod end linkage and neighboring components: Inspect for general wear or deformation - perhaps resulting from contact with key.
7. Position retainer (item 1) as shown.

8. Re-fasten arm, retainer, and rod end with existing hardware, except for:
 - a. 0.032"-thick washer (item 2) in place of previously installed 0.063"-thick washer at location shown.
