## SERVICE LETTER 277

### Horizontal Stabilizer Rear Spar Cracking at Finlet Struts

<b>Aircraft Makes/Model(s):</b>	<b>Float Model(s):</b>	<b>Compliance:</b> Mandatory	<b>By:</b> MAS
Air Tractor	10000A	<b>Part Number:</b> 1013054	<b>Approved:</b> DRH
AT-802 and AT-802A		<b>Date:</b> 2/11/2026	<b>Revision:</b> A

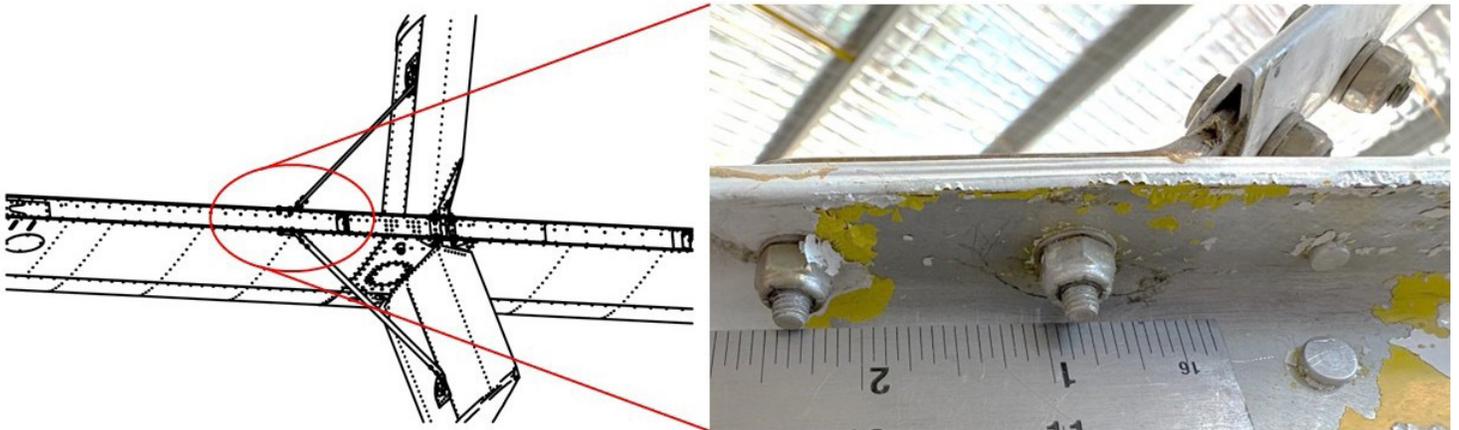
**Figure 1 – Inspection Location (shown with struts installed)**

Instances of cracks near the finlet strut attachment (tall finlets) to the rear horizontal stabilizer spar have been observed. To date, all reported spar cracks related to this attachment point have been located near the outboard fastener of the finlet strut bracket.

1. Position and prepare aircraft for safe maintenance.
2. Proper inspection may require removal of elevator. Refer to Air Tractor service documents as needed.
3. Visually inspect for cracks on the rear horizontal stabilizer spar near the finlet strut attach point. Cracking has been observed originating on the spar flange near the bend and propagating in an arc around the outboard bolt location. Refer to Figure 1.

4. If no cracks are present continue to the next step, otherwise:
  - Any cracks discovered in this area of the horizontal stabilizer spar necessitate replacement or repair of spar; the procedure for replacing or repairing the spar is beyond the scope of this service letter. Contact local Air Tractor dealer for replacement parts and any relevant/available service documents.
5. Repeat for opposite horizontal stabilizer if not already accomplished.
