## SERVICE LETTER 277

### Horizontal Stabilizer Rear Spar Cracking at Finlet Struts

<b>Aircraft Makes/Model(s):</b>	<b>Float Model(s):</b>	<b>Compliance:</b> Mandatory	<b>By:</b> MAS
Air Tractor AT-802 and AT-802A	10000A	<b>Part Number:</b> 1013054	<b>Approved:</b> DRH
		<b>Date:</b> 6/18/2026	<b>Revision:</b> B

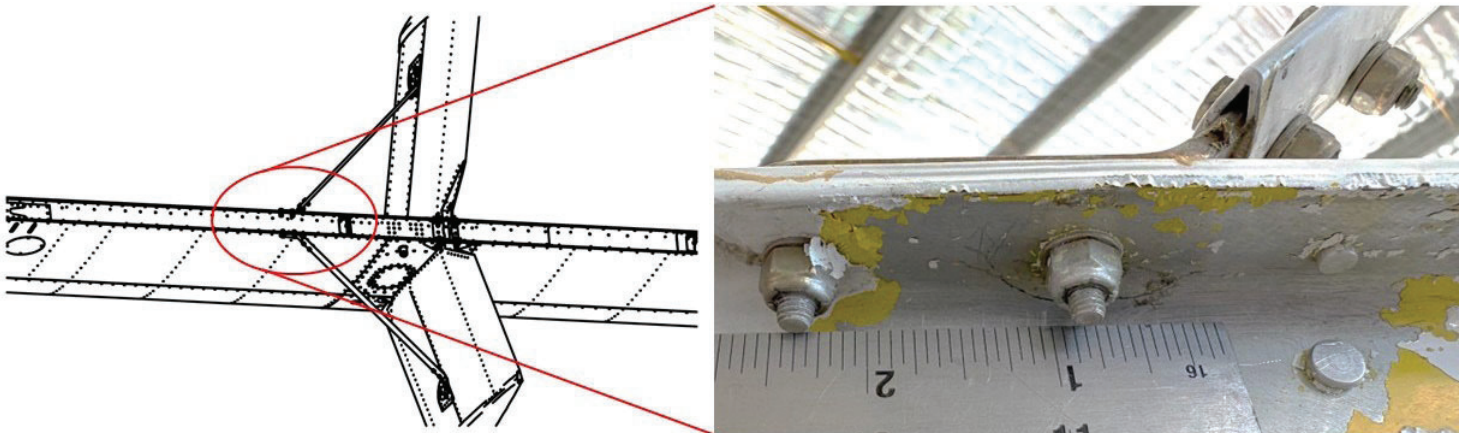
**Figure 1 – Inspection Location (shown with struts installed)**

Instances of cracks near the finlet strut attachment (tall finlets) to the rear horizontal stabilizer spar have been observed. To date, all reported spar cracks related to this attachment point have been located near the outboard fastener of the finlet strut bracket. Rework of stabilizer spars and reinstallation of finlets in accordance with Service Letter 253, and the potential shift in finlet position associated with this work, may pre-load in the finlet strut.

5. Clean the area that is to be inspected, removing any contaminants, corrosion prevention compounds, etc.
6. Visually inspect for cracks on the rear horizontal stabilizer spar near the finlet strut attach point using a bright light source. Use of a 10x magnification tool is highly recommended. Cracking has been observed originating on the spar flange near the bend and propagating in an arc around the outboard bolt location. Refer to Figure 1.

7. If no cracks are present continue to the next step, otherwise:
  - Any cracks discovered in this area of the horizontal stabilizer spar necessitate replacement or repair of spar; the procedure for replacing or repairing the spar is beyond the scope of this service letter. Contact local Air Tractor dealer for replacement parts and any relevant/available service documents.
8. Reinstall finlet struts. To correct pre-load or missalignment replace the strut fitting on each affected strut. Replacement of the fitting requires match-drilling from the strut through strut fitting. Replace damaged or deformed struts. Refer to Figure 2 and Table 1 below. Apply corrosion protection to match-drilled holes. Torque fasteners to 20-25 in-lbs. Refer also to Parts Manual 1002179 and installation drawing 7D1-4399.

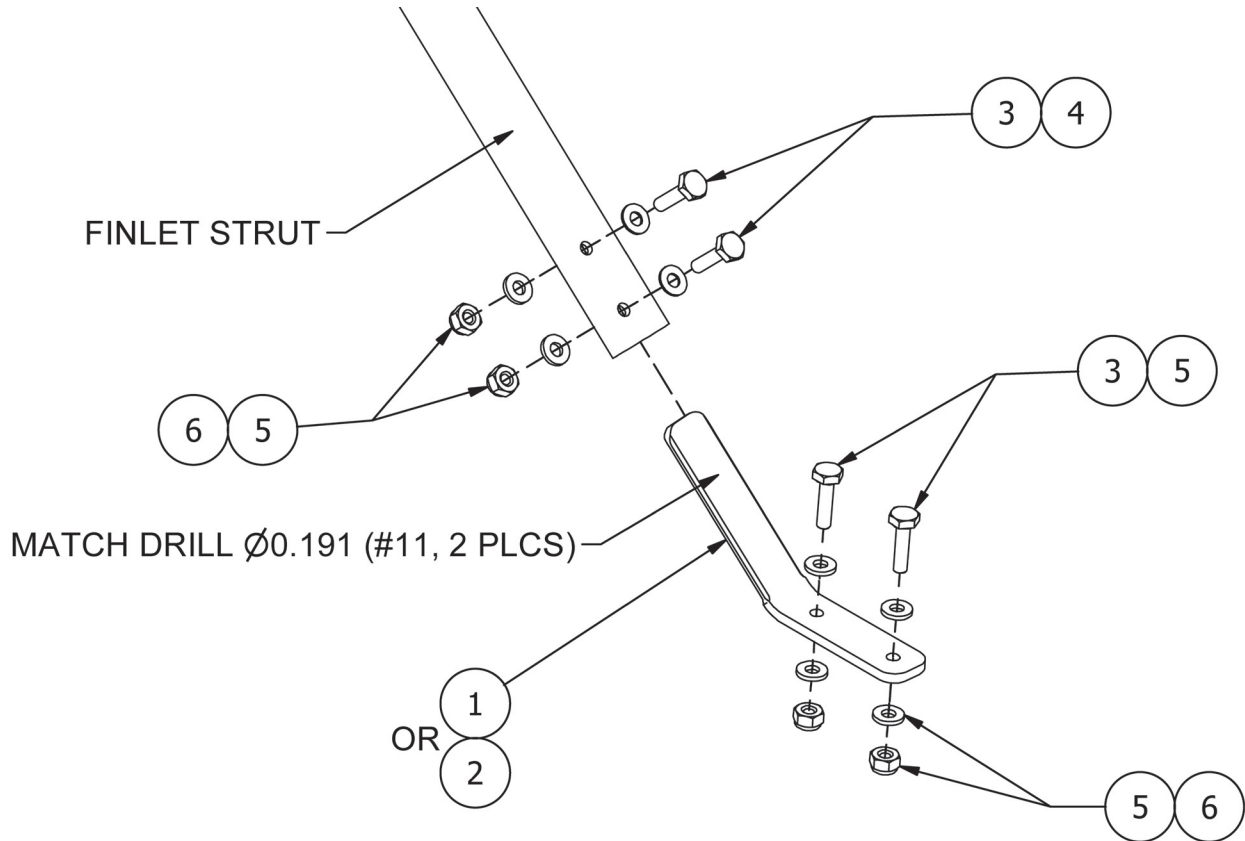
**Figure 2 – Finlet Strut to Spar Attachment**

1. Position and prepare aircraft for safe maintenance.
2. Inspection may require removal of elevator. Refer to Air Tractor service documents as needed.
3. Remove bolts securing the finlet strut fittings to the rear spar, but not from finlet. Observe position of fitting and check for fit with the spar; fitting is to fully rest flat against spar. Check the alignment of the bolt holes; up to .030 inches of missalignment is acceptable. Correction of this condition is addressed below, following spar inspection.

4. Observe condition of finlet strut. A "sprung" or bent strut are signs of an improper fit. Correction of this condition is addressed below, following spar inspection.
