## SERVICE LETTER 277

### Horizontal Stabilizer Rear Spar Cracking at Finlet Struts

| Air Tractor | 10000A | <b>Part Number:</b> 1013054 | <b>Approved:</b> DRH |
| AT-802 and AT-802A | | <b>Date:</b> 7/27/2026 | <b>Revision:</b> C |

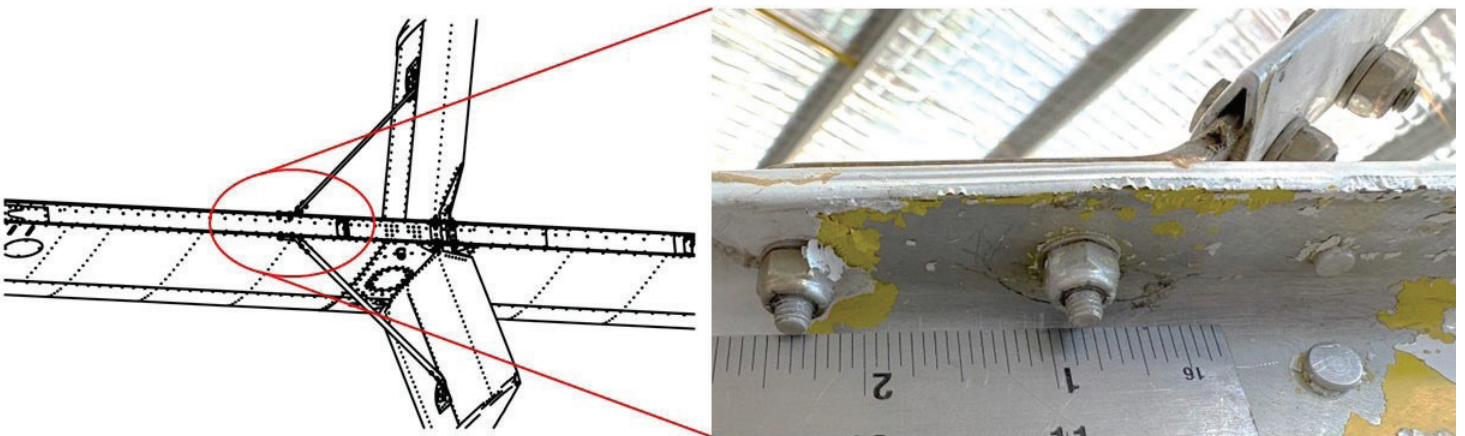
**Figure 1 – Inspection Location (shown with struts installed)**

Instances of cracks near the finlet strut attachment (tall finlets) to the rear horizontal stabilizer spar have been observed. To date, all reported spar cracks related to this attachment point have been located near the outboard fastener of the finlet strut bracket. Rework of stabilizer spars and reinstallation of finlets in accordance with Service Letter 253, and the potential shift in finlet position associated with this work, may pre-load in the finlet strut.

5. Clean the area that is to be inspected, removing any contaminants, corrosion prevention compounds, etc.
6. Visually inspect for cracks on the rear horizontal stabilizer spar near the finlet strut attach point using a bright light source. Use of a 10x magnification tool is required. Cracking has been observed originating on the spar flange near the bend and propagating in an arc around the outboard bolt location. Refer to Figure 1.

7. If no cracks are present continue to the next step, otherwise:
  - Any cracks discovered in this area of the horizontal stabilizer spar necessitate replacement of the spar; the procedure for replacing the spar is beyond the scope of this service letter. Contact local Air Tractor dealer for replacement parts and any relevant/available service documents.
8. Reinstall finlet struts. To correct pre-load or missalignment replace the strut fitting on each affected strut. Replacement of the fitting requires match-drilling from the strut through strut fitting. Replace damaged or deformed struts. Refer to Figure 2 and Table 1 below. Apply corrosion protection to match-drilled holes. Torque fasteners to 20-25 in-lbs. Refer also to Parts Manual 1002179 and installation drawing 7D1-4399.
