## SERVICE LETTER 280

### Slide Tube Corrosion

<b>Aircraft Makes/Model(s):</b>	<b>Float Model(s):</b>	<b>Compliance:</b> Optional	<b>By:</b> MAS
Air Tractor AT-802A, AT-802 Textron Aviation 208 Pilatus PC-6/B2-H4 DeHavilland DHC-2, DHC-3, DHC-6	6000A, 6100A, 8000A, 10000A, 13000A	<b>Part Number:</b> 1013066	<b>Approved:</b> DRH
		<b>Date:</b> 4/15/2026	<b>Revision:</b> A

All Wipline model 6000A, 6100A, 8000A, 10000A, and 13000A amphibian floats. Associated Wipaire STCs are: SA610GL, SA309CH, SA227CH, SA1311GL, SA331CH, SA01795CH, SA2CH

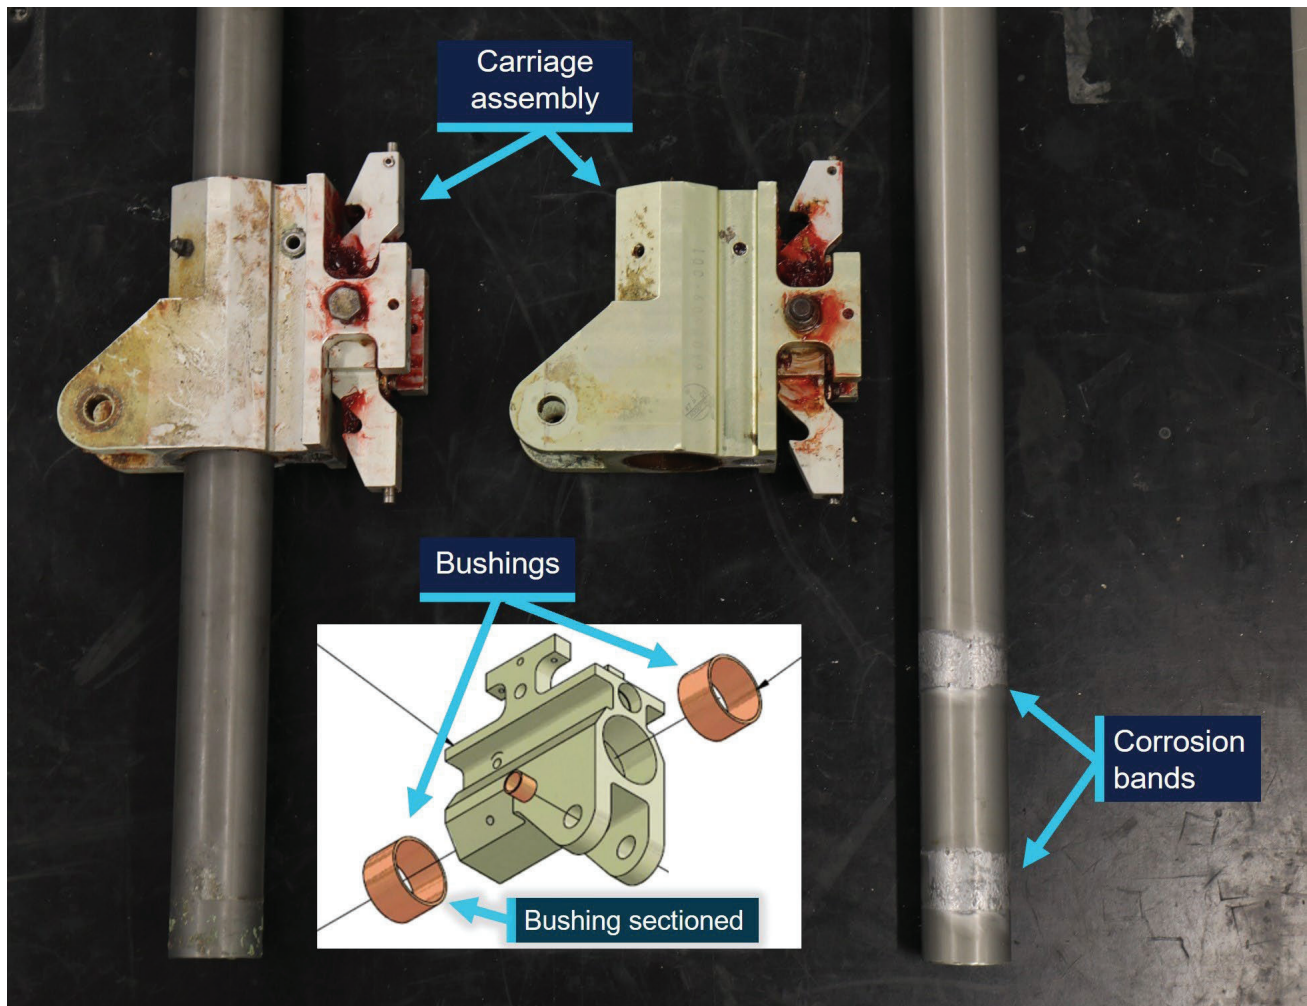
**Figure 1: Slide Tube and Carriage Overview**

The interaction of the carriage bushings, slide tubes, and contamination/debris has been observed to wear these components, leading to exposed metal and corrosion. The lubricating grease, particularly when present in excess amounts, is known to trap contamination.

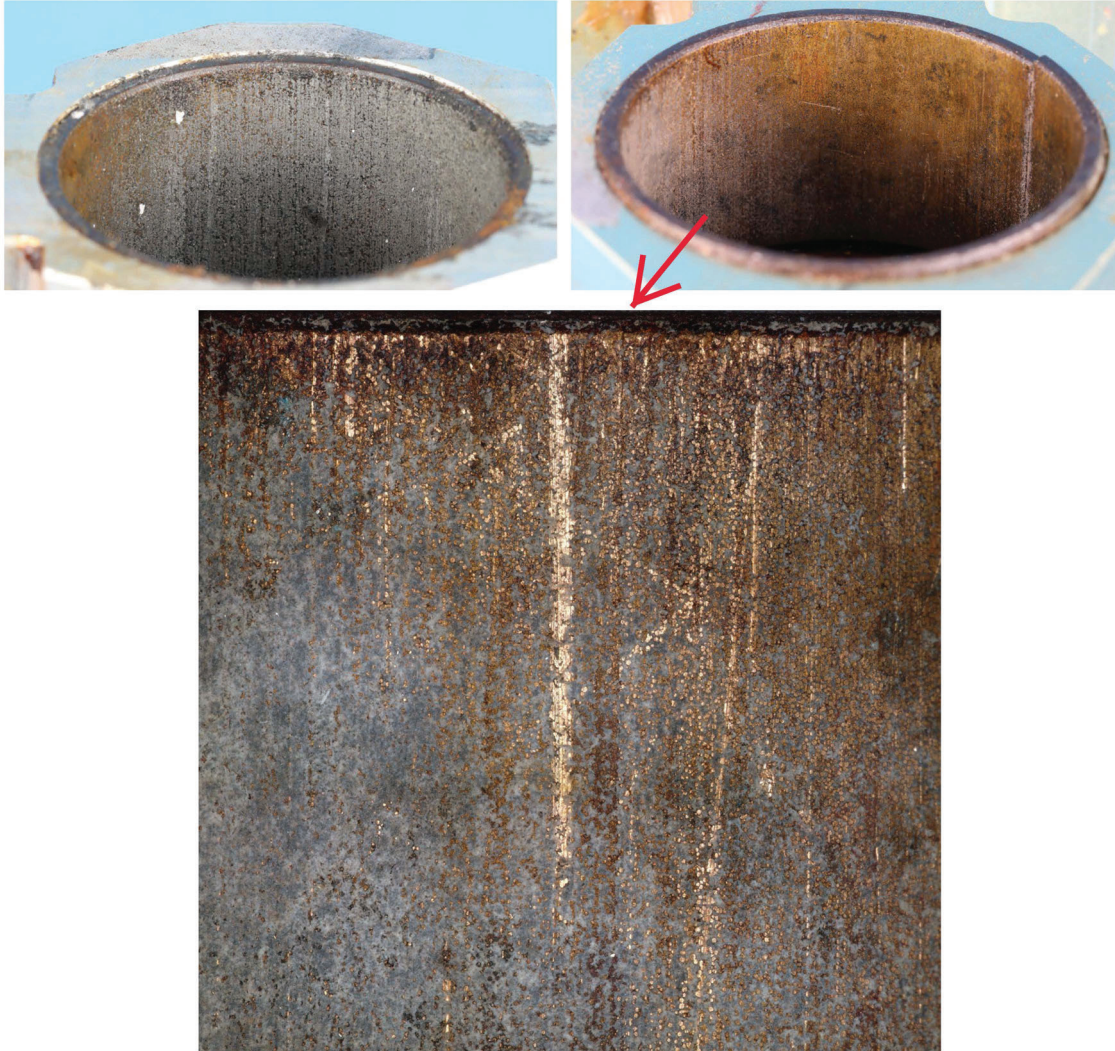
**Figure 2: Worn Carriage Bushings**

The carriage bushings shown above are in different stages of wear of the PTFE layer, exposing the bronze layer. The bushing shown on the right was sectioned for closer examination (lower image).

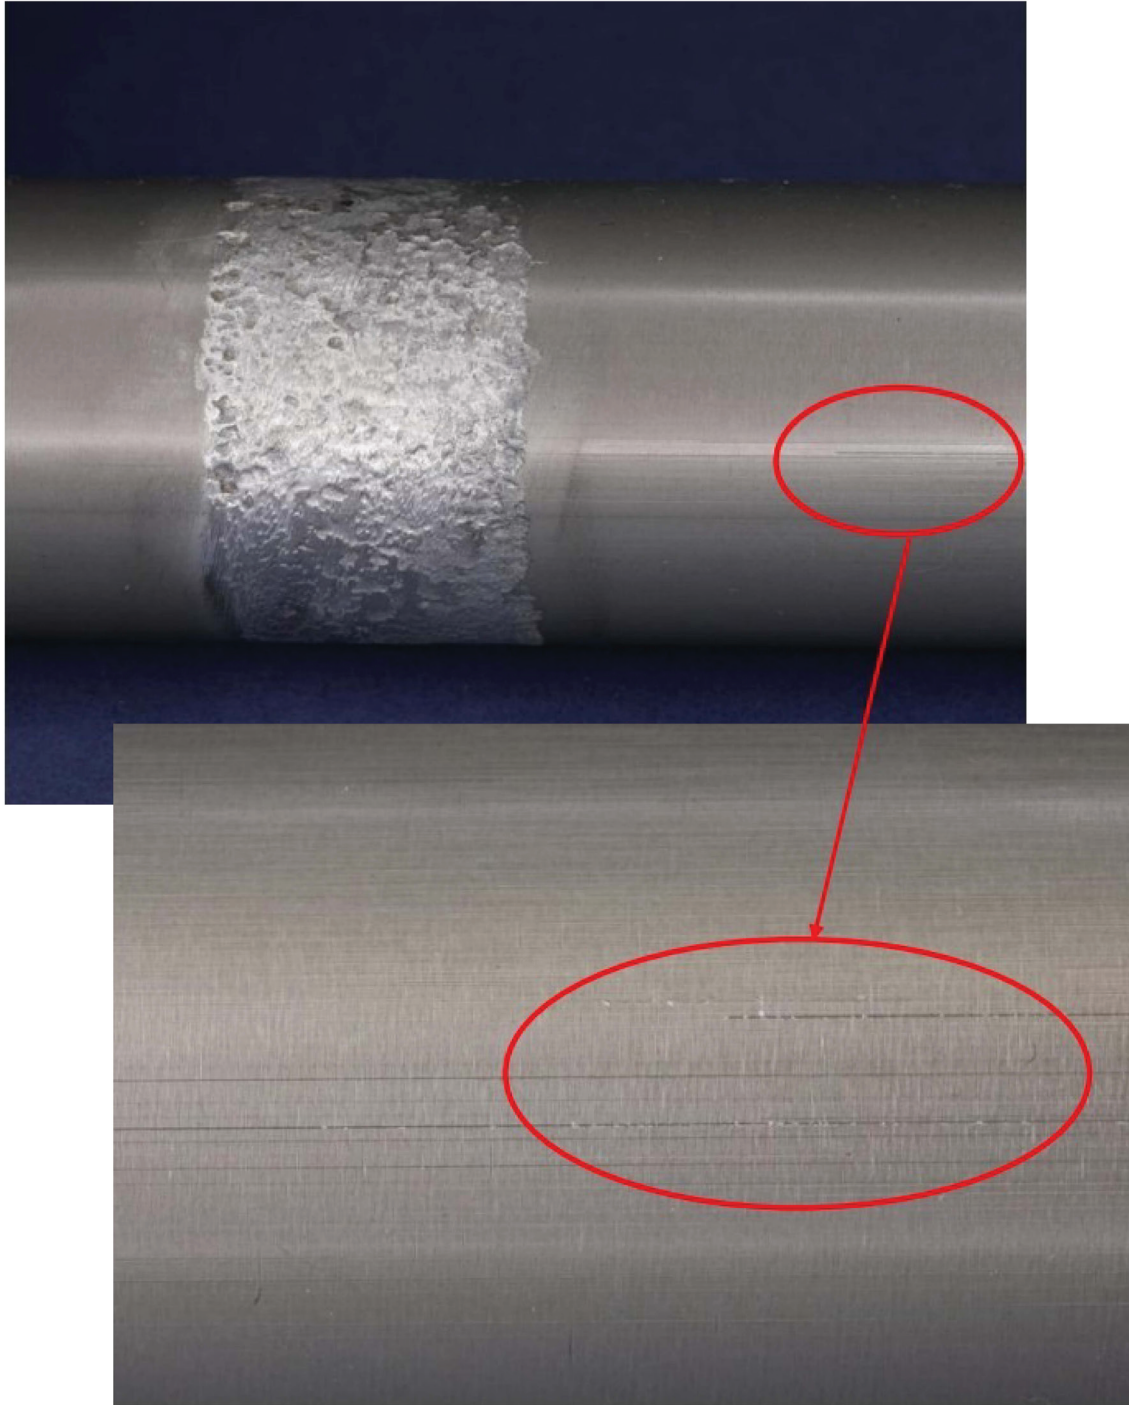
**Figure 3: Corrosion and Scoring on Slide Tube**

Contamination and similar debris can create longitudinal scoring along the slide tube, exposing bare aluminum, as seen in the lower image. Exposed bronze in the carriage bushings creates potential for galvanic corrosion with the aluminum of the slide tube. A circumferential band of galvanic corrosion is shown in the upper image. Such corrosion has potential to seize landing gear.

1. Clean the slide tube with clean solvent, remove any buildup of dry or excessive dirty lubricants.
2. Inspect the slide tube for signs of corrosion (particularly in the area where carriage is in gear down position) and for gouging and/or nicks in the anodized coating caused by gravel/debris being thrown by the main landing gear tires. Replace on condition. See images included in this service letter.
3. If wear of PTFE layer of carriage bushings is evident from the visible ends OR previous step saw imperfections in slide tube warranting replacement, remove carriage for further inspection. Replace carriage assembly as needed. See images included in this service letter.

4. Grease the slide tube actuator mechanism thoroughly, applying HCF grease, p/n 605, or equivalent and wipe the slide tube down with a clean rag soaked in lubricant, making sure to apply evenly.
