SERVICE LETTER 274

3000/3450 Rotary Actuator Shaft Key Retainer

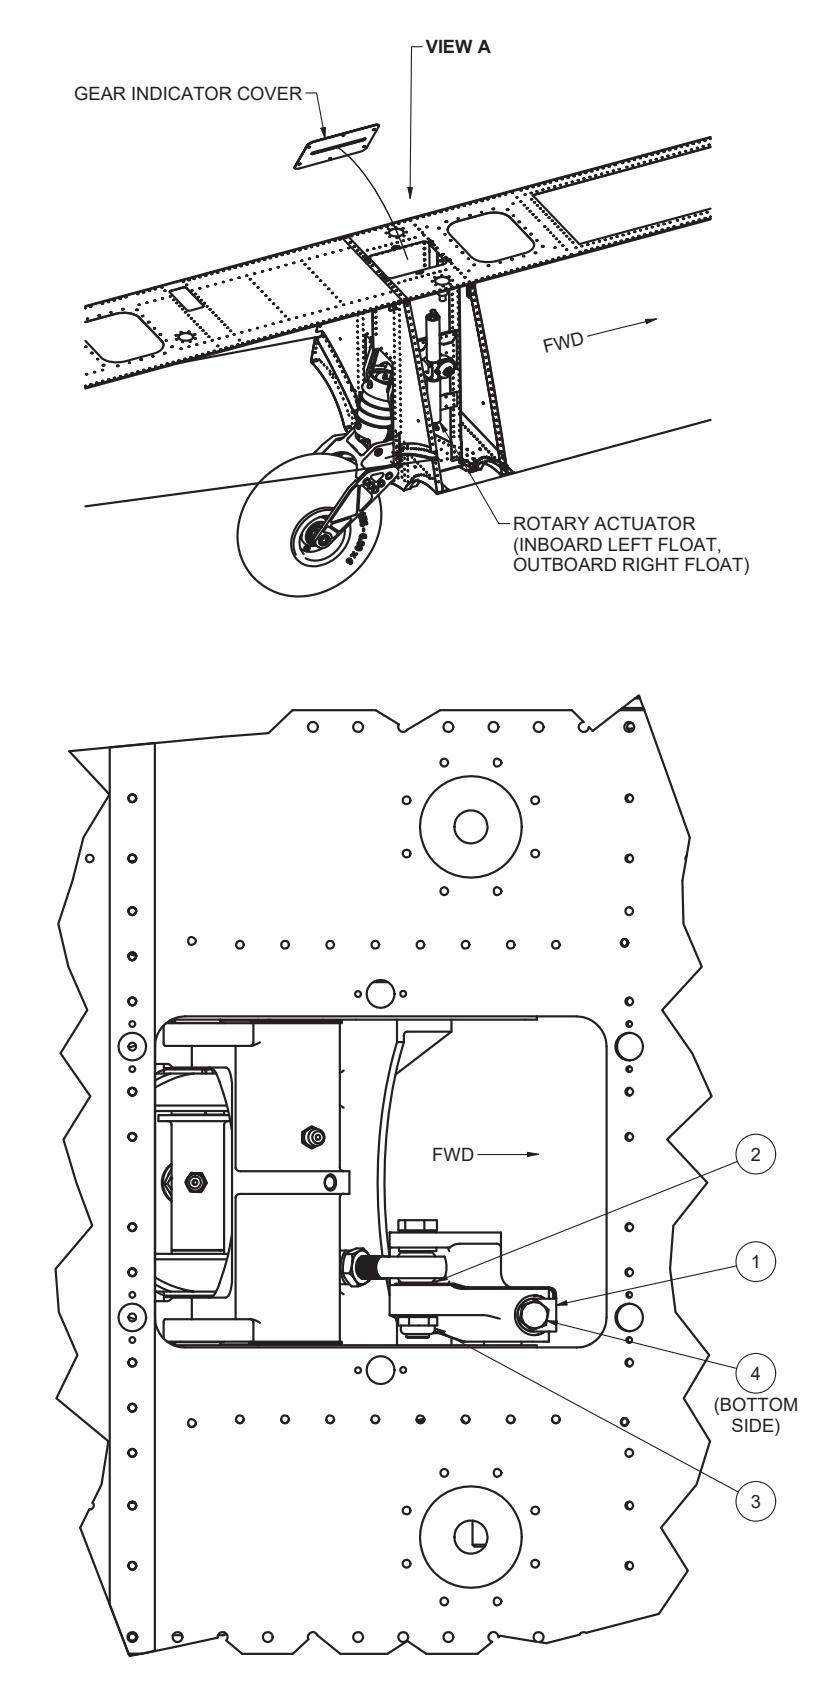
Figure 1

The central rotating shaft within these rotary actuators is splined into landing gear linkage with a square key. The tolerances of these parts are such that it is possible for the key to slip from the keyway, perhaps disengaging the actuator from the linkage and/or damaging nearby components. To remedy this, a retainer entered production in 2025 with float serial numbers:

- 7. Position retainer (item 1) as shown.
- 8. Re-fasten arm, retainer, and rod end with existing hardware, except for:
 - a. 0.032"-thick washer (item 2) in place of previously installed 0.063"-thick washer at location shown.
 - b. New locknuts (items 3, 4).
- 9. Re-install gear indicator cover.
- 10. Repeat steps 3-9 for opposite float.
- 11. Reset landing gear motor circuit breaker.
- 12. With aircraft on jacks, perform a gear retraction/extension test to check that system is functioning correctly.
