SERVICE LETTER: 100

EFFECTIVITY: 3450, 8000, 9000 13000 Amphib. and Seaplane floats

BACKGROUND INFORMATION: The step strut requires periodic greasing to operate properly and must be removed from the airplane and taken apart to do this. In the interest of increasing the ease of preventative maintenance on our products, we have redesigned the step strut in production to have a spiral grease-way with a small greasing aperture in the strut so a needle fitting can be used. While the redesigned parts are not required and lubrication will still be easier if just the holes are drilled, investing in the new parts will greatly increase the ability of this improvement to lubricate these moving parts.

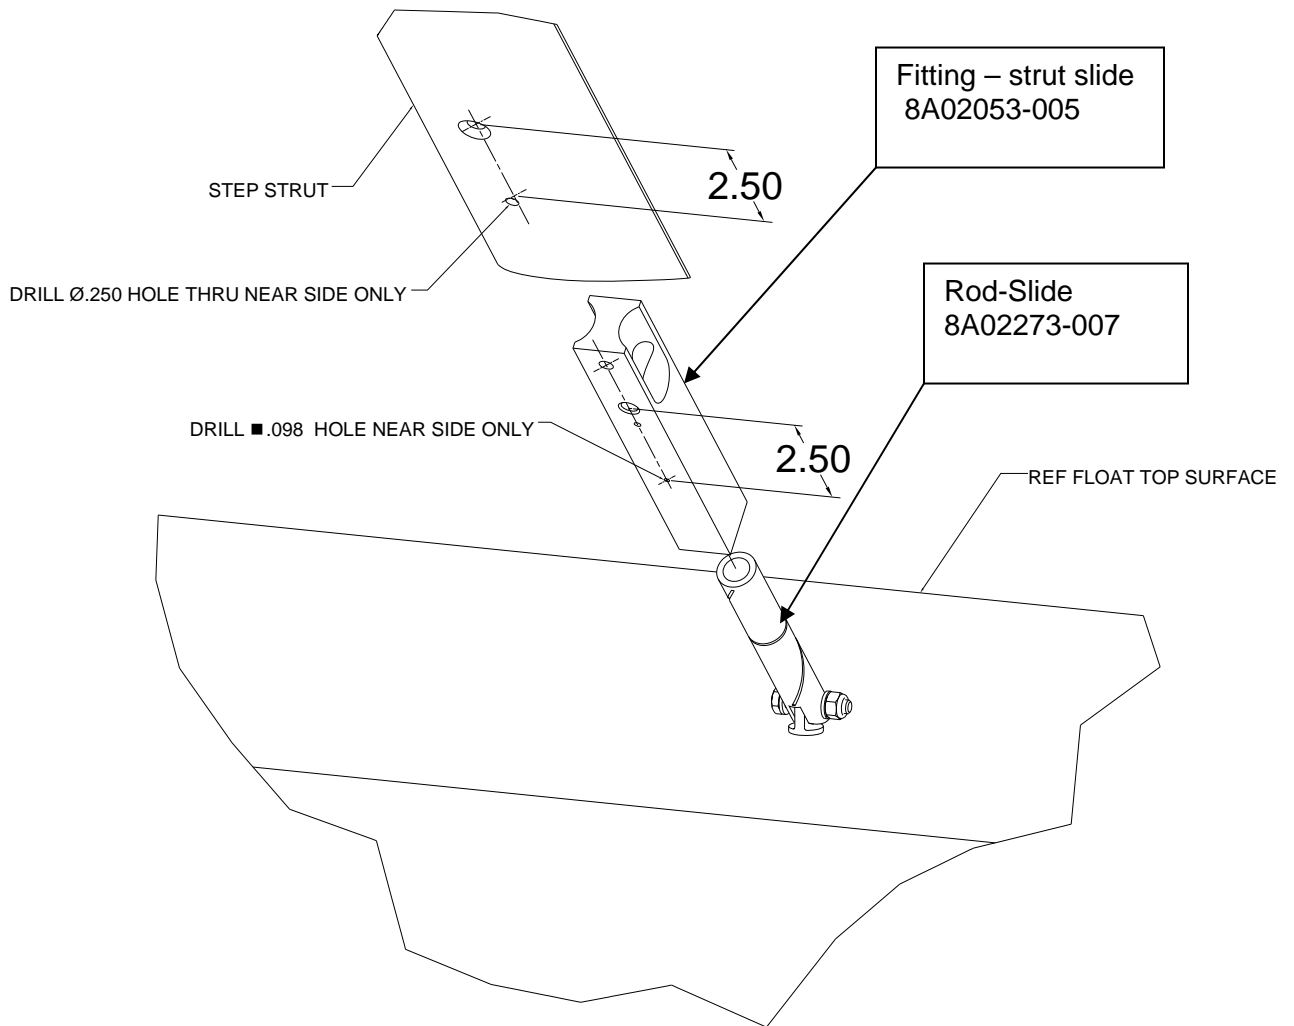
1. Remove the step strut from the aircraft.
2. With the inboard side of the strut facing up, use a straight edge from the center line of the top screw down to the center line of the bottom screw and mark the line.
3. Drill a .250 hole through the strut and a .098 hole through one side of the internal fitting.
4. Carefully clean out any shavings and deburr the edges of the strut and fitting holes.
5. As we have redesigned the Rod Slide by adding a machined spiral to aid in grease migration, it is recommended that customers upgrade to better facilitate lubrication. Reinstall the lower grease pins and struts.
6. Grease the inboard hole on the strut with a needle point.
7. Make a logbook entry regarding the compliance of this Service Letter.
