SERVICE LETTER 189

8750 AMPHIBIOUS CARRY THROUGH STRAP DOUBLER INSTALLATION

Aircraft Makes/Model(s):	Float Model(s):	Compliance: As required	By: MAS
Textron Aviation 208 and 208B	8750A	Part Number: 1009949	Approved: DRH
		Date: 2/17/2025	Revision: F

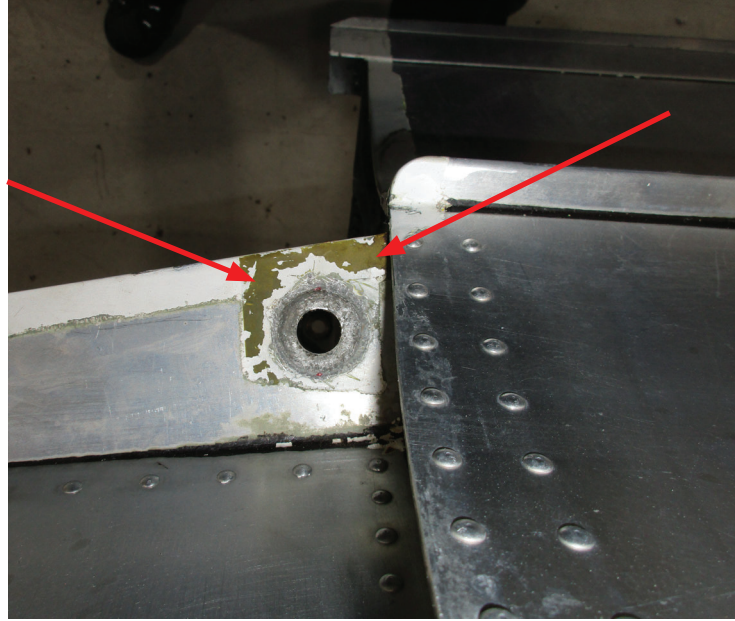
Example Carry Thru Strap Corrosion

Floats operated in salty or brackish water are susceptible to corrosion around the trunnion hole on the carry through strap.

As required. This is a repair option to replacing a carry through strap that has corrosion at the main landing gear trunnion.

NOTE: If all corrosion will not be removed using a 1 1/8" or 1 3/8" reamer, then the carry through strap should be replaced.

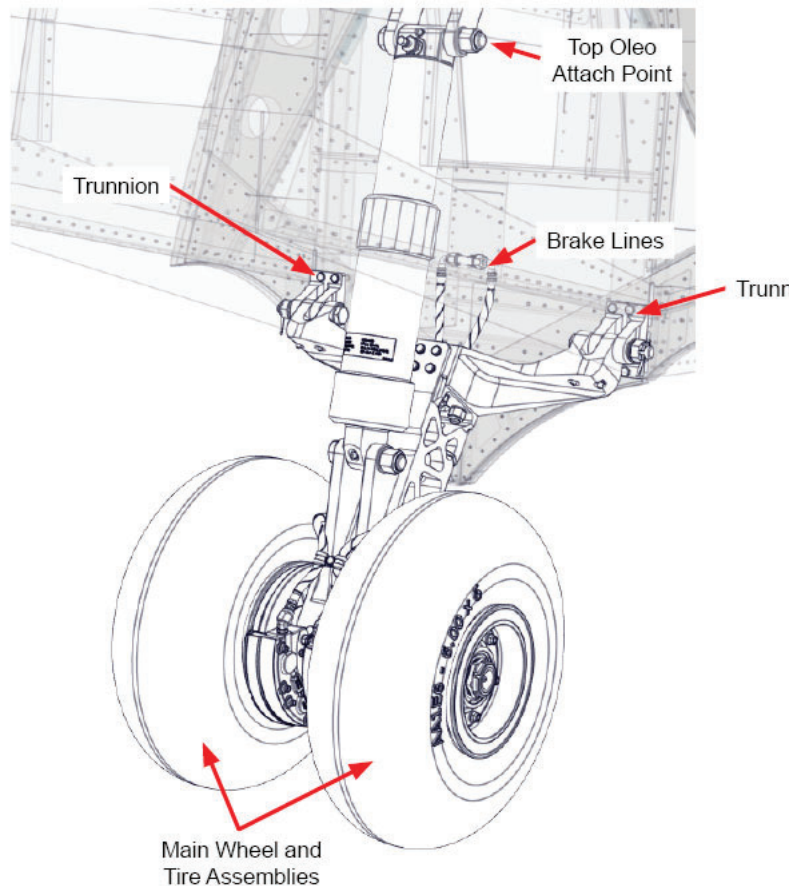
Figure 1

9. Remove both INBD and OTB trunnion from step bulkhead to facilitate inspection of carry through strap.
10. Inspect for corrosion on OTB side of strap at trunnion attach point under washer.
11. Inspect for corrosion on INBD side of strap at trunnion attach point where p/n 1003729 hat bushing contacts carry through strap.
12. If no corrosion is present, reinstall as original starting at item 14 in Method "A" work instructions
13. If corrosion is present, it must be decided how much material can be removed to effectively remove corrosion damage from strap and install repair doubler(s) per Method "A" work instructions.
 - a. p/n 1009949-01 **1 1/8" diameter repair kit**
 - b. p/n 1009949-02 **1 3/8" diameter repair kit**
14. If corrosion is present and exceeds repair doubler kit dimensions in Method "A", proceed with work instructions in Method "B".

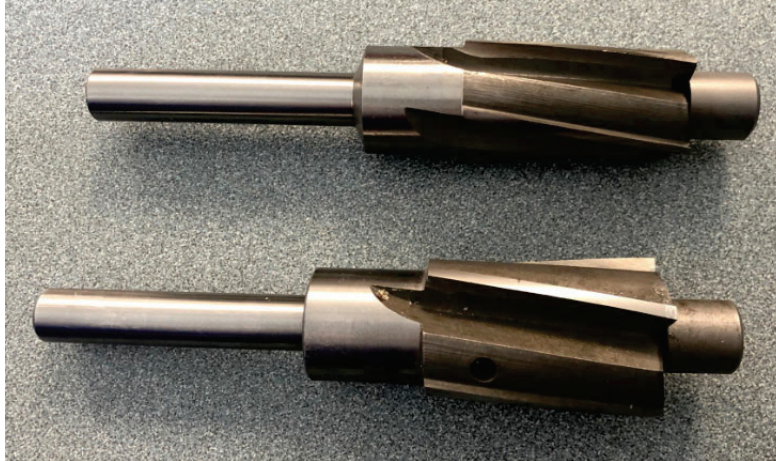
Example Reamer

1. Temporarily install each trunnion.
2. Using a slow speed drill and a 1 1/8" or 1 3/8" reamer with a 5/8" guide, ream out the bolt hole using the trunnion as a guide. Contact Wipaire Customer Service regarding tool use.

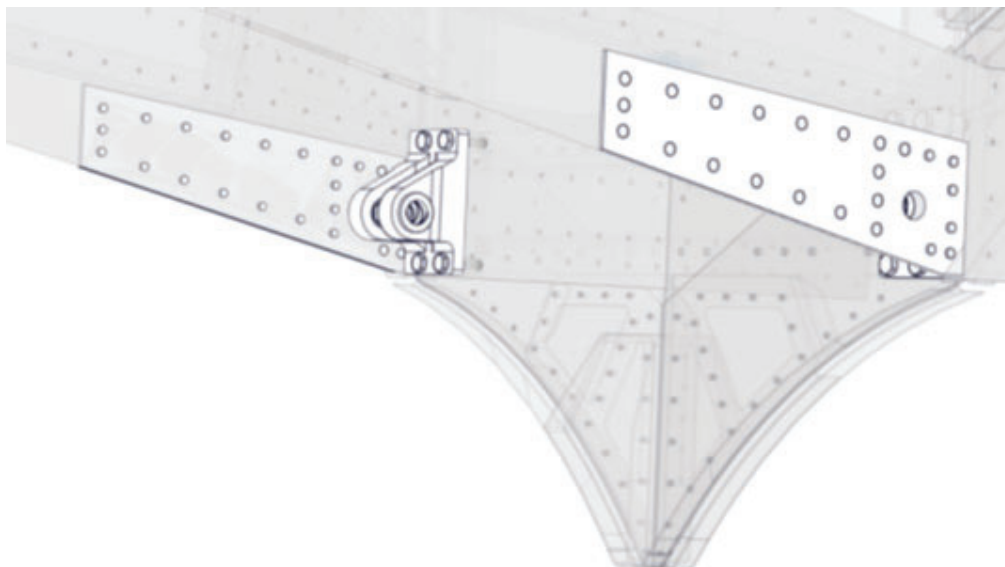
Figure 2

7. Temporarily install AN trunnion bolt (for alignment).
8. Secure the doubler to the carry through strap and back drill the (18) aft rivet holes (see rivets boxed in figure 2).

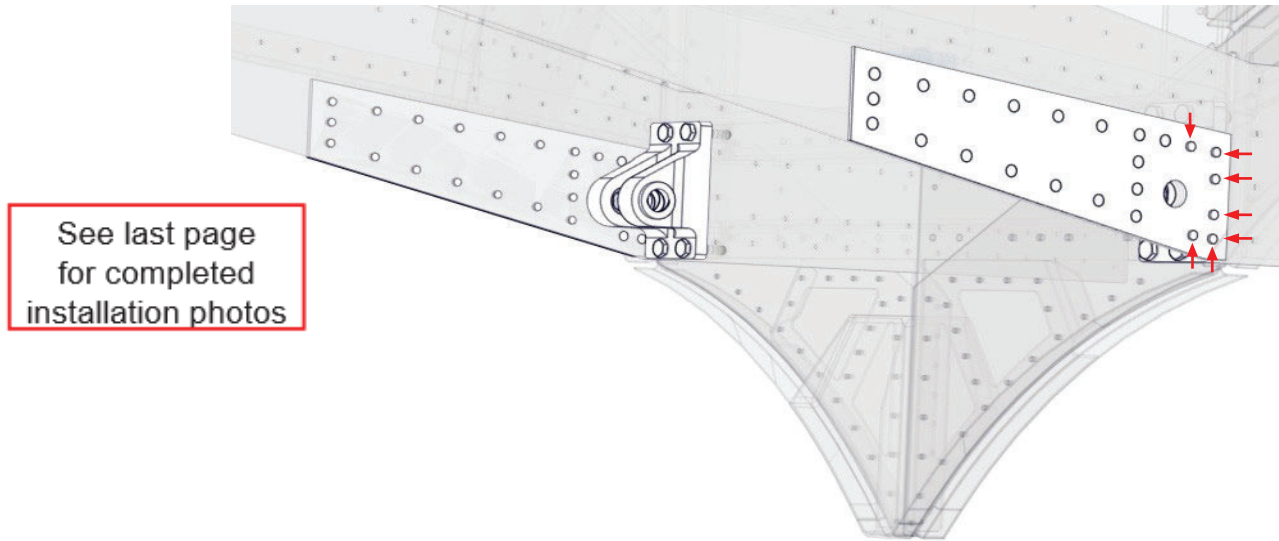
Figure 3

9. Remove each trunnion and backdrill the remaining (6) rivet holes (indicated by arrows in figure 3).
10. Countersink the (6) rivet holes on the inboard side of each carry through strap.
11. Fully seal the backside of the double with PR 1422-B2 or equivalent.
12. Wet install the double to the carry through strap using AN427AD5-XX or equivalent.
13. Install the remaining (6 rivets) flush with each carry through strap using AN426AD5-XX or equivalent.

NOTE: Counter sink rivets indicated with an arrow as well as the same rivets on the opposing side.

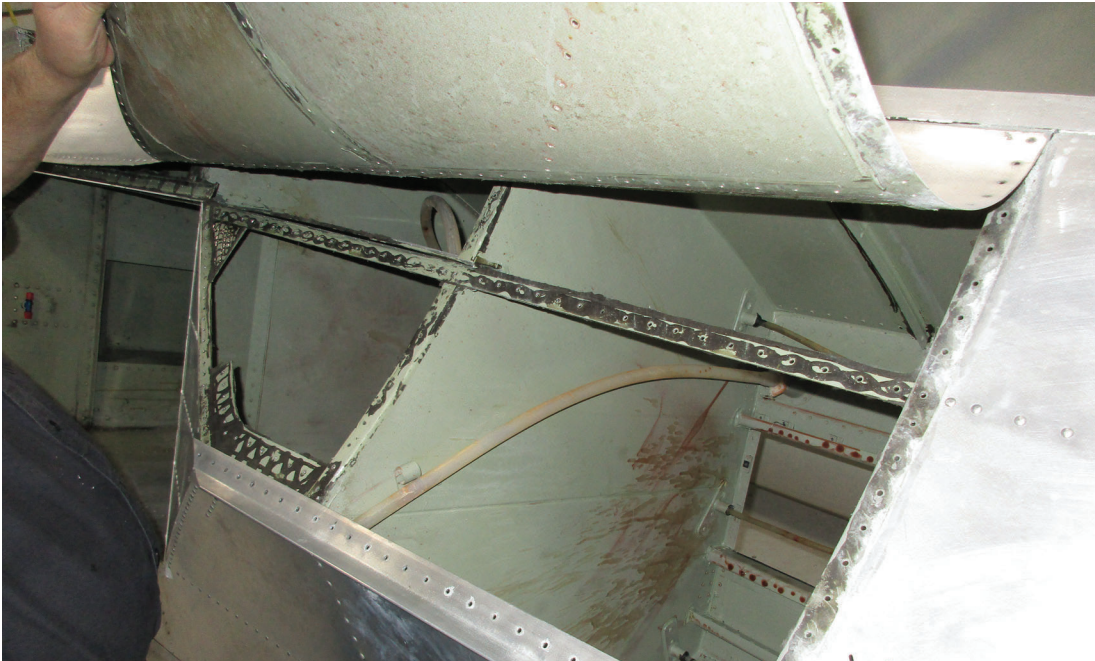
Figure 6

1. Support aircraft on stands. Refer to 8750 Service Manual for details.
2. Pull Amphib Pump 1 and Amphib Pump 2 circuit breakers.
3. Pull parking break.
4. Remove baggage floor, foam, bulkhead #9 panel.
5. Disconnect brake lines from bulkhead #10.
6. Remove main landing gear assembly including oleo.
7. Remove wheel well panel.
8. Drill off suction breaker between bulkheads 12-13.
9. Drill and loosen aft keel between bulkheads 11-15.
10. Drill and loosen aft skin from bulkheads 10-13, including inner sister keel and next to the carry thru strap. It is not necessary to drill out the flush rivets from the aft chine to remove the carry thru strap (see Figure 6).

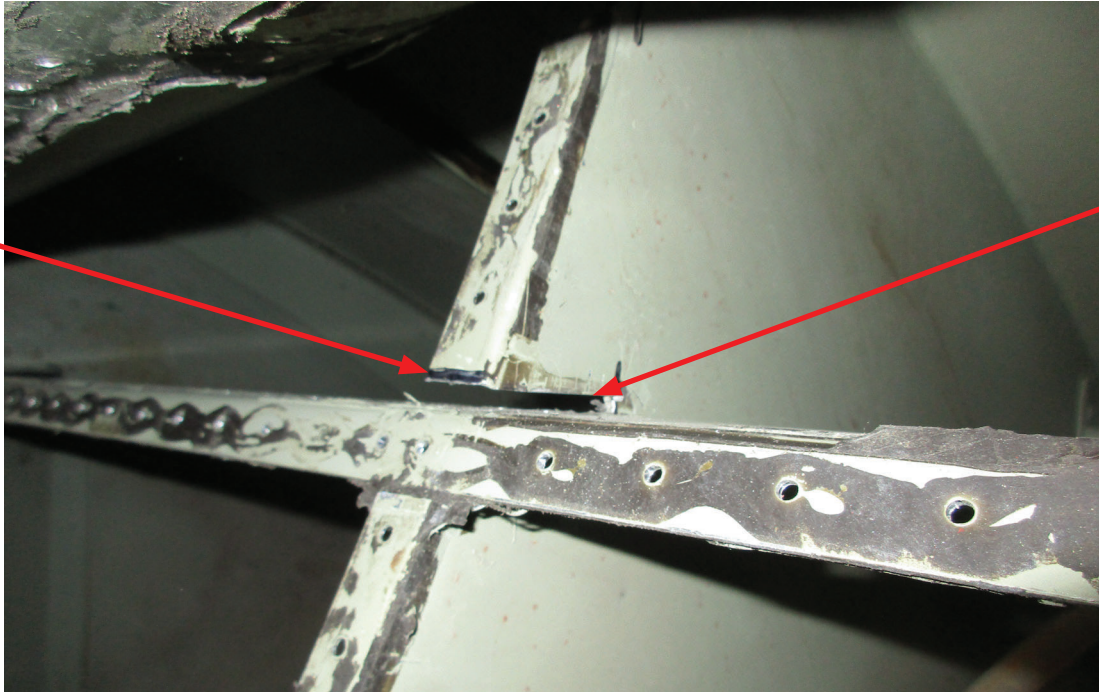
Figure 7

11. Drill out all rivets from the carry thru strap and remove all sealer.
12. Bulkhead #12 needs to be notched before removing the carry thru strap (see Figure 7).

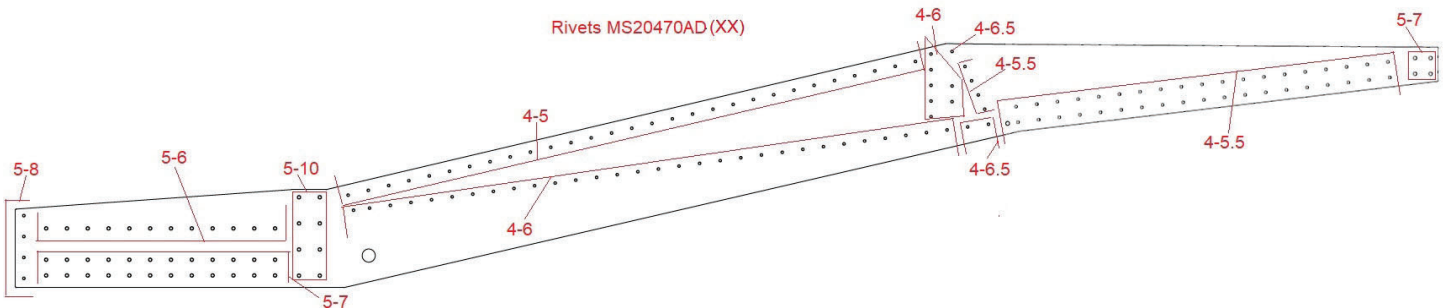
Figure 8

13. With carry thru strap removed, clean and remove any sealer as needed.
14. Fit new carry thru strap to float p/n 1006339 (LH) or p/n 1006340 (RH)
15. Apply sealer to new carry thru strap and rivet into place (see Figure 8).
