SERVICE LETTER NUMBER 146			
TITLE: 13000 BULKHEAD #6 CRACK REPAIR			
BY: C. SCHLEMMER	AIRCRAFT MAKE/MODEL(S):	FLOAT MODEL(S):	NOTE(S):
APP: J. SORTOR	DEHAVILLAND TWIN OTTER	13000	COMPLIANCE OPTIONAL S/L P/N 1006027 ECO 24031
DATE: 04/03/15			
REV: B

FAA APPROVAL HAS BEEN OBTAINED FOR TECHNICAL DATA IN THIS PUBLICATION THAT AFFECTS STC OR TSO DESIGN COMPLIANCE

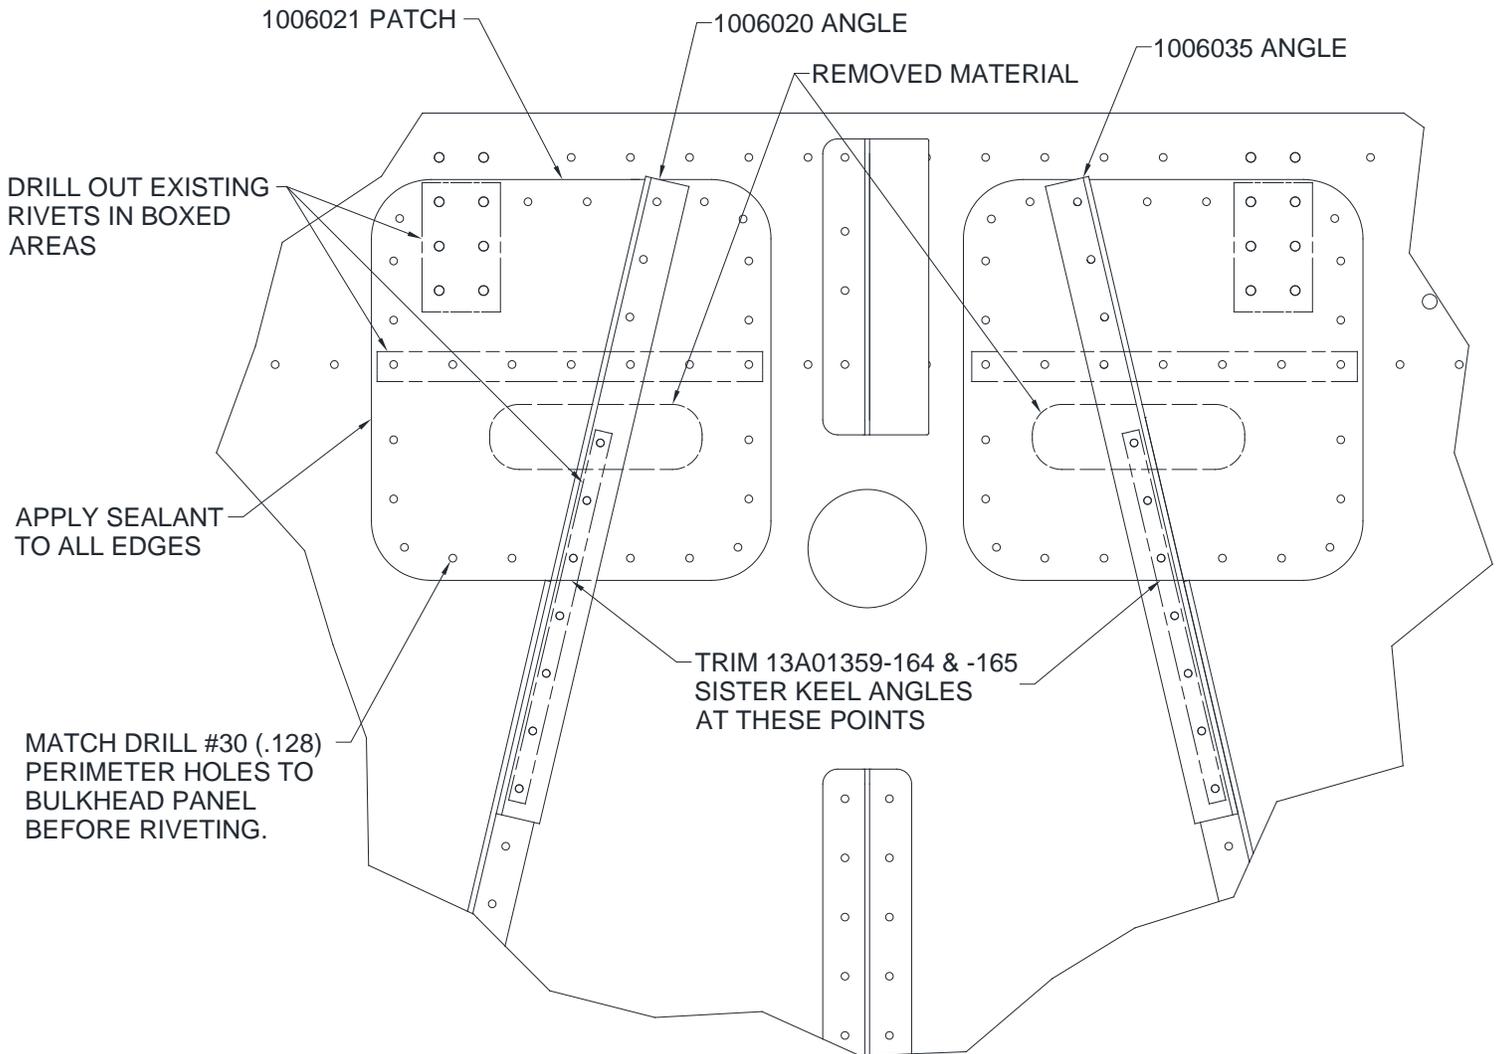
DETAIL B
13A01000-190
BULKHEAD ASS'Y

13A01000-190
BULKHEAD #6 ASSY, RH
(AFTER REPAIR)

5. Drill out remaining rivets in boxed area as shown in Detail A drawing.
6. Trim bulkhead material to completely remove crack. Radius corners of trimmed area to 0.5" minimum. Maintain minimum distance of 3 times the diameter size from rivet line.

REMOVE MATERIAL ENCOMPASSING CRACKS.
MAINTAIN MINIMUM 3X DIA SIZE FROM RIVET LINE.
CORNERS MUST BE 0.50 R MINIMUM.
