SERVICE LETTER: 76

DATE: July 18, 2024

TITLE: AT-802 Fire Boss Finlet Inspection & Repair

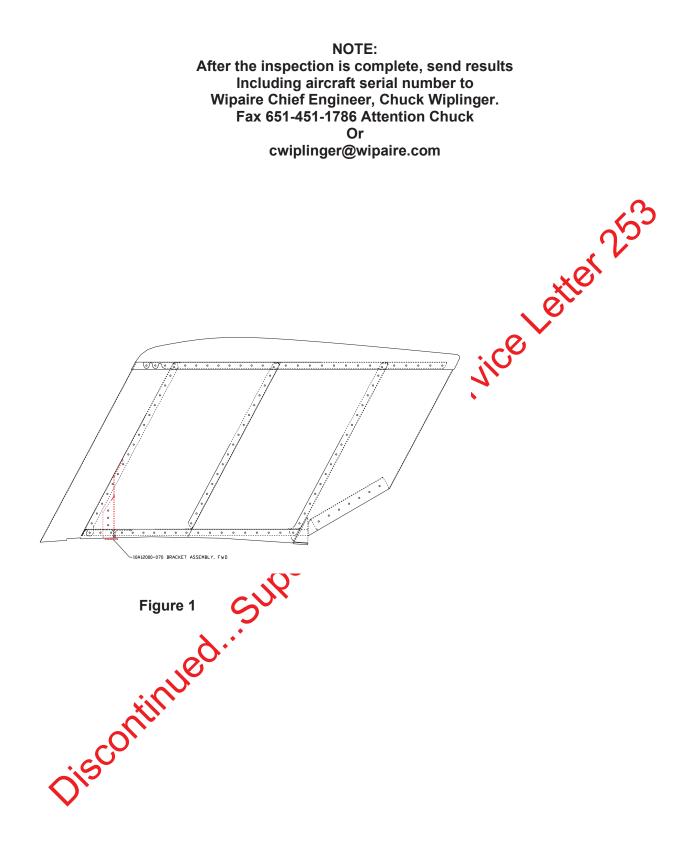
BACKGROUND INFORMATION: AT-802 with Fire Boss modifications have been experiencing cracking along the weld on the front bracket that holds the finlet onto the horizontal stabilizer. Thus far the cracks have been limited to the early model conversions. Corrosion in this area may have been a factor.

Visually inspect the welded seam of the finlet's forward attach bracket (p/n 10A12000-070) for cracks along the weld. Fax or email results of inspection as noted below. Pictures may be helpful to Wipaire Engineering.

If any crack or corrosion is found on the fitting and is less than .6 centimeters (1/4 inch), there are 2 options of compliance.

Option 1: Mark the end and re-inspected ery 10 hours for propagation. If there is propagation, replace the pracket as soon as practical or re-weld as per Option 2.

Option 2: Remove the bracket from the finlet using the directions included for field replacement in Service Kit 55. Remove all finish from the bracket. Clean and re-weld crack area and continue the weld all the way around the bracket, as shown in Figure 2, as per FAR 43.13. Stress relieve the bracket and re-price and paint for corrosion protection.

If crack or corrosion is longer than .6 centimeters (1/4 inch), field replacement of the bracket will be necessary. Detailed procedures are listed in Service Kit 55 for the field Replacement of the bracket.
