SERVICE LETTER NUMBER 157			
10000 BULKHEADS 8-12, LOWER FLANGE REINFORCEMENT			
BY: MAB	AIRCRAFT	FLOAT MODEL(S):	NOTES: OPTIONAL
APP: SDW	MAKE/MODEL(S):	10000	COMPLIANCE
DATE: 5/21/2019	AIR TRACTOR		S/L P/N 1008067
REV: B	AT-802, AT-802A

This service letter applies to Air Tractor AT-802 and AT-802A when equipped with Wipline model 10000 floats (STC SA01795CH).

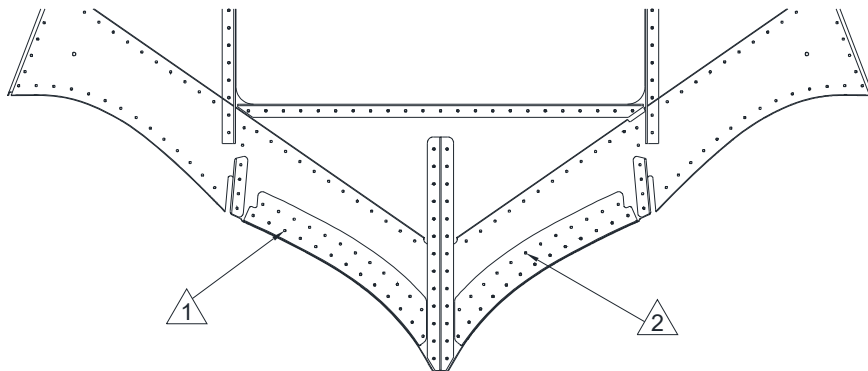
FIGURE 8: FRONT VIEW – BULKHEAD DOUBLERS AND RIVET LOCATIONS

Aircraft equipped with Wipline model 10000 amphibian floats that regularly operate in rough water, may experience cracking of the forward and aft lower bulkhead flanges located in the baggage area of the float as indicated in Figure 1. This service letter and associated kit reinforce the lower bulkhead flanges to reduce probability of cracking as a result of operations in rough water.

- 4) Deburr all drilled rivet holes in bulkheads and doublers.
- 5) One doubler at a time; apply PR1422 sealant completely to mating faces of doubler, bulkhead, and bottom skin, then rivet appropriate doublers as called out in the Parts List and Figures 2-6 to the forward and aft lower bulkhead flanges and bottom skin using MS20470AD4 rivets, grip as required. Perform this operation at bow bulkheads indicated in Figure 1. Drive rivets while sealant is wet.
- 6) Wipe away excess wet sealant after riveting.
- 7) Replace baggage hatch floors and reinstall top deck covers with new seals.
- 8) Water check floats
