SERVICE LETTER 253

Horizontal Stabilizer Spar Cracking At Finlets

Aircraft Makes/Model(s):	Float Model(s):	Compliance: Mandatory	By: MAS
Air Tractor AT-802 & AT-802A	10000A	Part Number: 1012347	Approved: DRH
		Date: 7/3/2024	Revision: D

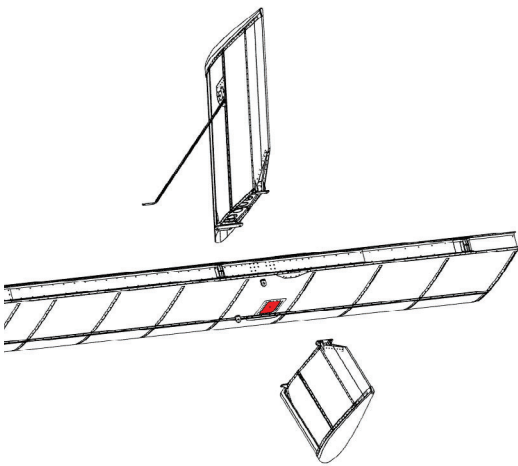
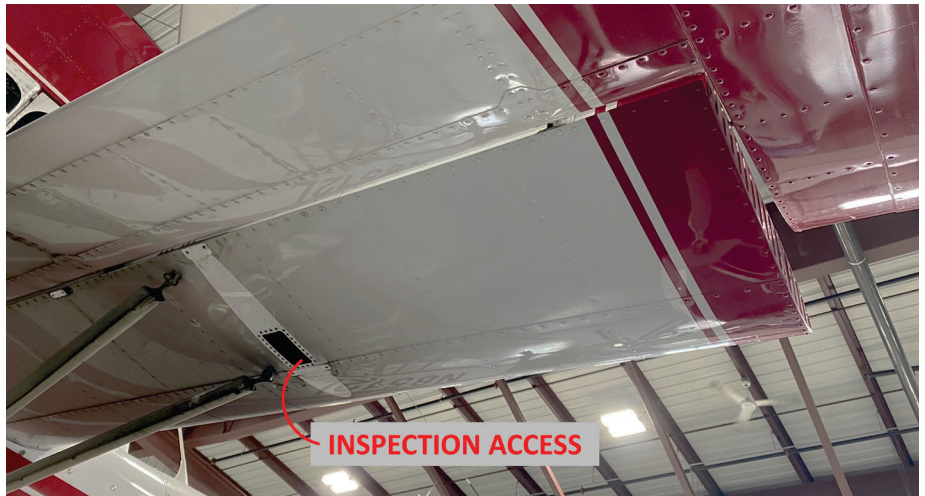
Figure 2

Inspection Access Locations

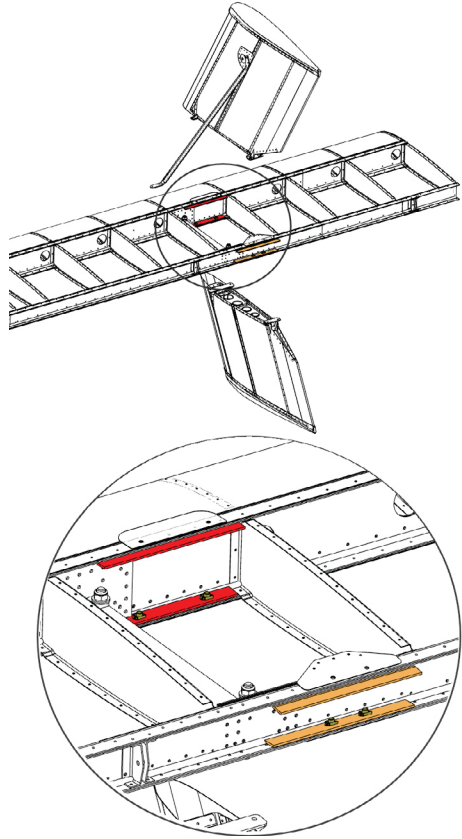
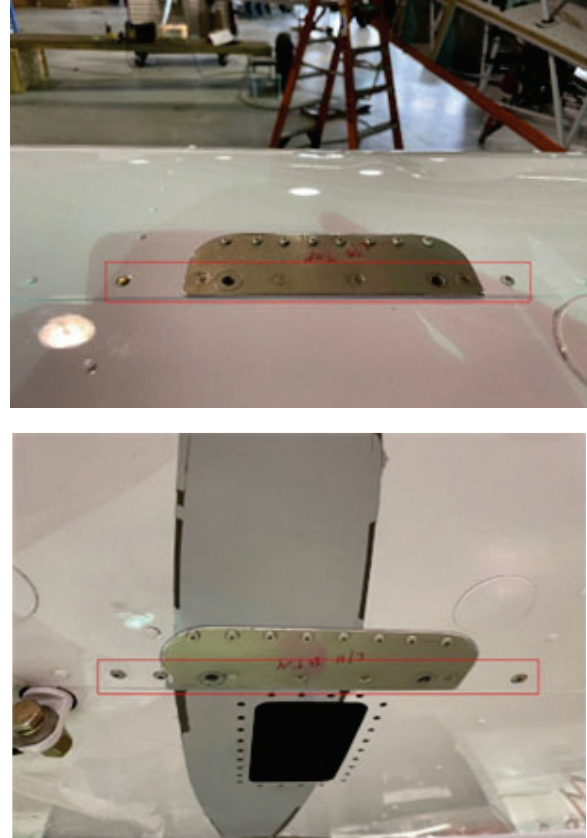
Figure 3

4. Remove the upper and lower spar strap (10A12001-074) from the forward horizontal stabilizer spar by drilling out the rivets holding it in place. See the parts highlighted in red in Figure 3.

Stabilizer forward spar strap locations (LH stabilizer shown)

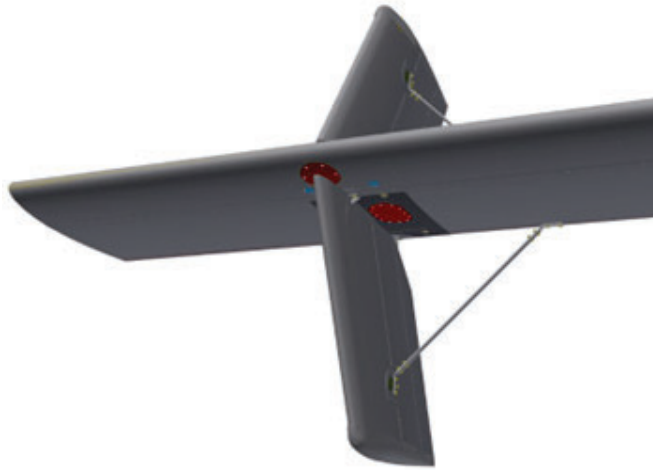
Figure 7
Access Locations

4. Clean the area that is to be inspected.
5. Visually inspect for:
 - a. Cracks on the forward and aft horizontal stabilizer spar at finlet attach areas, including both upper and lower flanges and the web area between.

- b. Cracks emanating from any holes, including those with fasteners installed.
 - c. Cracks on bathtub fittings, especially at holes which may or may not have fasteners installed at time of inspection (forward fittings are removed for 1500hr inspection), and in the radiused corners of these fittings.

- d. Elongated holes and corrosion in the areas and parts described above.
6. If no damage is detected continue to the next step, otherwise:

Damage as described above that is discovered in this area of the horizontal stabilizer spar necessitates replacement of spar; the procedure for replacing the spar is beyond the scope of this service letter. Forward spar assemblies may be ordered directly through Wipaire or local Air Tractor dealer. See the parts list in the “Work Instructions – Install Bathtub Fittings” section.

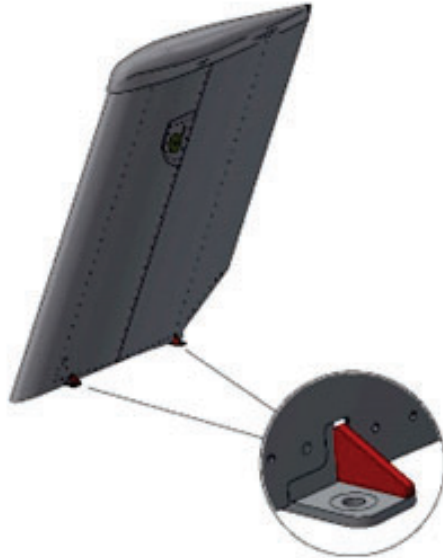
Figure 8
Finlet Mount Weldment Gussets

1. Remove elevator.
2. Remove finlets. To be eligible for reinstallation, finlet mount weldments must be a revision that includes the welded gussets shown in figure 8 below. It is also possible that general fitment issues will necessitate new finlet assemblies. Refer to installation drawing 7D1-4399 for replacement part numbers.

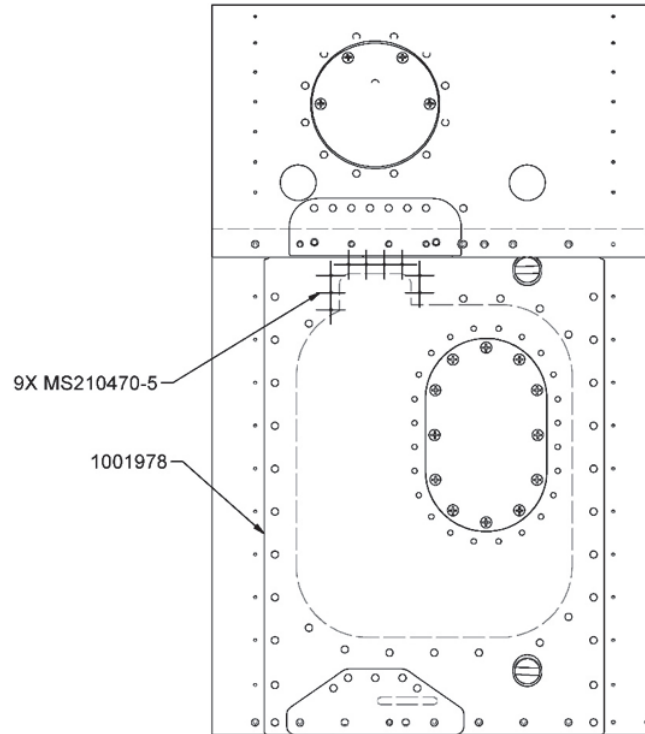
Figure 9
Alternate Skin Patch

Note: Service Letter kit utilizes an alternate skin patch to accommodate prior modification of stabilizer skin. (1001978 in place of 1001971)
