# SERVICE LETTER 253

## Horizontal Stabilizer Spar Cracking At Finlets

<b>Aircraft Makes/Model(s):</b>	<b>Float Model(s):</b>	<b>Compliance:</b> Mandatory	<b>By:</b> MAS
Air Tractor AT-802 & AT-802A	10000A	<b>Part Number:</b> 1012347	<b>Approved:</b> DRH
		<b>Date:</b> 6/18/2026	<b>Revision:</b> G

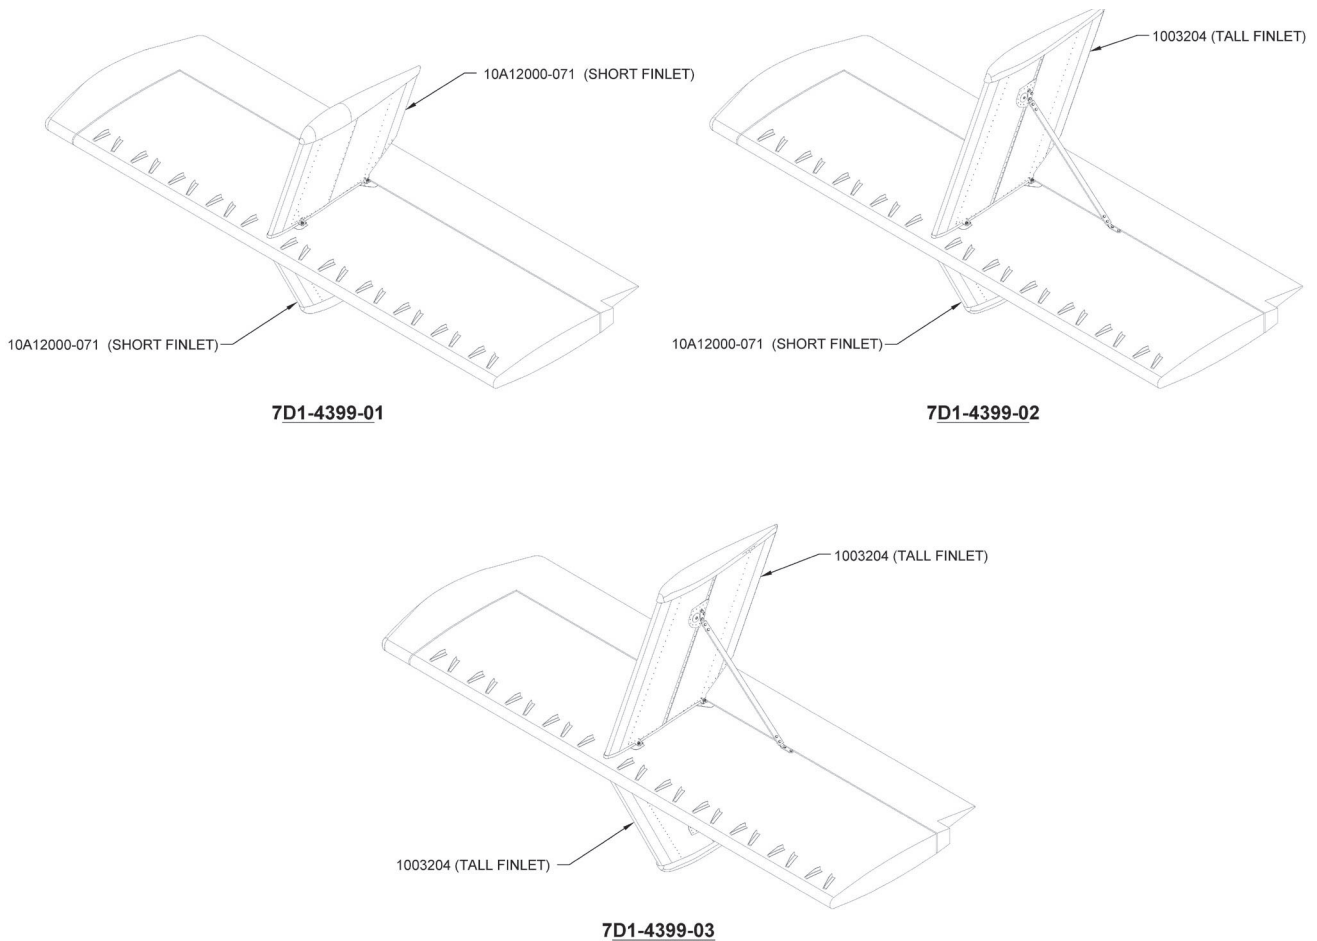
**Figure 1**  
**Finlet Configurations (RH Stabilizer Shown)**

Compliance is mandatory with initial inspection window and recurring inspection intervals based on finlet configuration and spar reinforcement method. Refer to Figure 1 and the tables within the Compliance Method section. Inspection and retrofit procedures are described in the various "work instruction" sections of this service letter.

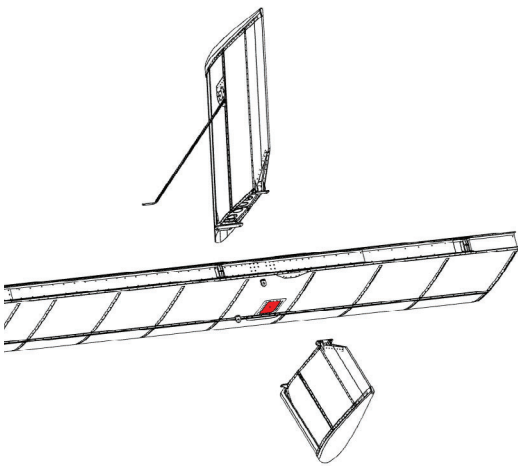
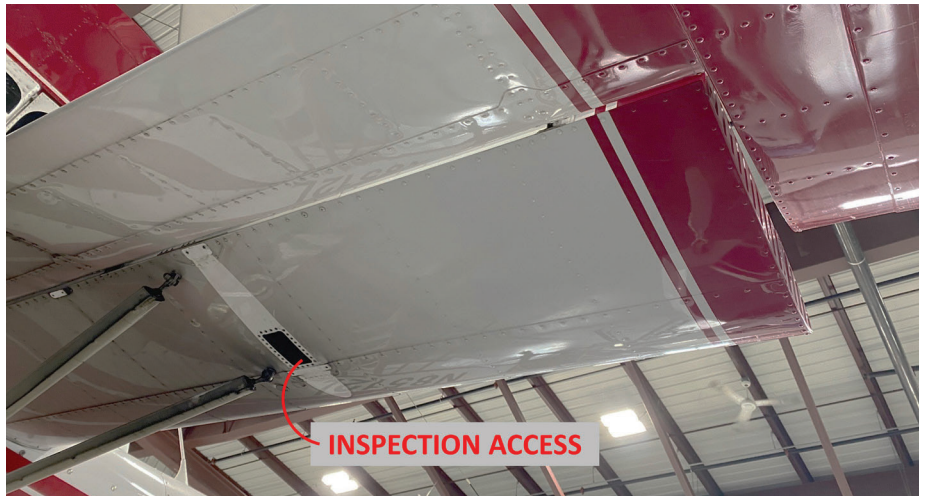
Figure 2

#### Inspection Access Locations

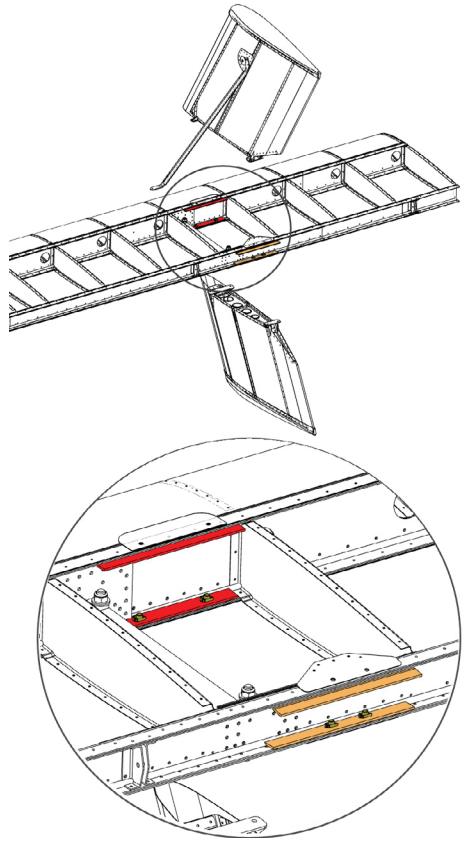
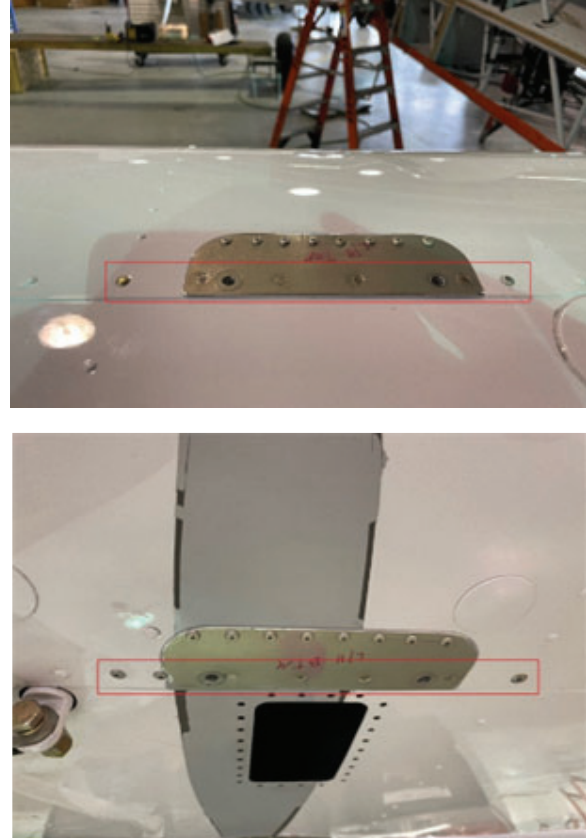
**Figure 3**

4. Remove the upper and lower spar strap (10A12001-074) from the forward horizontal stabilizer spar by drilling out the rivets holding it in place. See the parts highlighted in red in Figure 3.

**Stabilizer forward spar strap locations (LH stabilizer shown)**

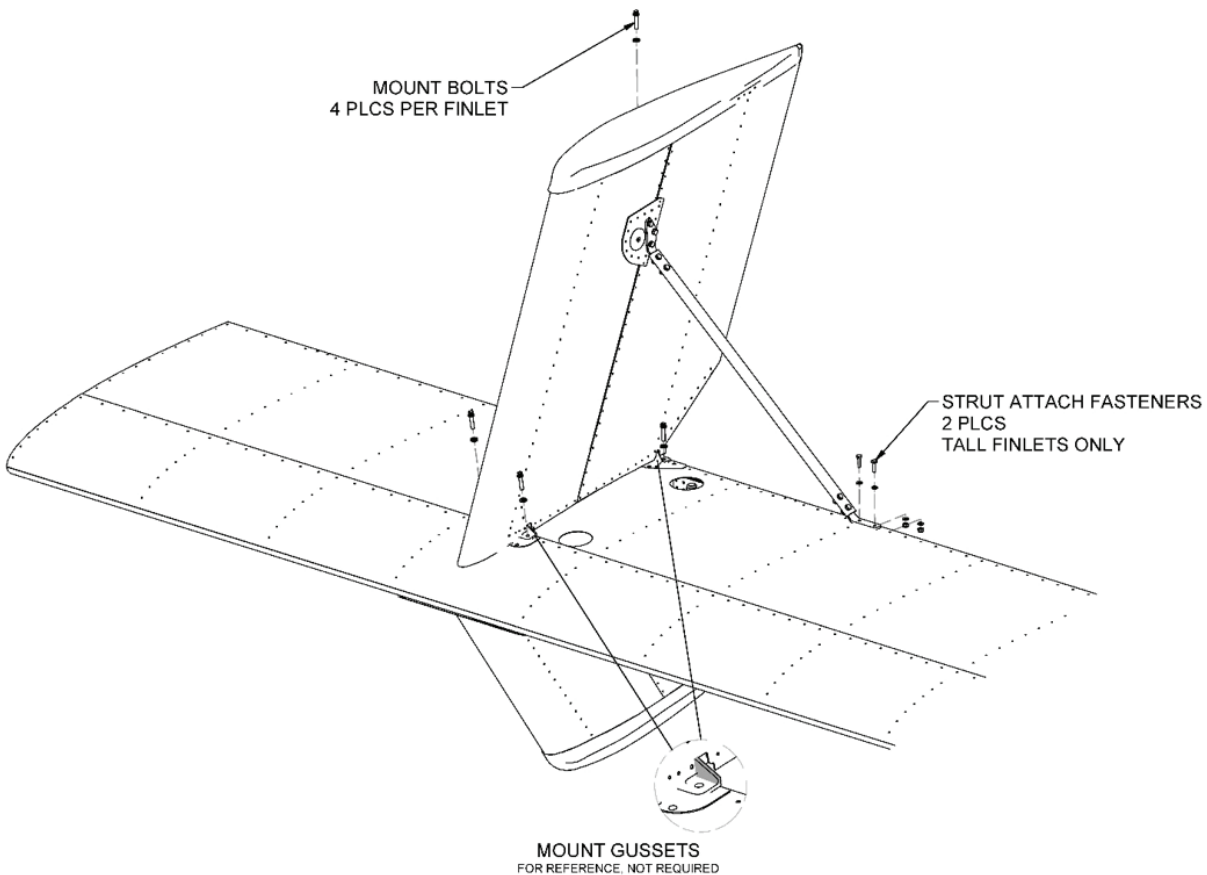
**Figure 8**  
**Finlet**

1. Remove elevator per Air Tractor service documents.
2. Remove finlets. Each finlet is fastened by (4) bolts at the mount weldments. If present, detach strut from horizontal by removing (2) bolts through aft spar. Refer to Figure 8.

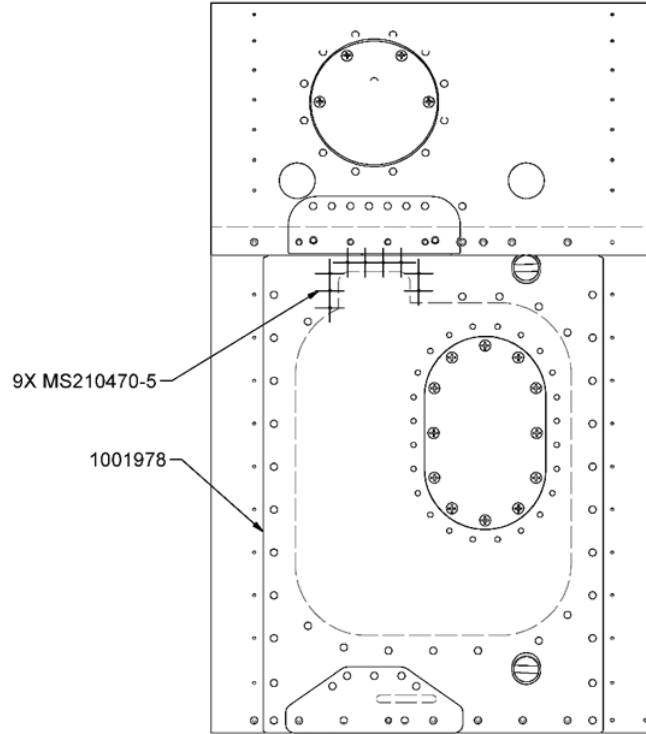
**Figure 9**  
**Alternate Skin Patch**

**Note:** Service Letter kit utilizes an alternate skin patch to accommodate prior modification of stabilizer skin. (1001978 in place of 1001971)
