## SERVICE LETTER 253

### Horizontal Stabilizer Spar Cracking At Finlets

| Aircraft Makes/Model(s): | Float Model(s): | Compliance: Mandatory | By: MAS |
| Air Tractor<br>AT-802 & AT-802A | 10000A | Part Number: 1012347 | Approved: DRH |

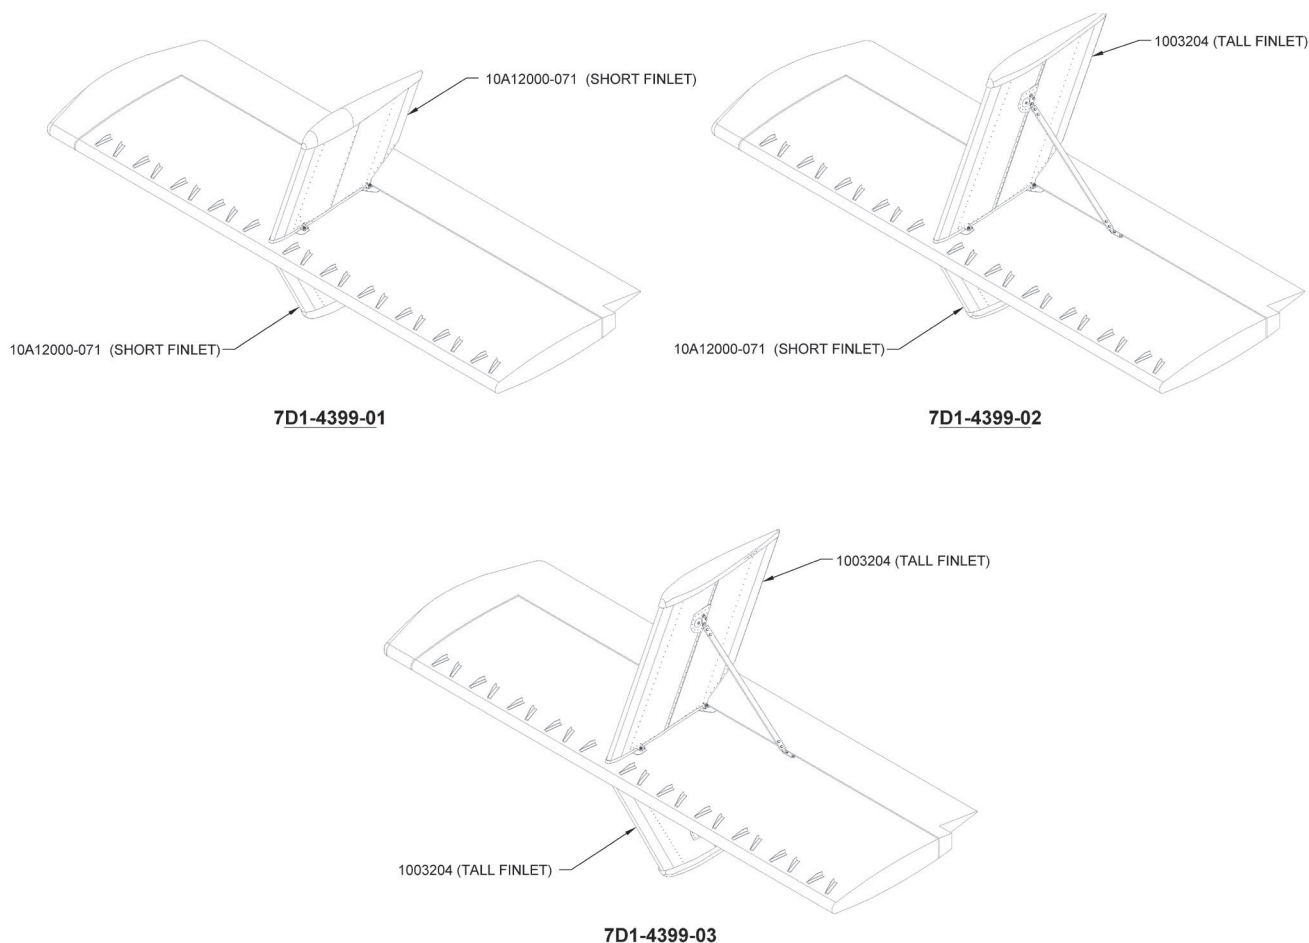
**Figure 1**  
**Finlet Configurations (RH Stabilizer Shown)**

Compliance is mandatory with initial inspection window and recurring inspection intervals based on finlet configuration and spar reinforcement method. Refer to Figure 1 and the tables within the Compliance Method section. Inspection and retrofit procedures are described in the various "work instruction" sections of this service letter.
