**SERVICE MANUAL & ICA FOR THE
AMPHIBIAN GEAR ADVISORY SYSTEM &
LASER GEAR ADVISORY SYSTEM**

Document No.: 1008655

Revision: H

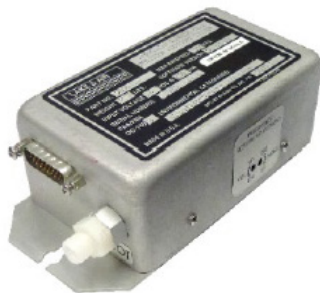
AGAS Controller 9600-1A (Discontinued)

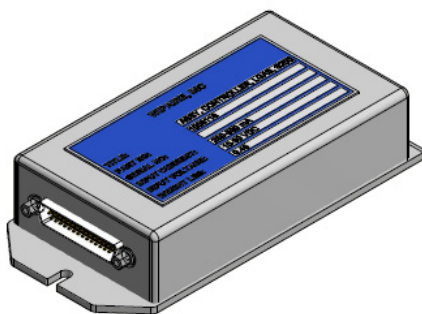
AGAS MKII / LGAS Controller 1006831 or 1006839

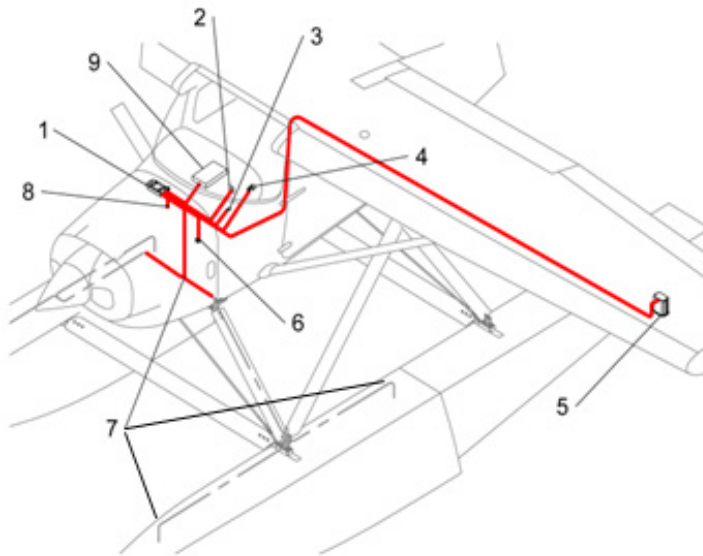
| 1. LGAS Controller | 4. Illuminated Switch (LGAS only) | 7. Landing Gear Position Switches |

- a) Adds a wing mounted laser array to determine if the aircraft is directly over land or water.
 - b) If below 400' agl, the LGAS compares the surface directly below aircraft with the gear position switches to determine if the gear is properly configured, and will only issue an alert if the gear position and laser indications are not in agreement with each other.

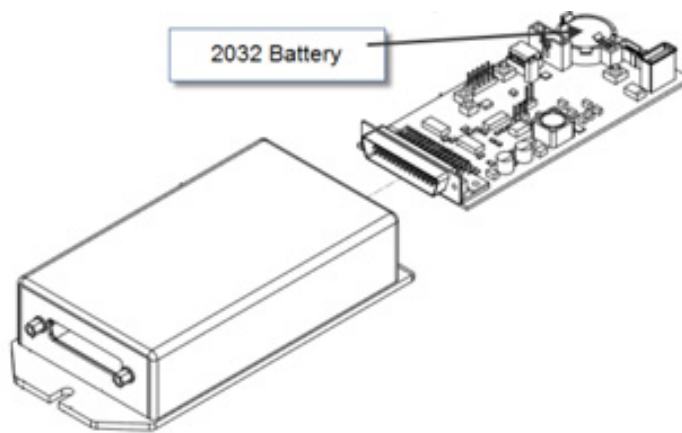
The AGAS MKII and LGAS (shown) computers maintain date and time information during periods of non-operation by means of a single 2032 coin battery installed on the printed circuit board. The battery has a minimum life of one year with reserves, although should be changed at annual inspection. If the battery should fall below minimum acceptable voltage, the gear advisory power up test will announce “CHANGE GEAR ADVISORY BATTERY,” instead of the typical “GEAR ADVISORY BATTERY OK” announcement. The system may continue to function normally for several days after the battery change announcement, but should be changed as soon as practicable.

6. The board is equipped with a small capacitor that will maintain the internal clock for 60-90 seconds during battery replacement. Carefully remove and replace the 2032 button cell, observing proper polarity of the battery.

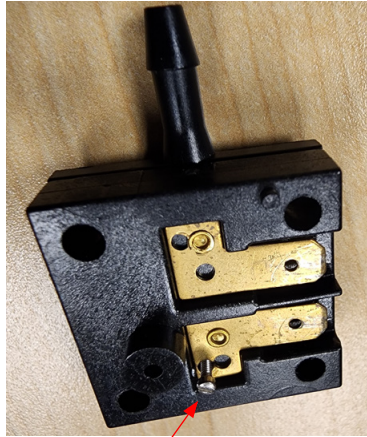
Set screw is adjustable.

1. Set airspeed switch by putting a multimeter set to continuity on the contacts of the switch.
2. Set the airspeed from a pitot static test box to the desired speed. Refer to the installation drawing and/or the Recommended Gear Advisory Speeds chart below for recommended speeds.
3. Once airspeed is set, adjust screw on airspeed switch until the contact closes.

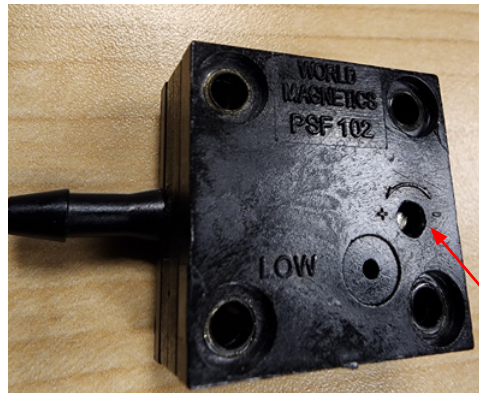
Do not cover this hole. This can affect the airspeed reading.

4. If switch is being reinstalled to airframe, ensure an air gap between static port and surrounding structure.

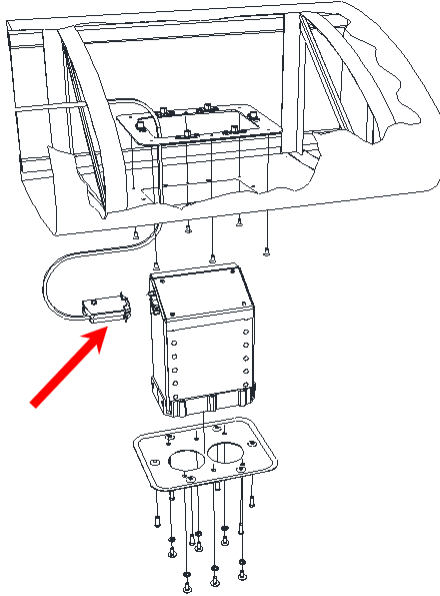
To disconnect Laser Assembly:

1. Remove Laser from its stowed location, normally located in wing.
2. Disconnect 9-pin connector from Laser Assembly and stow Wing Harness using plastic cable-ties. Ensure re-stowed Harness will not interfere with control cables, linkages.
3. Replace Laser assembly in wing.
4. "Laser Inoperable" must be placarded near gear handle assembly.
5. Make appropriate logbook entries for the service performed.

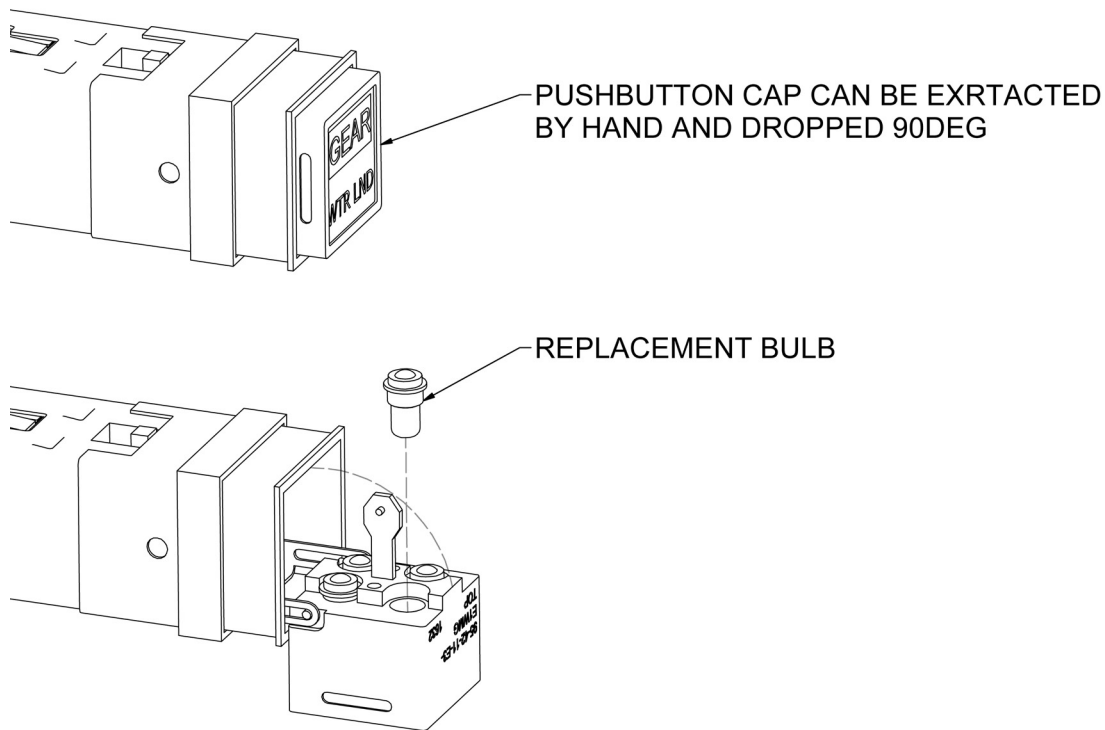
To replace bulb (aka lamp):

1. Extract illuminated pushbutton cap by hand using the slots on either side.
2. Once clear of housing, cap can be dropped 90deg for access to bulbs.
3. Remove bulb(s) and replace. Replacement bulbs are available through Wipaire, PN 14-112
4. Reinsert cap into switch housing.
