# **SERVICE MANUAL & ICA FOR THE AMPHIBIAN GEAR ADVISORY SYSTEM & LASER GEAR ADVISORY SYSTEM**

**Document No.: 1008655**

**Revision: J**

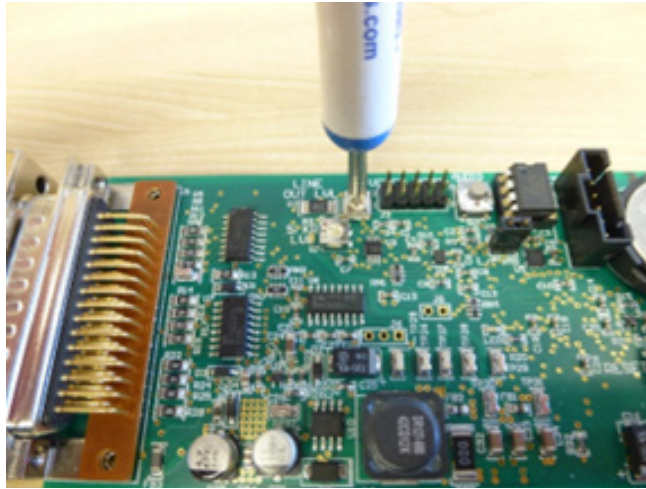
2. With enclosure removed, carefully reattach board to 44-pin connector from airplane. To avoid damage, do NOT touch any of the components on the board.
3. Locate the R1 potentiometer near edge of circuit board (as shown at right) and using a small screwdriver, rotate switch to find center of its range.

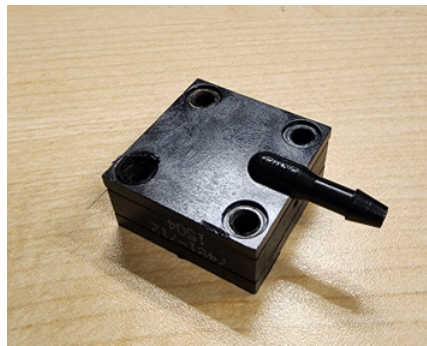
**Airspeed Switch**

**Note:** Airspeed switches are not pre-set by Wipaire for a specific airframe prior to installation.

Airspeed threshold setting can be adjusted using a multimeter and pitot-static test box as follows:
