Float / Ski Model  
Wipline 10000 Floats

Title  
Wipline 10000 floats baggage floor repair

## **SERVICE KIT: 74**

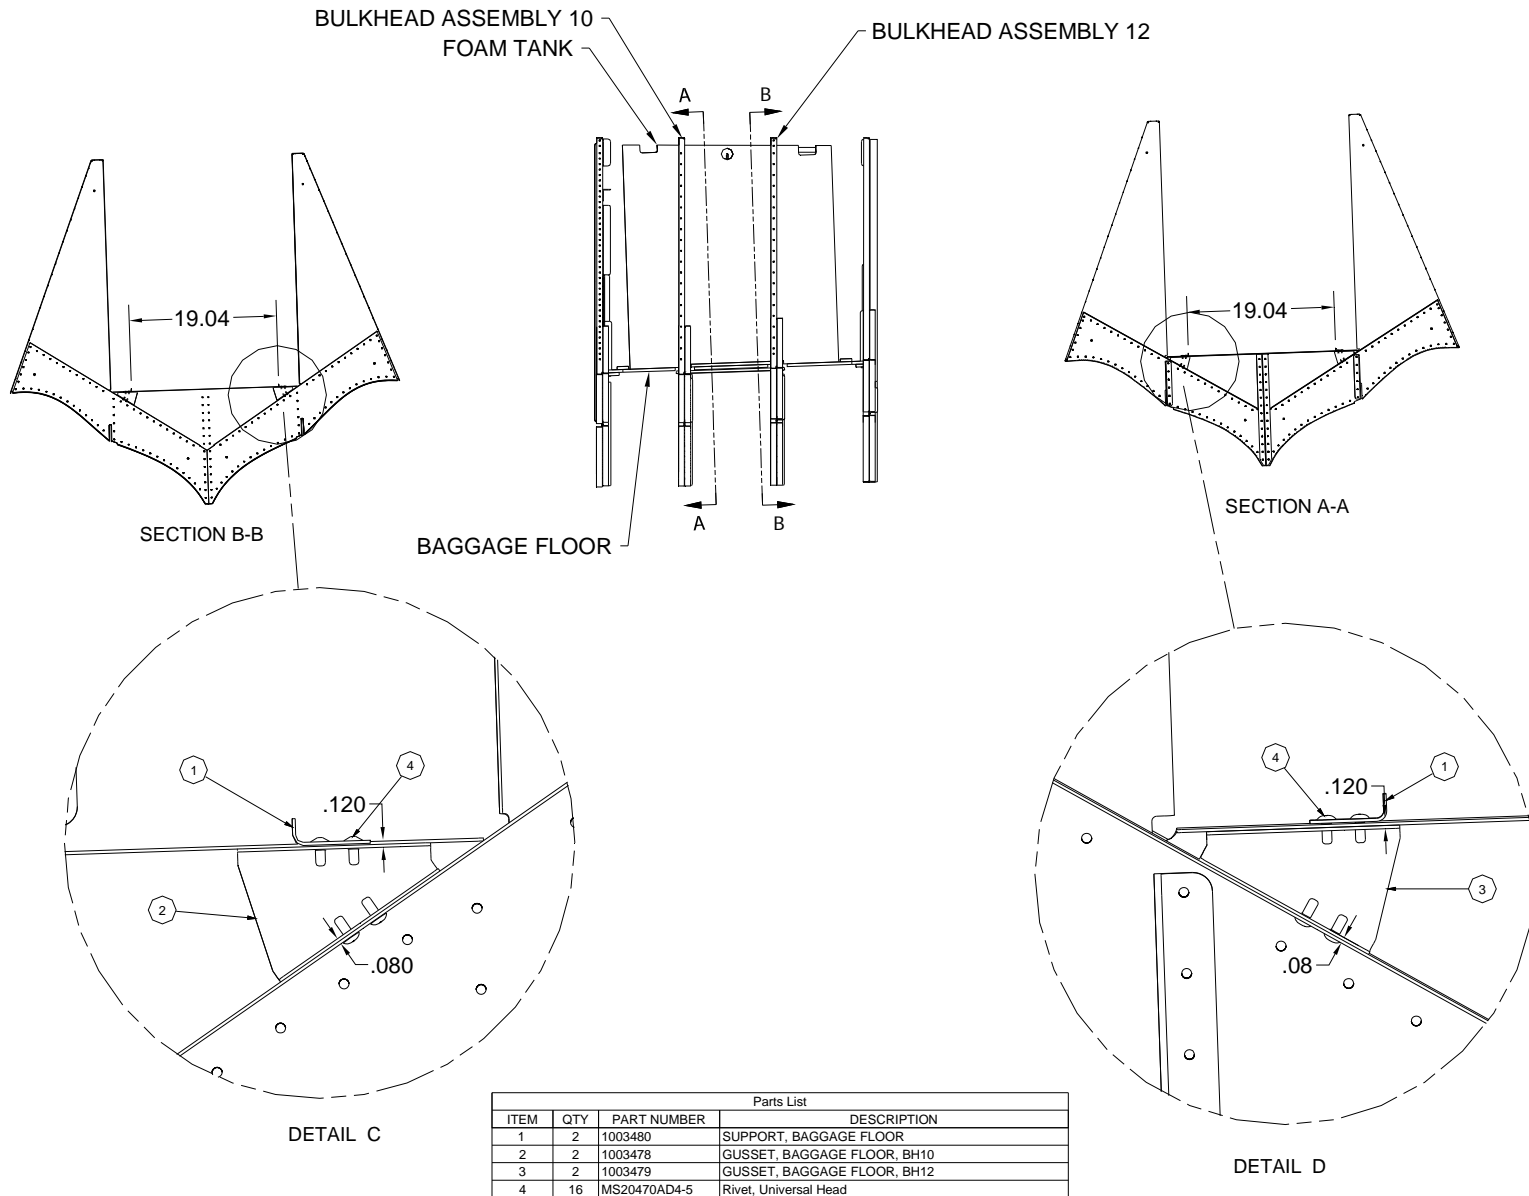
**COMPLIANCE:** This Service Kit is to be complied with as needed based on the findings of regular inspections inside the baggage compartments. Later serial numbered floats should not encounter this problem as the reliefs in the floor and reinforced corners of the central panel as shown on page 2 were incorporated into production.

**BACKGROUND INFORMATION:** A few operators have experienced the baggage bulkheads cracking. After investigation it was determined this can happen because the baggage floor flexes under loads and puts pressure on the nearby bulkheads. Refer to Service Letter 101 for more information.

**METHOD OF COMPLIANCE:** Install included parts with Service Kit 1002760 as per drawing 1002760. Use sealant between all mating parts, rivets are not included in the kit.
